Fatality Assessment and Control Evaluation Project

KY FACE # 01KY062

May 22, 2002

SUBJECT: Youth Riding as Passenger on Tractor Killed by Overturn

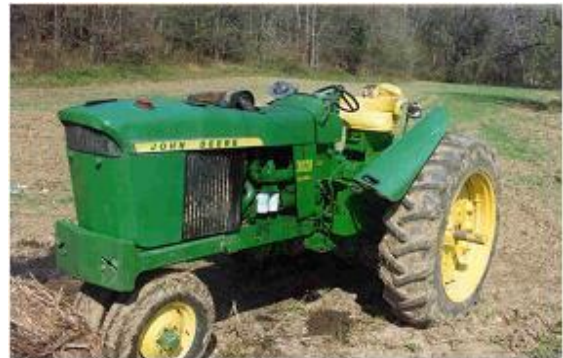
On the day of the incident the driver of the tractor and the victim had been baling hay since morning. At approximately 19:30 the victim was accompanying the driver and was seated on the fender over the left wheel of the tractor (see Figure 1). The tractor was a 65 horsepower diesel-powered John Deere 1969 tricycle, Model 3020, which the driver had bought used 2 years prior. The rear tires were spread 67" apart (center to center). This 6200-pound tractor (Official Guide – Tractors and Farm Equipment¹) was designed as a general-purpose farm tractor. The tractor and its tires were in good condition prior to the incident and the brakes were functioning. The tractor was not equipped with a ROPS or seatbelt. The rear tires were fluid filled to approximately the same level, one-third to one-half full. The tractor had no front-end counter weights for greater stability.

Figure 1. Tractor that overturned showing fender on which victim had been sitting.

Discussion #1: Tractors are designed for one operator with one set of controls and do not have passenger seats. A space is available for a person to sit on the fender; however, this is not the designers' intent. An estimated 1,100 youth less than 20 years old were injured in tractor related incidents in the United States during 1998 (CDC DHHS June 2001)², some of these severe enough to be fatal.

Recommendation #1: Individuals should not ride as passengers on an operating tractor, and drivers should not allow extra riders/passengers.

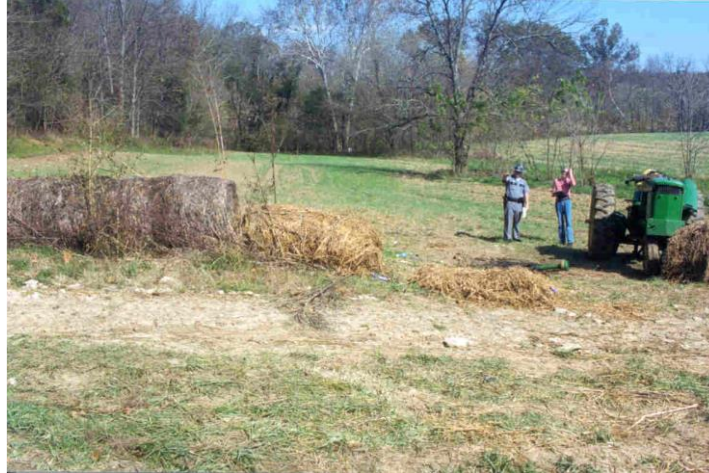
The weather was cloudy and about 70 degrees. Rainfall a couple of days prior to the day of the incident had left the ground somewhat muddy. The driver was attempting to load a bale of hay onto a 3.5 foot spike that was 2 inches in diameter. It was dusk and the tractor had its headlights on. The tractor had been moving backwards towards the bale of hay in a westerly direction down a slope that declined approximately 1 inch per foot, increasing to a slope of approximately

Figure 2. Site of Tractor Incident.

2 inches per foot at the spot where the tractor overturned (see Figure 2). As it reversed, the right rear wheel of the tractor proceeded over the hay bale causing the tractor to overturn sideways to the left (see Figure 3). According to the driver's father, the driver reported that both the victim and the driver each attempted to push the other free of the falling tractor. The victim was trapped underneath the driver's seat. The driver was thrown clear by a rotating tire, but sustained damage to his lungs and ribs. Nevertheless he attempted to free the victim. When he was unable to free her, he started up the nearby road on a steep hill that led to his home, a quarter mile away.

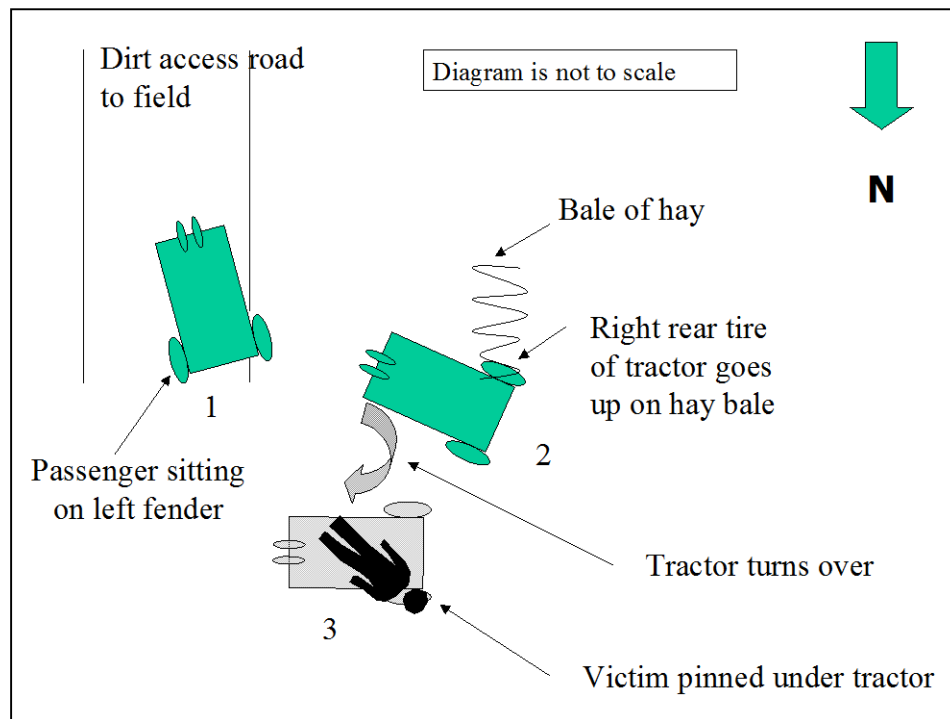
Figure 3. Schematic diagram showing sequence of tractor overturn and final position of victim. The father of the driver was working in an adjacent field without visual access to the field in

The tractor suffered minor damage such as: left side fender was bent, steering wheel broken, seat bent, exhaust stack bent over, right hand mounting fender bracket broken, air intake valve sheared off.

Discussion #2: Rollover protective structures prevent deaths³. The tractor involved in this incident, manufactured in 1969, was not equipped with ROPS or a seatbelt, which protect the operator in the event of a rollover, and in this case might have prevented a 180 degree overturn by the tractor. ROPS first became available as optional equipment on farm tractors in 1971. These safety features were not required on tractors, however, until 1976, when OSHA Standard 29 CFR 1928.51⁴ went into effect. Although this standard does not apply to tractors manufactured prior to 1976, and thus would not apply to the 1969 model tractor in this case, it is possible to retrofit older tractors with ROPS and seatbelts, and it is strongly recommended that this be done whenever possible. Tractor owners should contact dealers, manufacturers, or county extension agents for information on sources of retrofit ROPS and operator restraint systems. A retrofit ROPS is available for this tractor (A Guide To Agricultural Tractor Rollover Protective Structures⁵).

Discussion #4: Additional weight on the front of this tractor would have increased its stability and steering capabilities. While proceeding in reverse down a slight grade, the steering is affected by a reduction of the downward forces on the front wheels. To counteract, additional weights should be added to the front of the tractor. In addition, rear wheel weights are available and would add additional stability.

Recommendation #2: Tractor should be equipped with rollover protective structures and seatbelts.

Recommendation #4: Tractors should be equipped with front-end counterweights.

Recommendation #6: When purchasing used equipment, if it is not equipped with ROPS and/or seatbelts, such devices should be installed.
