Fatality Assessment and Control Evaluation Project

KY FACE # 02KY041

Date: March 11, 2003

**SUBJECT: Two Laborers Die From a Scaffolding Fall
Inside a Water Tank**

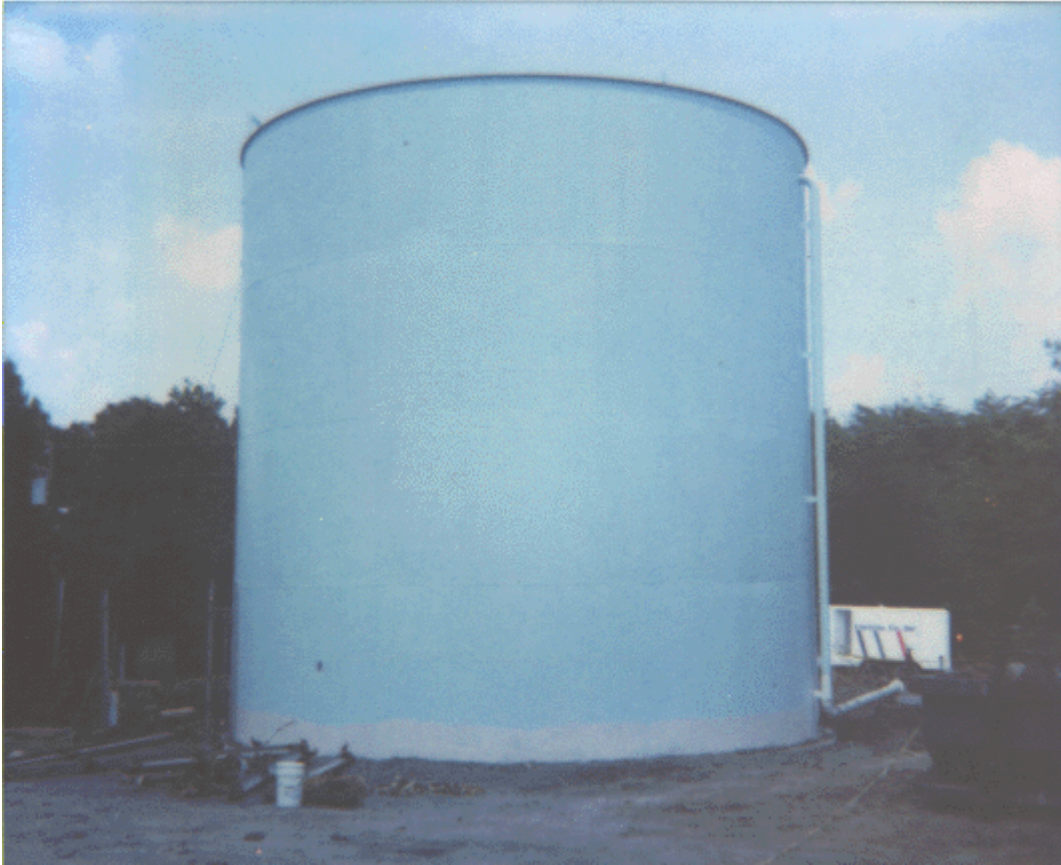
Upon investigation and reconstruction of the incident by Kentucky Labor Cabinet's Division of Occupational Safety and Health and the medical examiner, a piece of the anchoring mechanism, which secured the scaffolding, was discovered to be missing. The missing piece was not found at the site. In addition, neither laborer was wearing personal fall protection equipment at the time of the fatal incident. The personal fall protective equipment (body harness) was located in the toolbox onsite.

Picture of water tank where two men died as a result of falling when a cable slipped on suspended scaffolding. The tank was built in 1975 to provide water to a local community. It is 32 feet high and holds 200,000 gallons of water.

Recommendation No. 1: Scaffolding should be inspected for safety hazards prior to each work shift and every time the scaffolding is moved.

Discussion No. 1: Currently the Occupational Safety and Health Act 1926.451(f)(7) requires scaffolding to be inspected by a competent person prior to use after it is erected or has been modified. After the initial inspection, the scaffolding can be used without further inspection until it is modified. The scaffolding had not been inspected after it had been moved or the morning of the day of the fatal incident by a competent person.

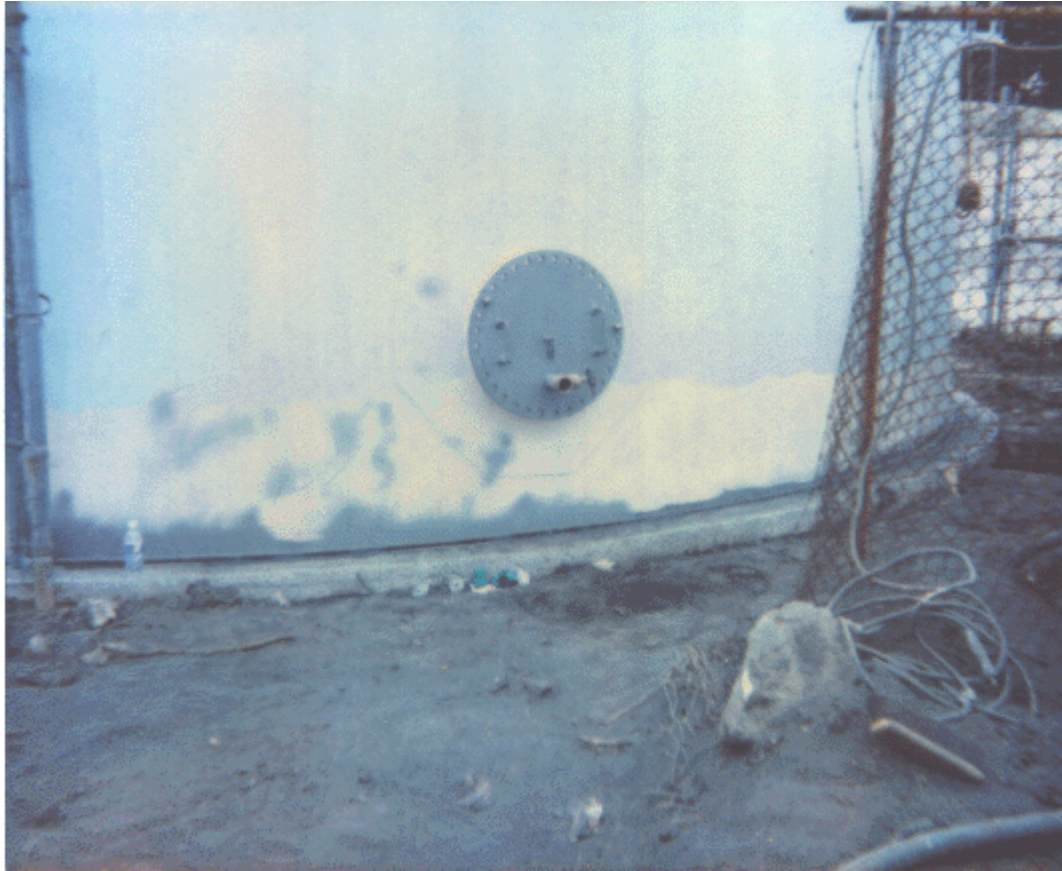
Picture of access / egress portal to water tank. The diameter of the access / egress is 24 inches and is 21 inches from the top of the concrete base, which is 5 inches deep.
