Fatality Assessment and Control Evaluation Project

KY FACE # 02KY085

SUBJECT: Migrant Worker Dies in Tractor Rollover

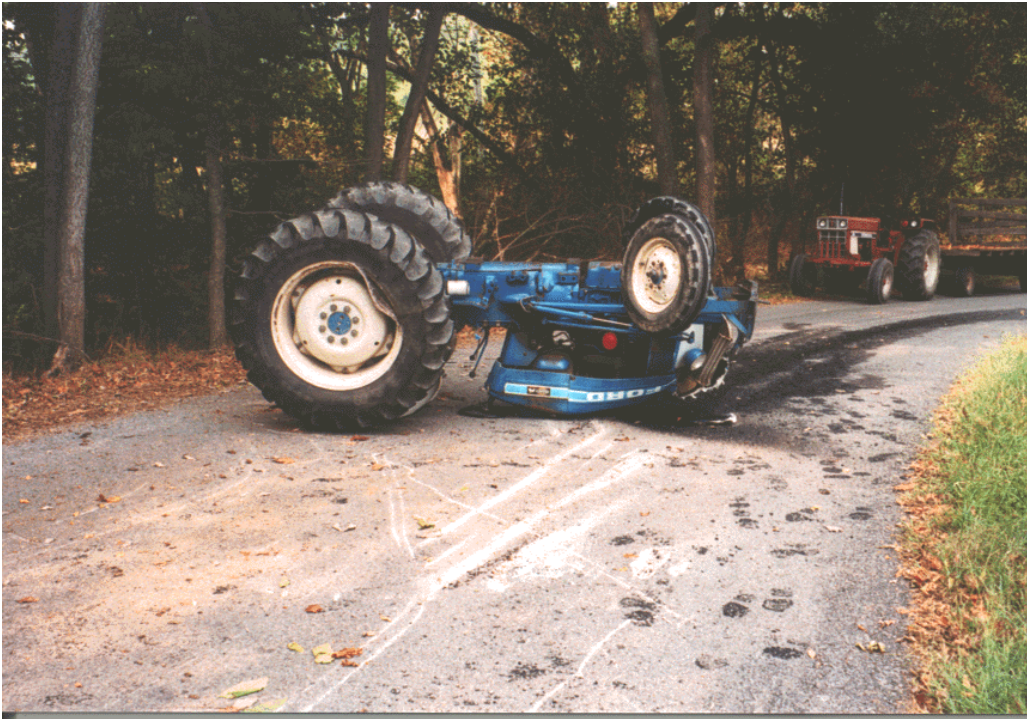
Tractor and wagon involved in the incident. The wagon had flipped and slid next to tractor. In this photo, the wagon had been up-righted and prepared to be returned to the farm.

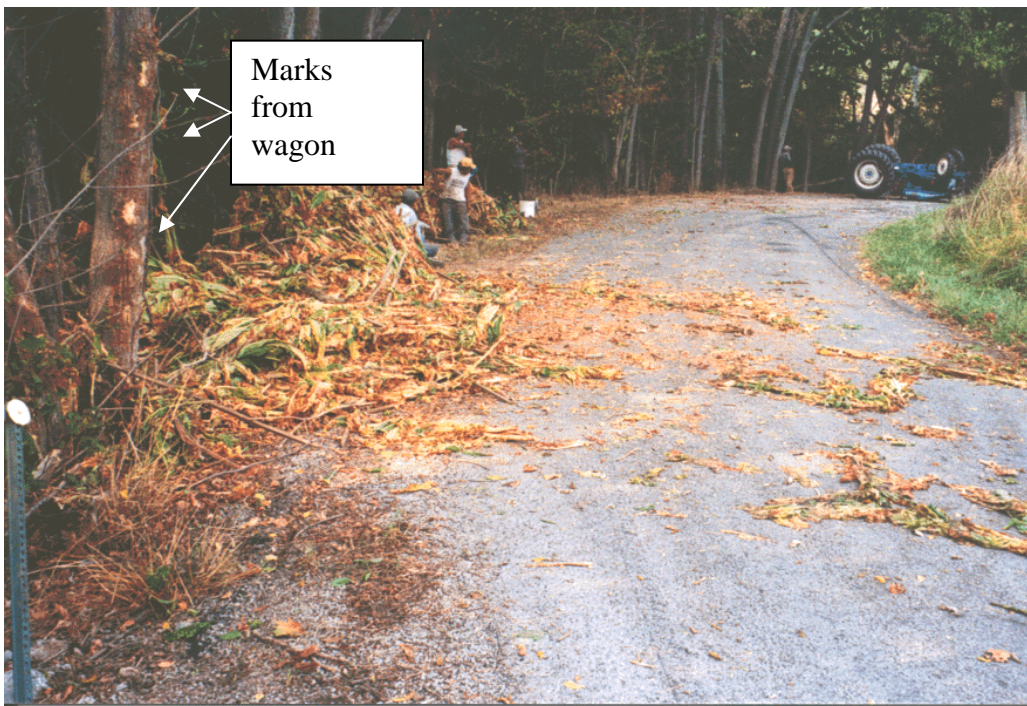
A picture of the tobacco which spilt from the wagon as it rode the tree line, flipped, then slid next to the tractor. Notice the marks on the trees where the wagon hit.

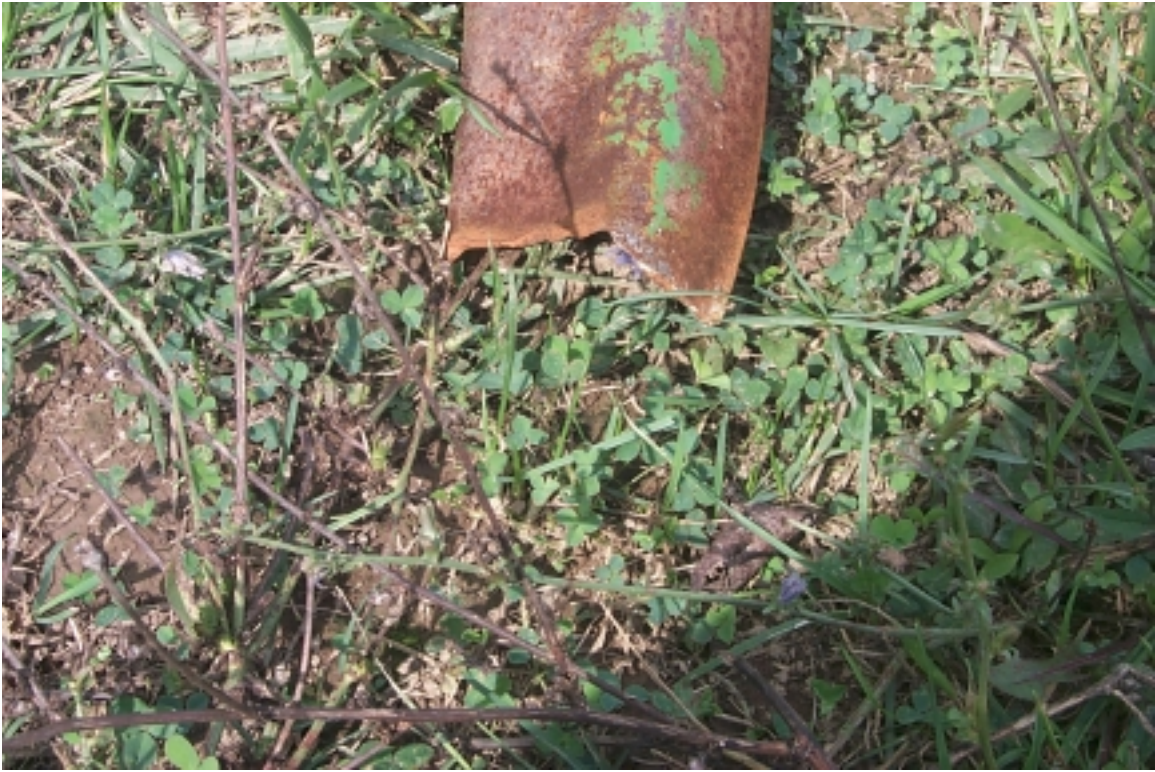
degrees. As they proceeded, the victim lost control of the tractor and the tractor sped up then started to jackknife. Near the bottom of the hill, the trailer came loose from the tractor, breaking at the end of the metal tongue. At the bottom of the hill, the road made a 90-degree curve to the right. The trailer went to the left side of the road, along a tree line, flipped over in the curve, and slid next to the tractor. In the meantime, the tractor had gone sideways in the road, flipped, then slid and came to rest with the tires in the air.

End of wagon tongue with pin hole sheared off.
