Hispanic Worker Dies In Tractor Rollover

Date of Incident: May 31, 2002
Report Release Date: June 3, 2003
Incident Number: 02KY099

Kentucky Fatality Assessment and Control Evaluation (FACE) Program

Incident Number: 02KY099

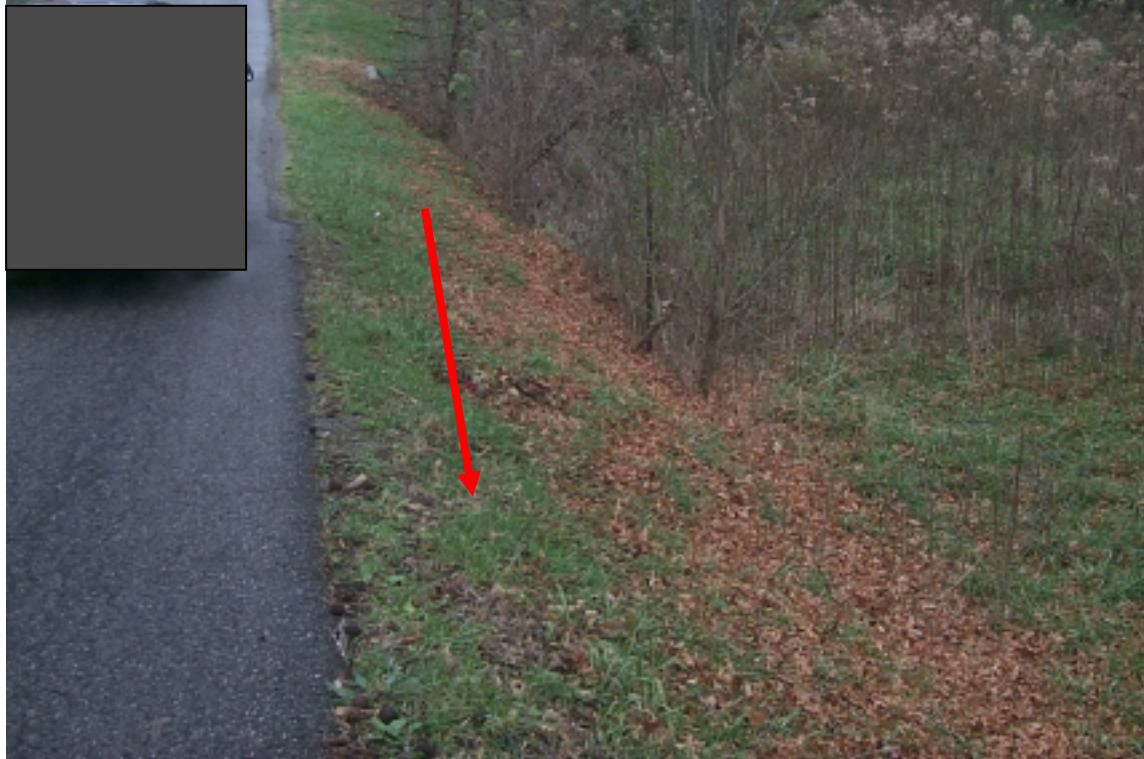
At the time of the incident, the tractor operator was mowing in a southwest direction. He had successfully mowed 30 feet beyond a culvert and was on the upper side of an 11.5 foot high bank with a slope of 25 degrees. At the bottom of the bank was a 3 strand, barbed-wire fence supported by iron fence posts. At some point the tractor flipped, rolled down the bank and over the fence, pinning the driver underneath the right wheel and seat of the tractor.

Embankment where tractor rolled. Slope 25 degrees. Arrow denotes direction tractor was moving.

Recommendation No. 1: Tractors should be equipped with rollover protective structures and seatbelts.

The tractor involved in this incident was a 1950 tractor. Roll Over Protective Structures were not available for purchase at the time this tractor was manufactured, nor is a commercially made ROPS currently available. However, tractor owners can contact local tractor dealers for ROPS to be retrofitted for older tractors.

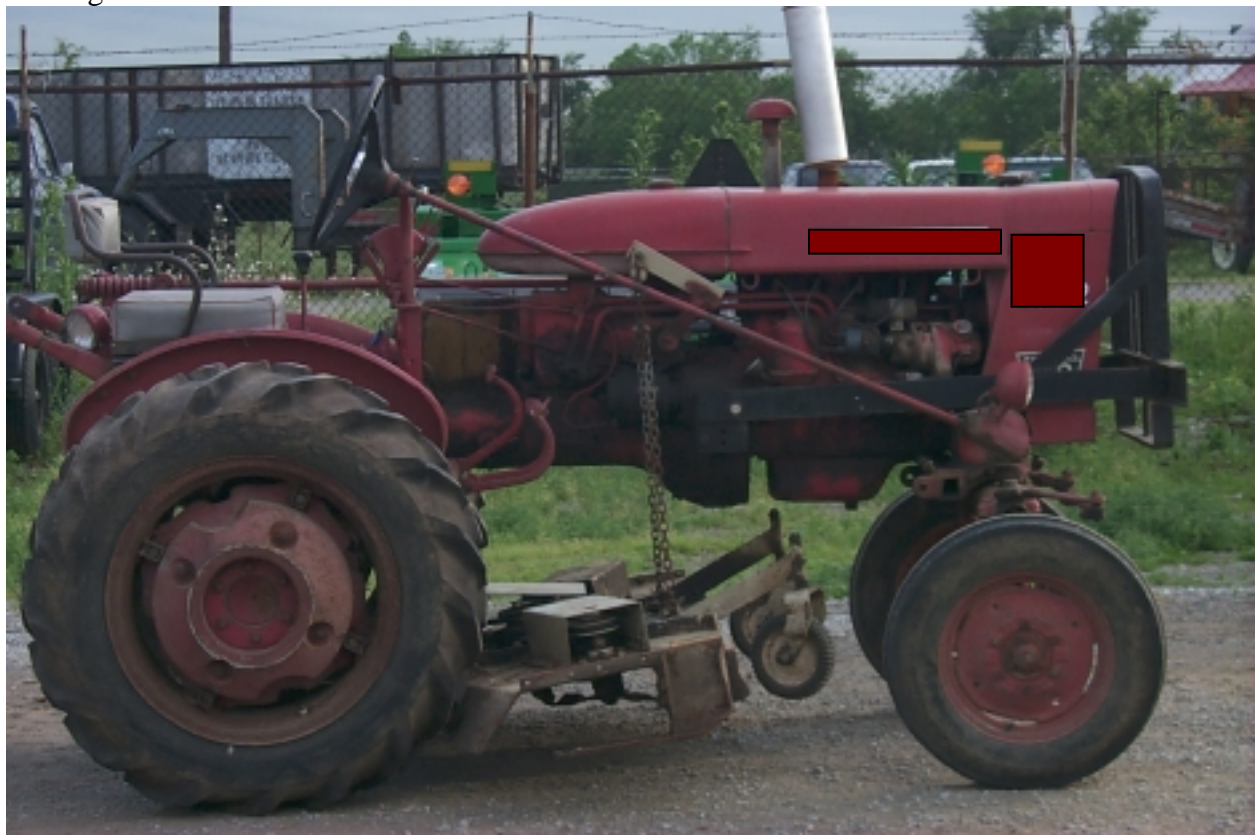
roadway. Earlier in the day, he had been instructed by Farmer 1 not to mow a particular banked section of roadway. This section of roadway was either left untrimmed or trimmed with a weedeater. He chose to mow the roadway with an early model tractor with air-filled tires. This particular tractor offsets the driver to the right of the engine block.

Picture of similar tractor involved in incident.
