Hispanic Laborer Dies From Fall Off Roof

Incident Number: 03KY017

Kentucky Fatality Assessment and Control Evaluation (FACE) Program

Subject: Hispanic Laborer Dies From Fall Off Roof

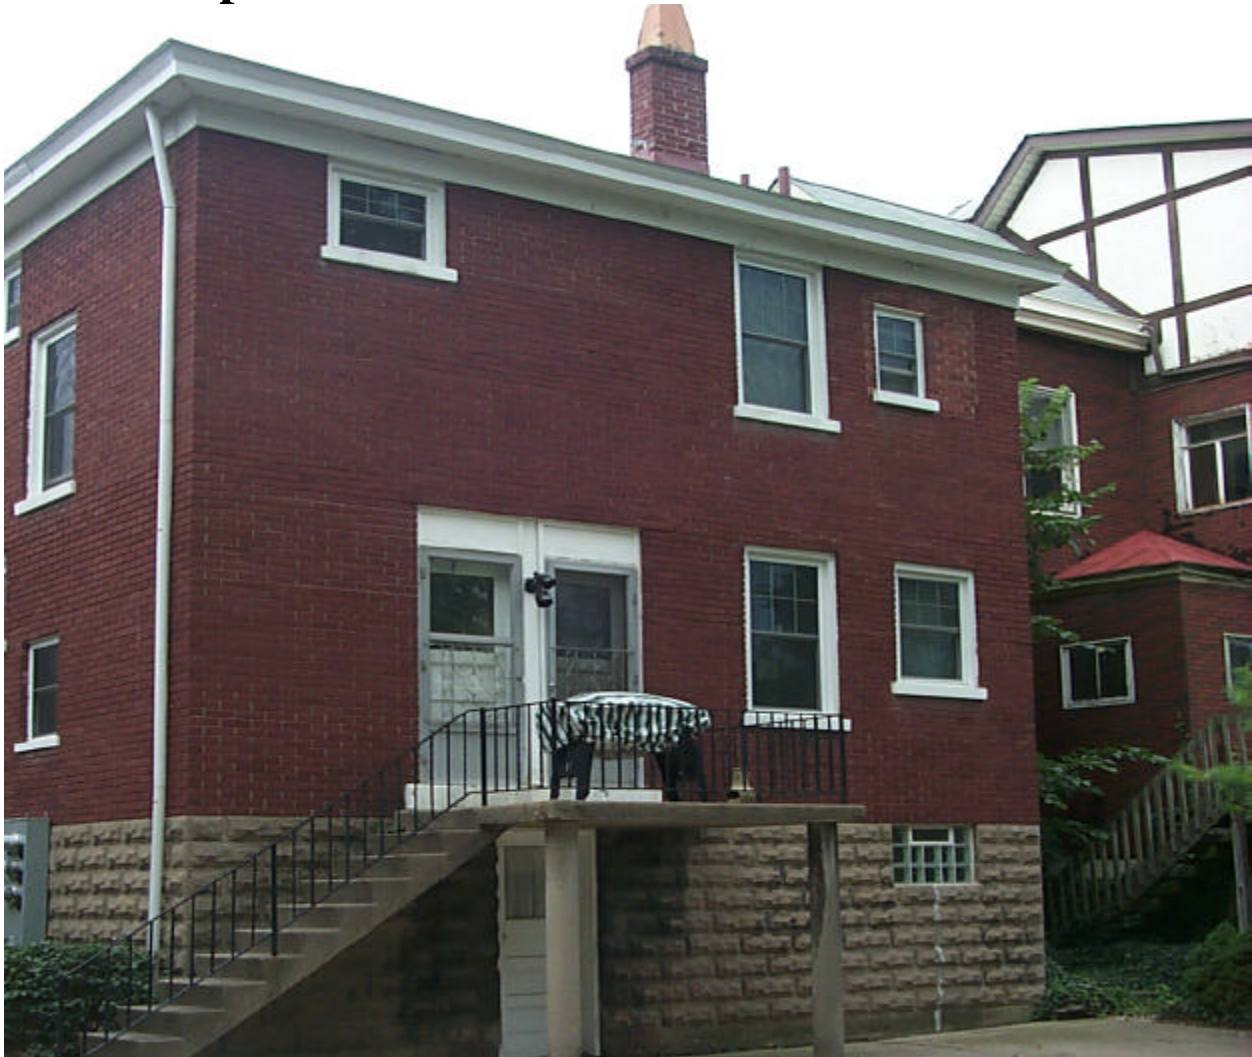
Roof from which Hispanic woman fell.

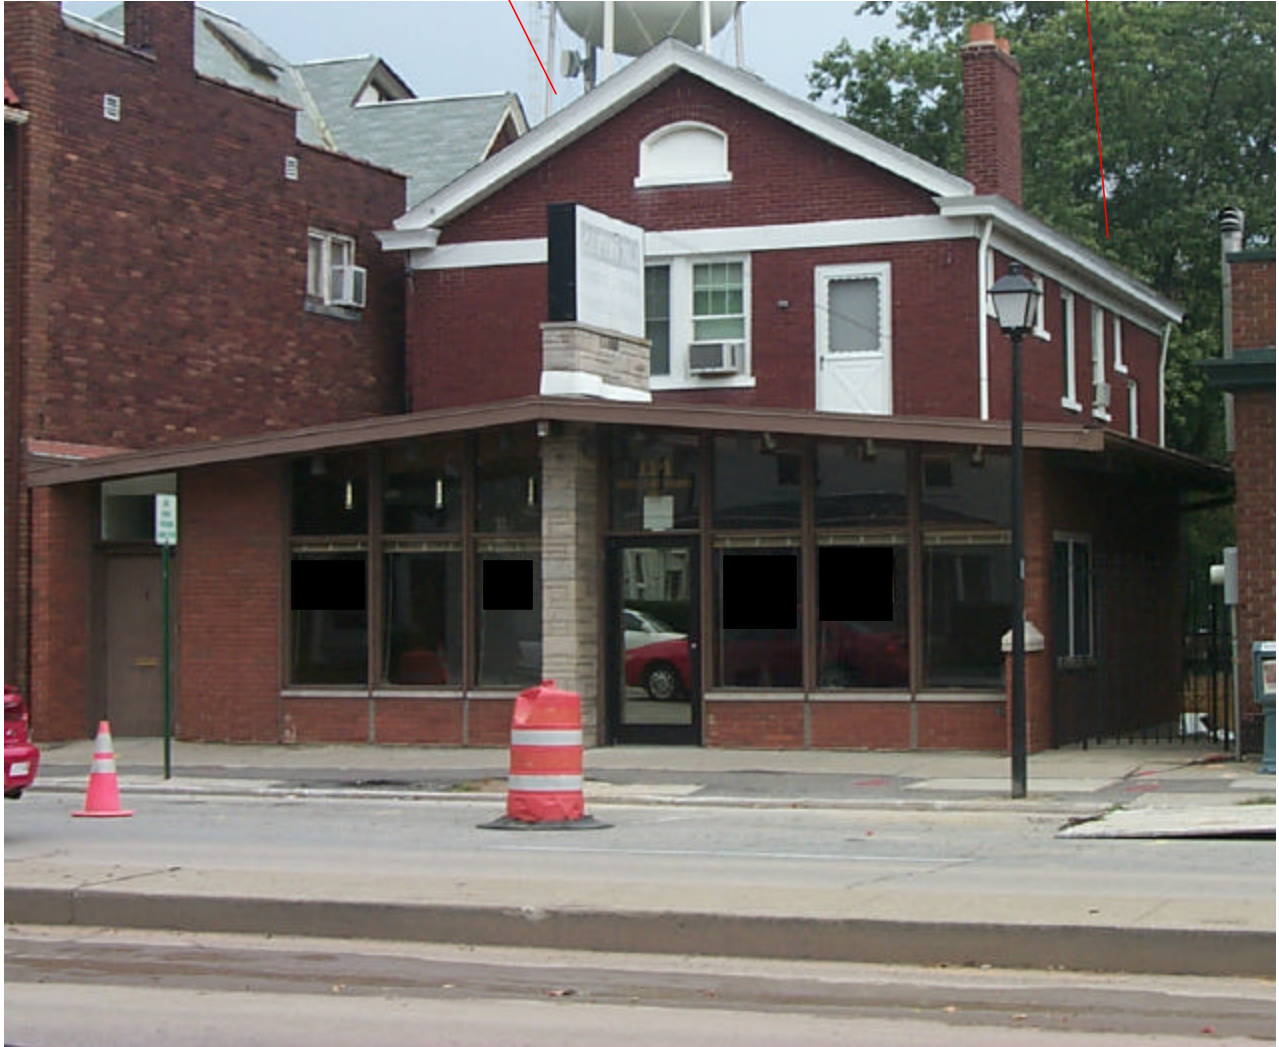
Photograph A

Both brothers were here

Location where
sister fell from

Front of building where incident occurred. The two brothers were working on the North side of the roof. The decedent fell from the right side back corner of the roof. North is to the left. One ladder was placed on the sidewalk to the lower level roof; the second ladder was placed on the lower level roof to the higher roof.

There were several methods the roofers could have used to work safely while working on the guttering. One method would have been to use approved scaffolding with appropriate side railings. Another method would have been to use body harnesses tied off to anchors attached to studs on the roof.

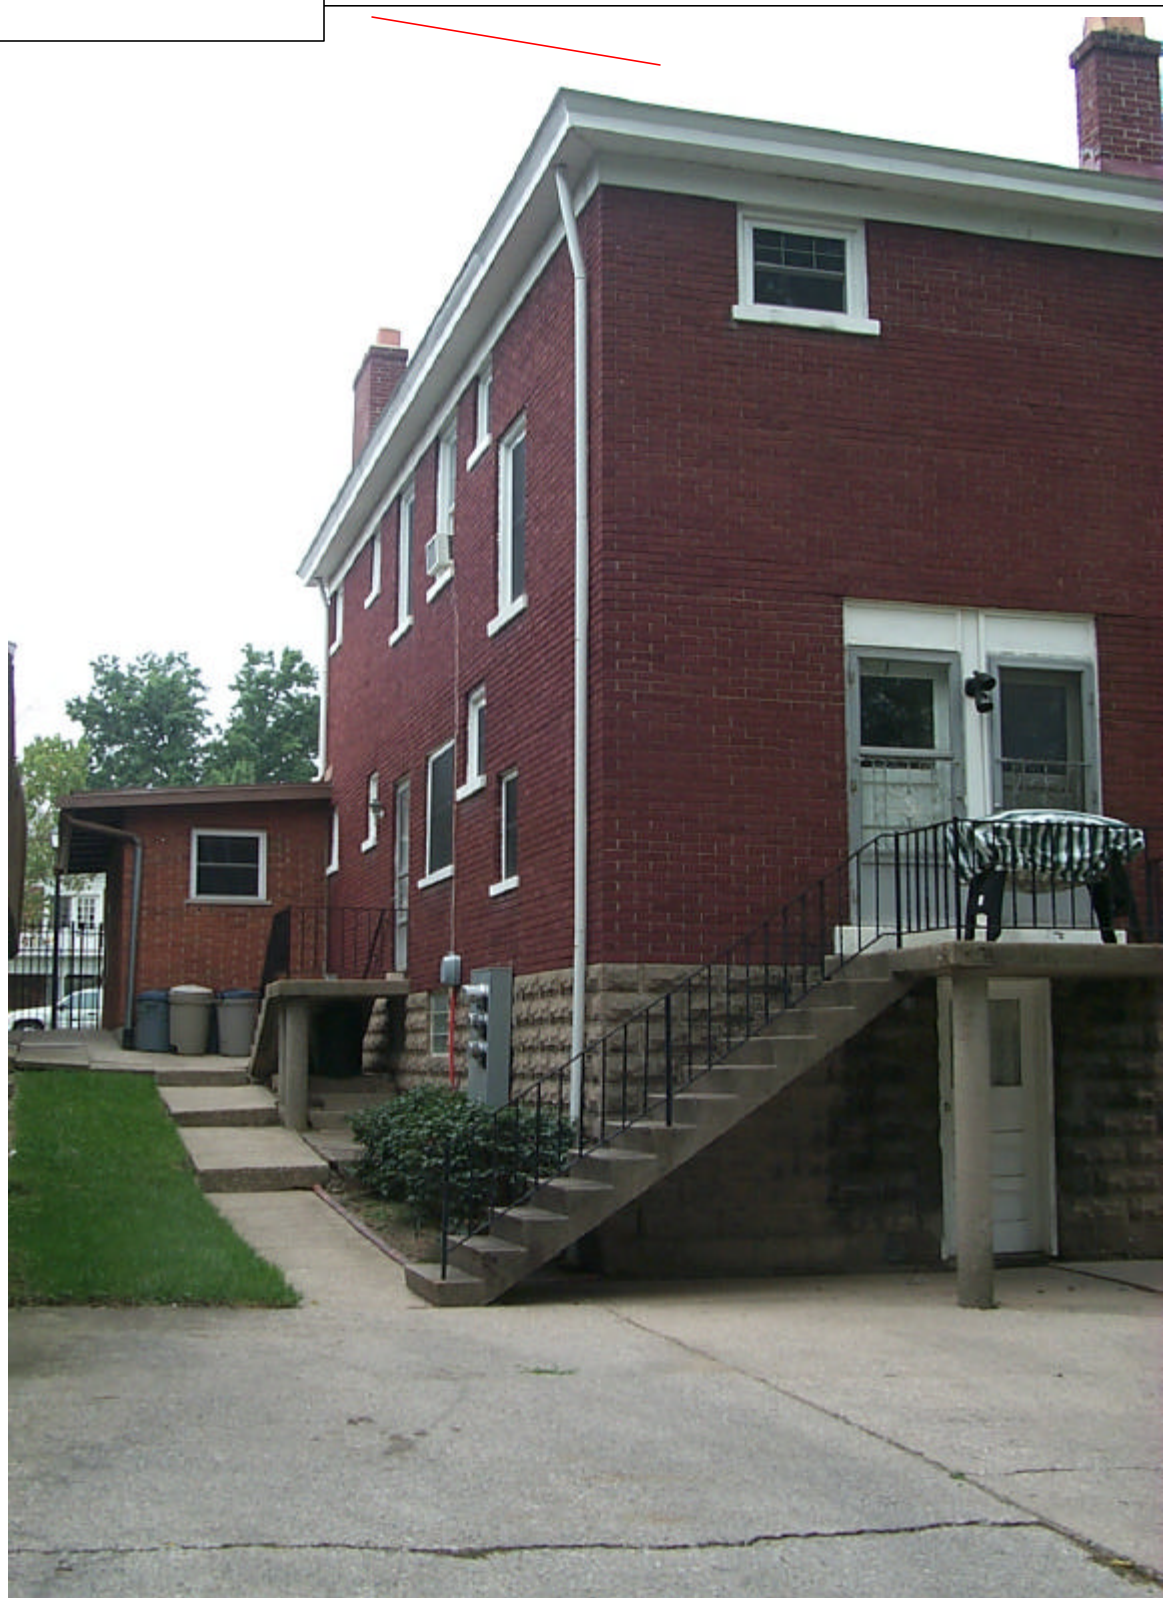
Photograph B

Corner from which
Laborer fell
