Bulldozer Owner / Operator Dies When Thrown Off Bulldozer Track

Incident Number: 03KY049

Kentucky Fatality Assessment and Control Evaluation (FACE) Program

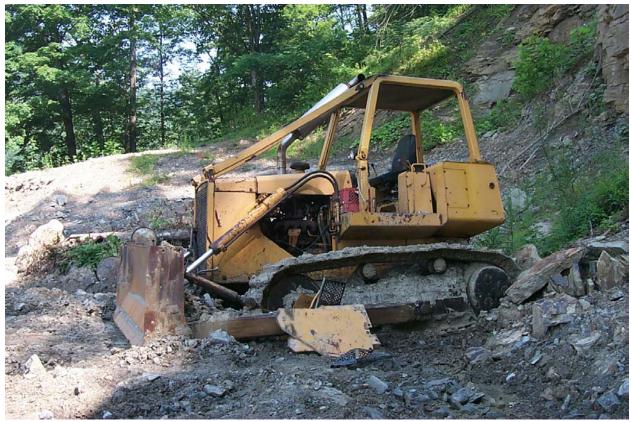
Picture of bulldozer in the mountainside after incident occurred.

As the men attempted to start the bulldozer, the laborer sat on the left track in front of the bulldozer cab and tightened the main lead connection to the starter, and the owner stood on the same track 3 - 4 ft away, leaned into the cab and pushed the starter button. The bulldozer suddenly jumped backwards and began moving, throwing the laborer sideways off the track while throwing the owner underneath the bulldozer track. The bulldozer started and traveled down the rear panel of a pickup truck that had been parked next to the bulldozer. As the bulldozer track ran over the decedent, the laborer got up, began following the dozer to turn it off, saw the decedent on the ground and went to check on him instead. While the bulldozer continued to drive itself backward approximately 70 feet until it reached the side of the mountain, the laborer assessed the situation and ran to the residence and told the homeowner to call emergency medical services (EMS) were contacted immediately at 6:07 pm. It is the local emergency services policy to implement advanced life support procedures whenever a bulldozer

is involved in an incident. Emergency medical services arrived at 6:19 pm, assessed the situation and called the coroner. The bulldozer continued to churn against the mountainside until the fuel ran out and the engine stopped. The coroner arrived and declared the operator dead at the scene.

Recommendation No. 1: Always start bulldozers and other heavy equipment from the cab with the seatbelt fastened.

Recommendation No. 3: Do not sit or stand on parts of bulldozers or other heavy equipment not intended for human occupancy.

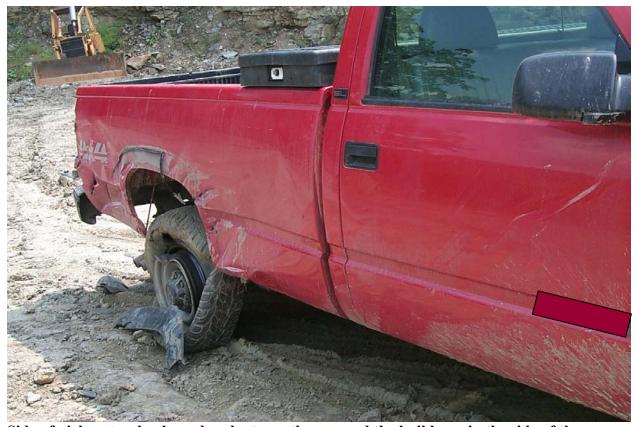
Side of pickup truck where decedent was thrown and the bulldozer in the side of the mountain.
