28-Year-Old Man Dies after Falling with Lift

Incident Number: 03KY056

Kentucky Fatality Assessment and Control Evaluation (FACE) Program

Subject: 28-Year-Old Sound Technician Dies after Falling from Lift

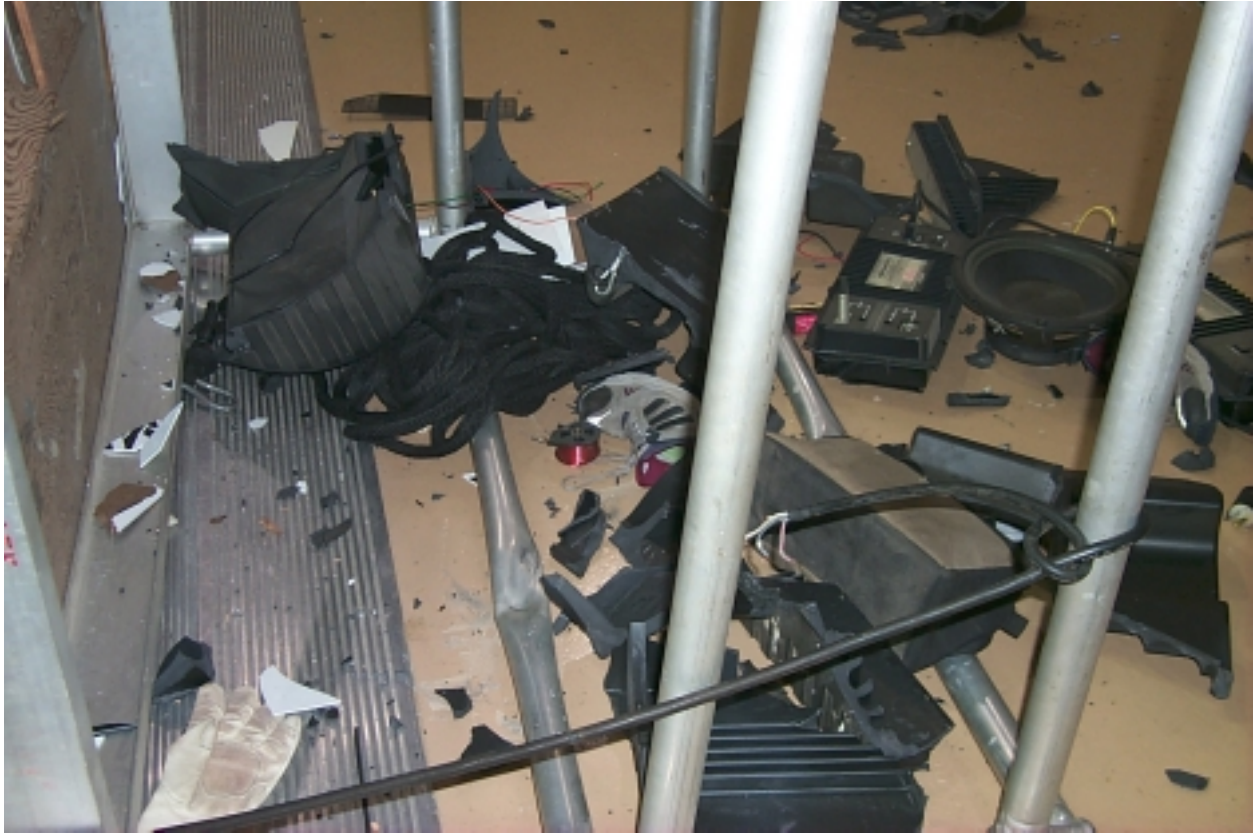
Telescoping lift basket that fell with the two workers and a speaker inside

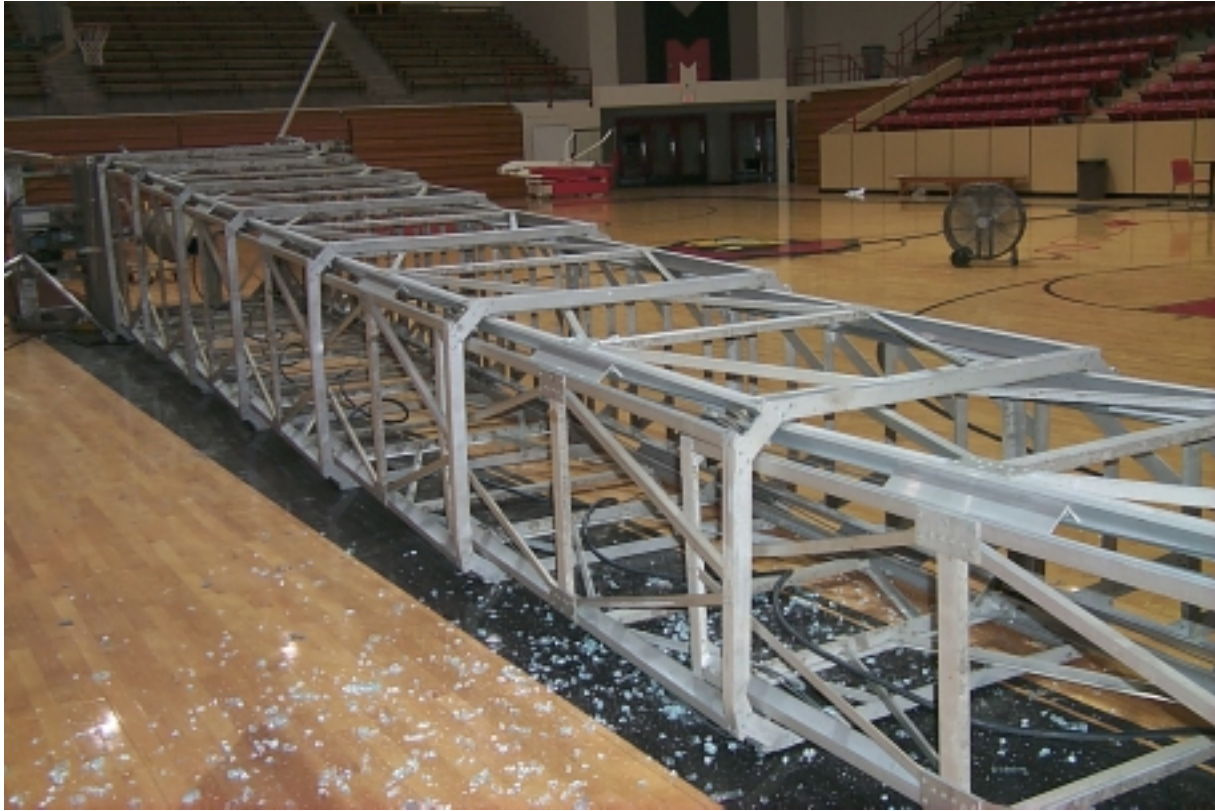
Picture of lift on its side from the basket end to the base end where ground control panel was located.

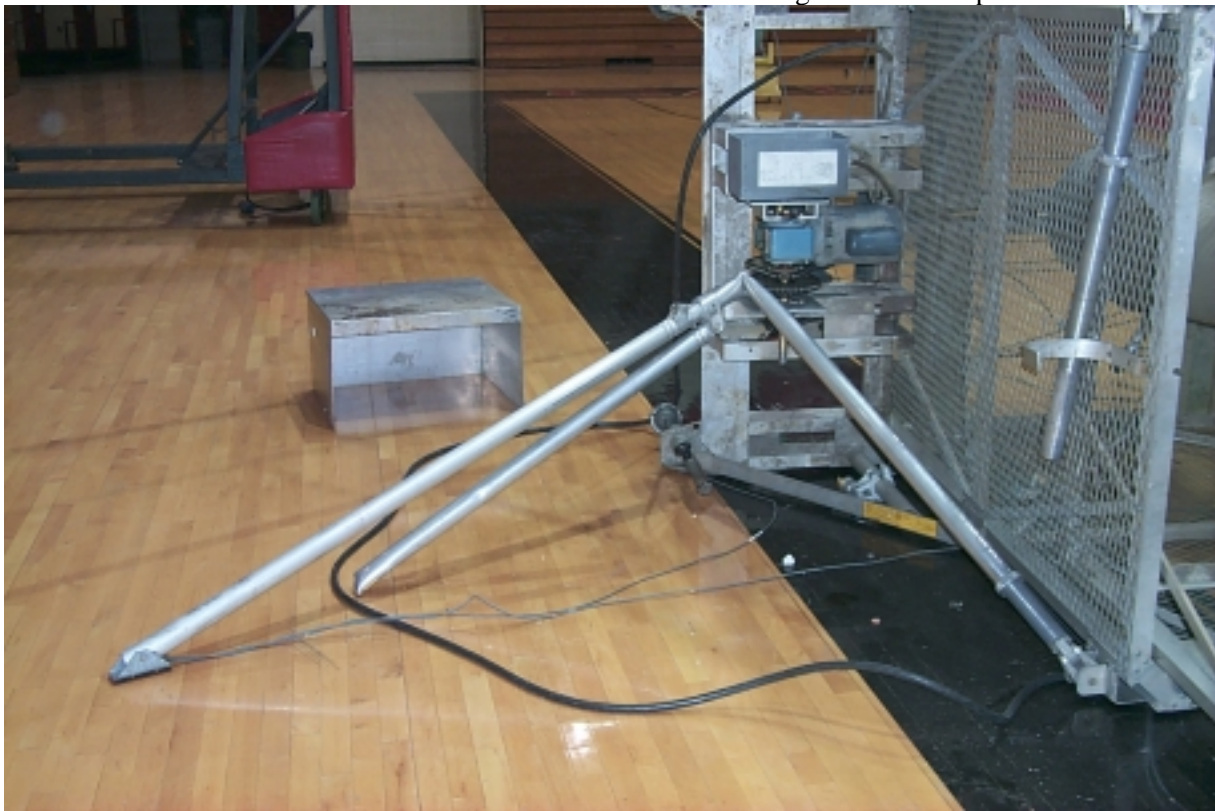
A competent person should be trained in calculation of the load capacity for lift equipment and be knowledgeable of work heights and outriggers. KY OSH Standard 1910.29(a)(3)(i) states the work height of a mobile work platform should be no more than four times the base and when this is not possible, outriggers should be used. It is believed that the combined weight of the two workers and the speaker were below the 500 pound limit of the platform of the lift. The outriggers had also been used, but it is unknown if they had been extended to an adequate distance to compensate for the additional height of the lift.

Picture of control ground control panel on its side and outrigger used to stabilize the lift. Notice it had been extended for use.

Recommendation No. 1: Training of supervisors and employees on equipment should include, but not be limited to: load capacity and weight calculations, work height and use of outriggers.

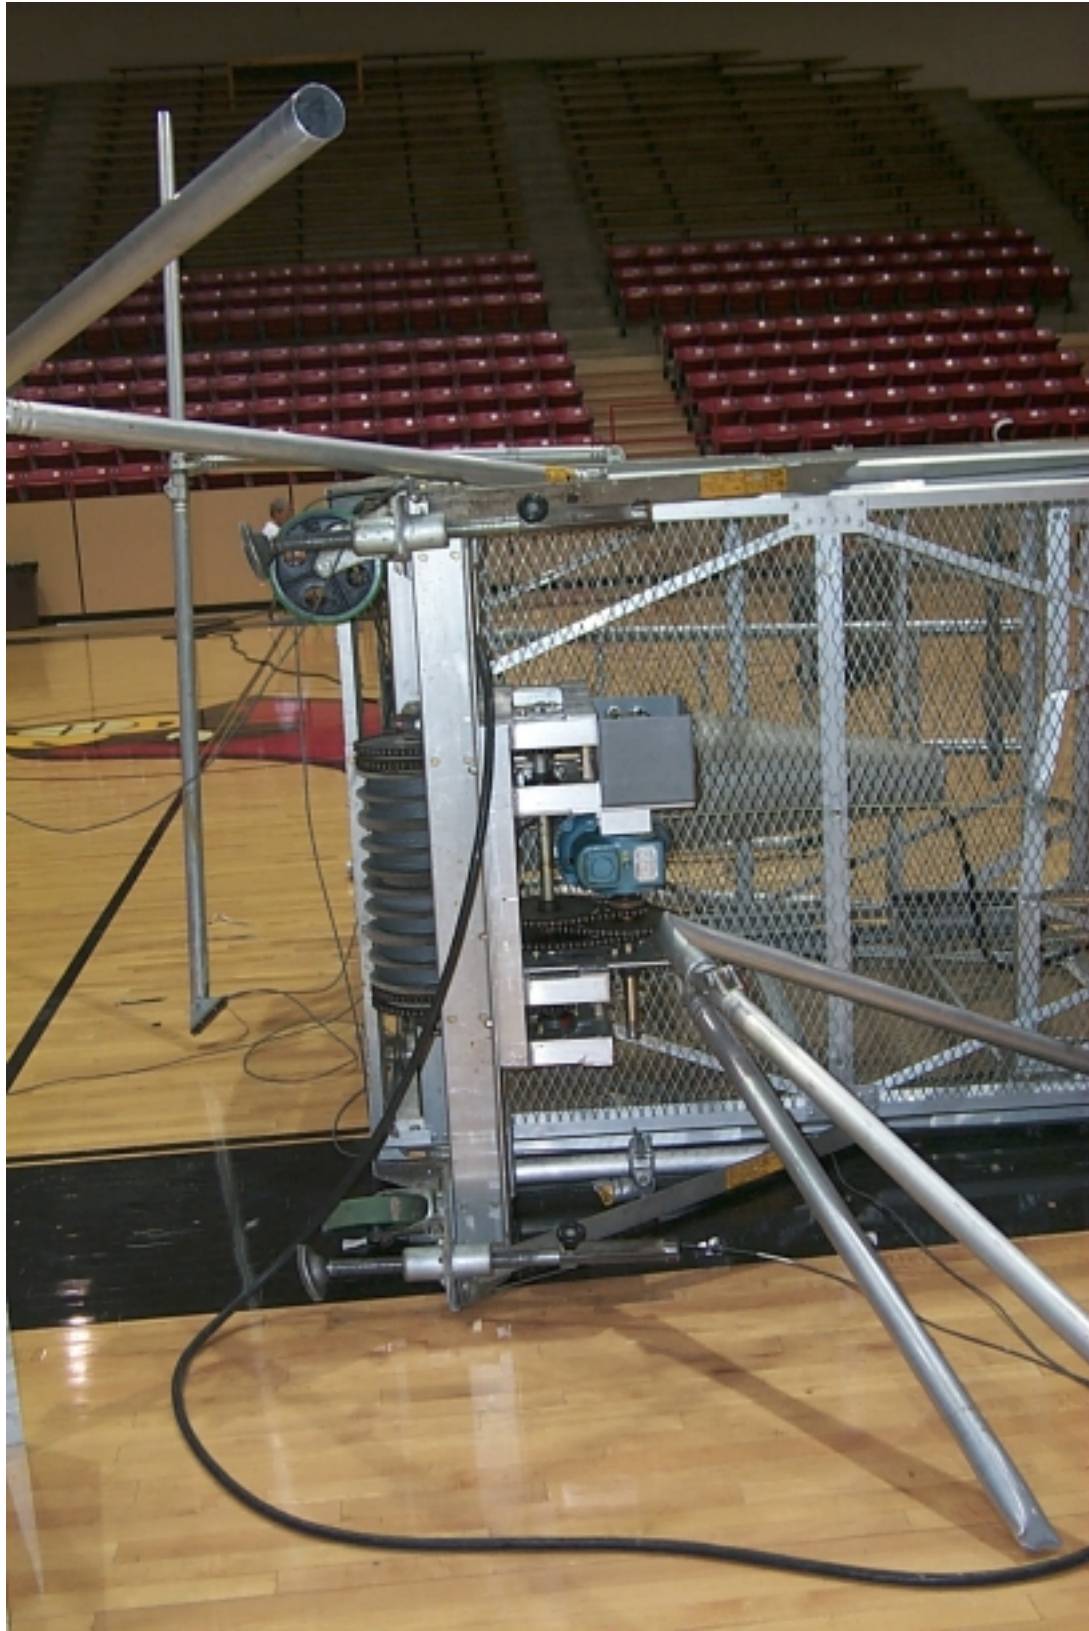
Base of telescoping lift on its side. Notice outriggers and leveling legs were in place to balance the lift.
