Master Plumber Dies When Trench Collapses

Incident Number: 03KY072

Kentucky Fatality Assessment and Control Evaluation (FACE) Program

Release Date: May 27, 2004

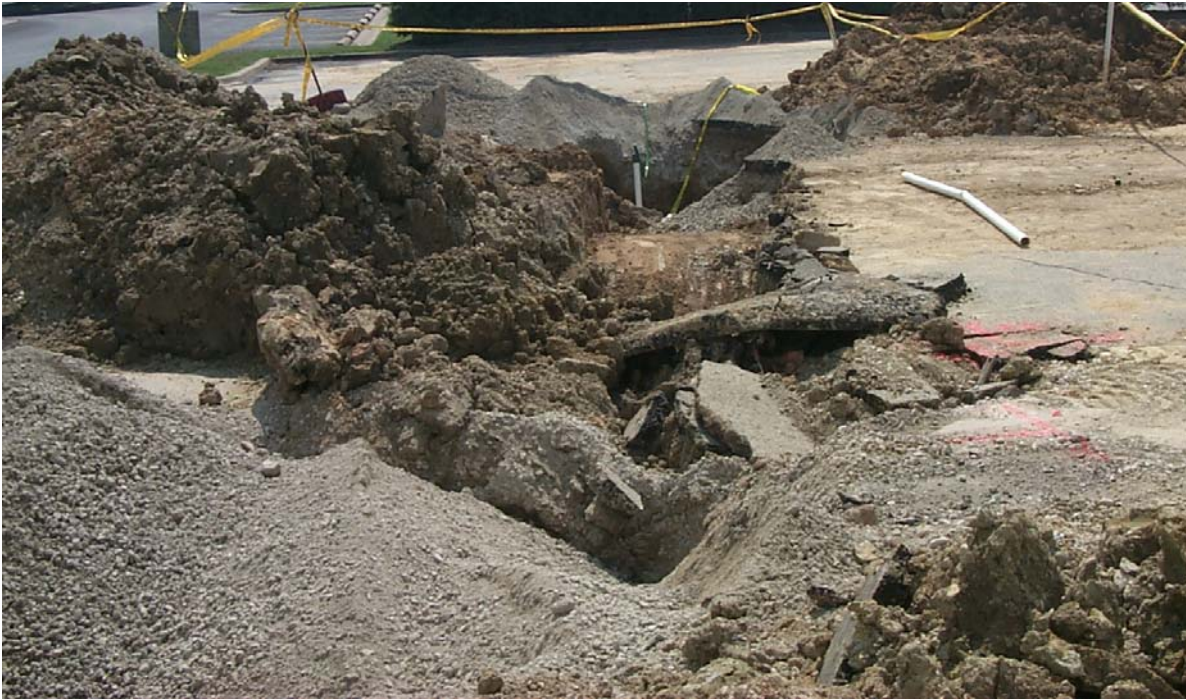
Excavation site where waterline was being repaired

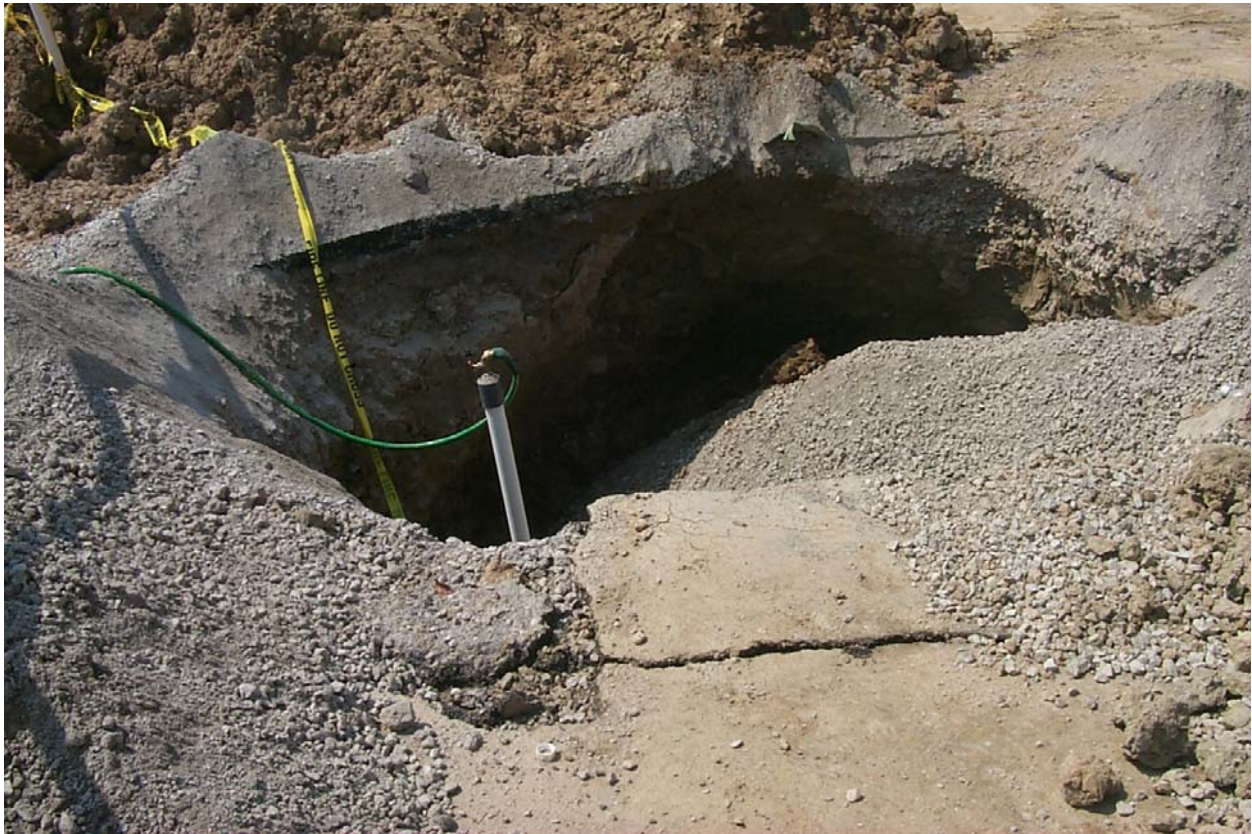
On July 29, the decedent was working alone on Leak No. 2. He used the backhoe to excavate until he found the second leak. It is unknown why he was repairing Leak No. 2. The trench was 8 feet deep and not shored. As the decedent stood in the trench and explained to two employees from the contracting company that he had found the second leak, the trench collapsed, burying him. Emergency services and the victim's employer were called. It took emergency services approximately 7 hours to excavate the scene and remove the decedent. The coroner was summoned and pronounced the victim dead at the scene.

Employers are required by OSHA Standard CFR 1926.652(a)(1) to protect employees from cave-ins while performing excavation work. This regulation also stipulates configurations for sloping sides of trenches and appropriate materials to be used in shoring walls of excavation sites. Any trench over 5 feet or more in depth must have an adequate protection system. Shoring equipment had been delivered to the site, but it is unclear if it was used in the first excavation. It is clear that the shoring equipment on site was not used in the second excavation, which collapsed.

Photograph of Leak No. 1 excavation. Excavation for Leak No. 2 where incident occurred was immediately filled in by the plumbing contractor after decedent had been removed by emergency personnel. This photo was taken the day after the incident.

Recommendation No. 2: Employers should train employees working in excavations on use of appropriate protective equipment.

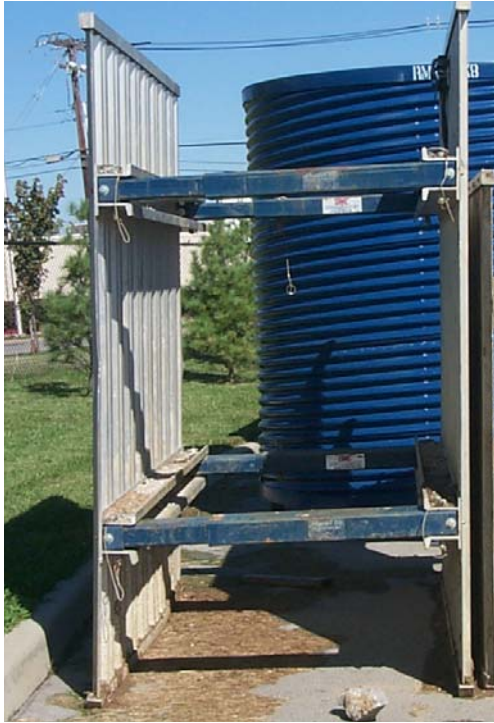
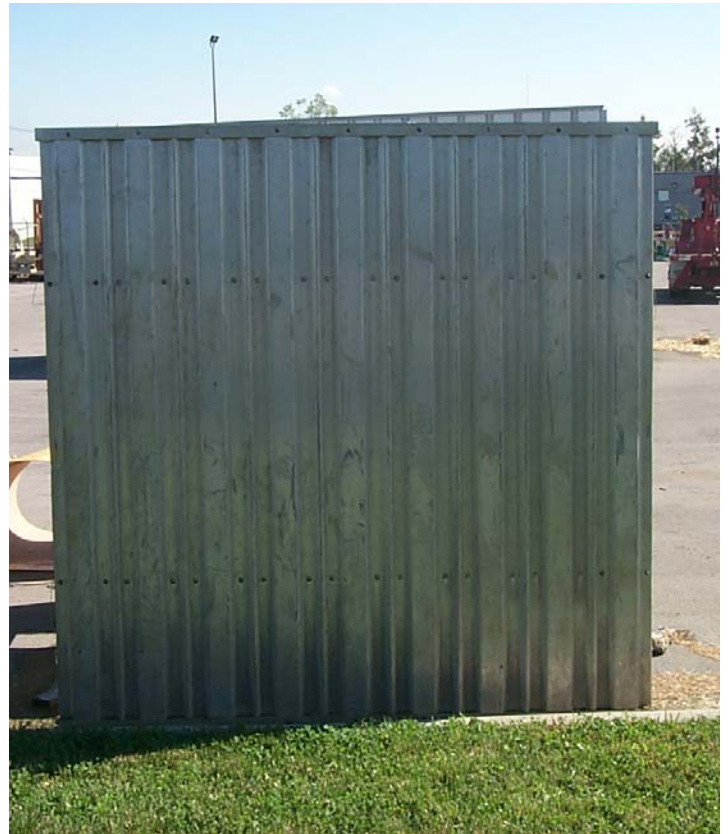
The employee involved in this incident did not use shoring equipment very often. It is unclear if he understood how to properly install and use the shoring equipment that was delivered to the site. It is possible that the shoring equipment was not suitable for either of the excavations. Other types of shoring equipment were available for rent. If the decedent had been properly trained in the use of shoring equipment, he could have made an educated decision to use more appropriate materials to brace the sides of the excavations.

Trench box similar to one available at the work site. The metal arms expand and contract to adjust the size of the box as needed in the excavation. A backhoe was on site to maneuver the box into the hole.

Recommendation No. 3: Employers should ensure appropriate training and refresher procedures for all employees handling seldom used equipment.
