**Bulldozer Owner / Operator Drowns While  
Trying to Repair a Pond  
Incident Number: 03KY073**

## **Kentucky Fatality Assessment and Control Evaluation (FACE) Program**

**Incident Number: 03KY073**

**Subject: Bulldozer Owner / Operator Drowns While  
Trying to Repair a Pond**

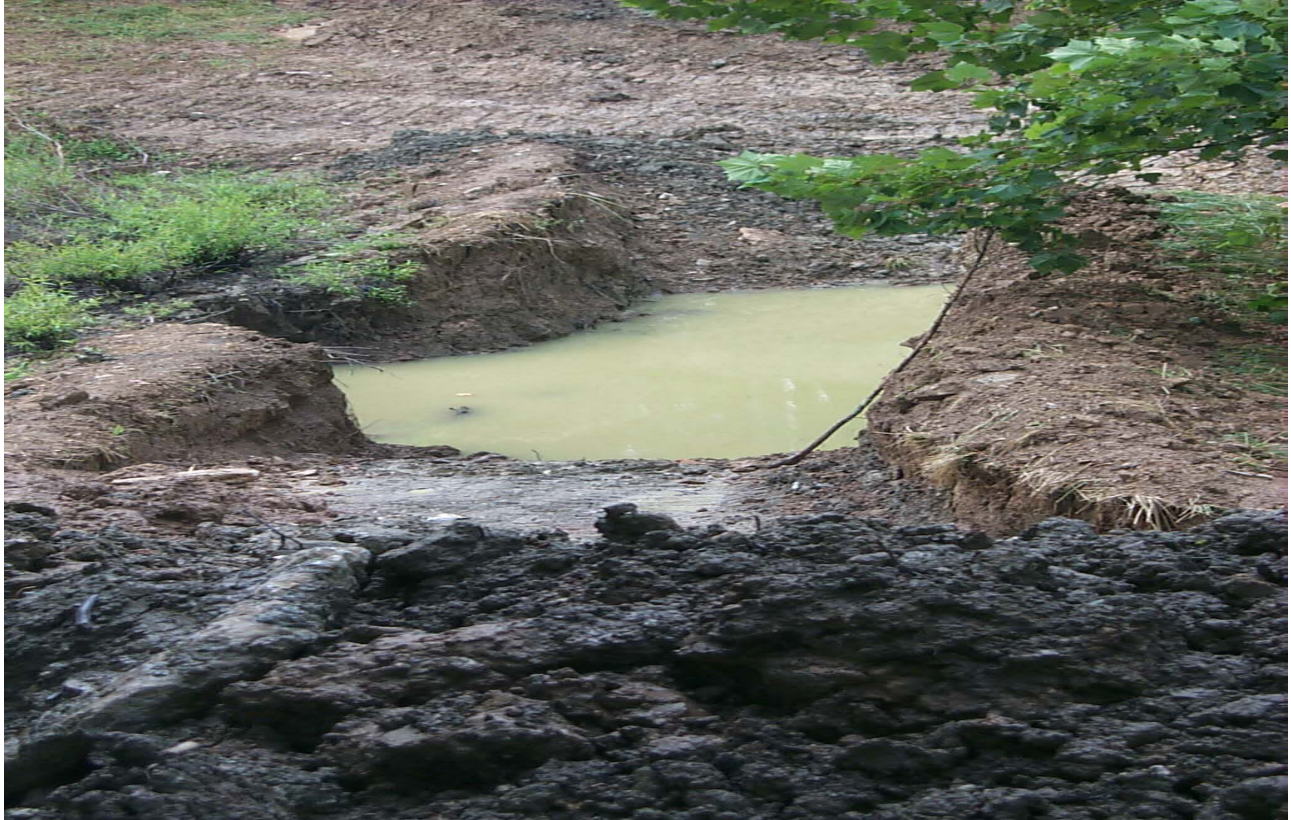
**Location where bulldozer and operator were found. The depth of the water is difficult to determine. The pond is to the left in the photograph.**

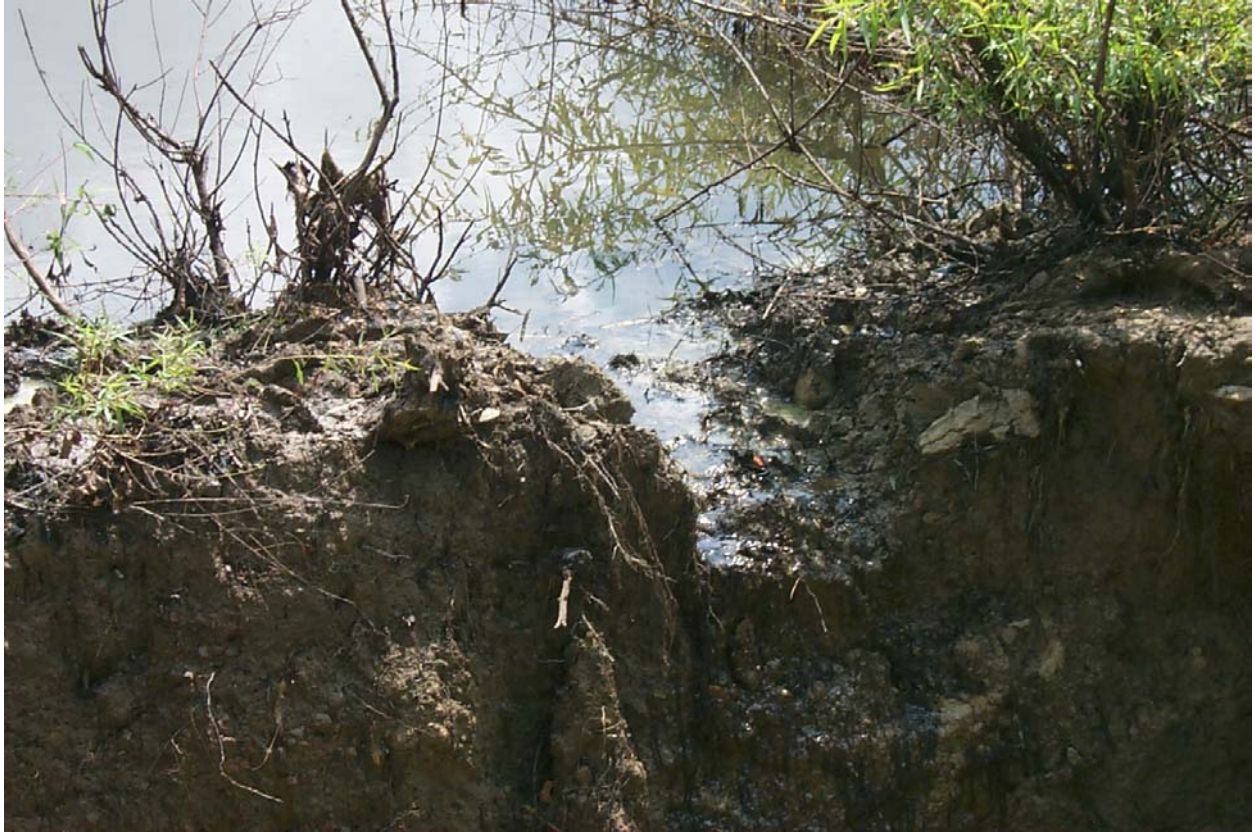
The bulldozer had been fueled the day before so the operator began the day at 6:45 am with a full tank of fuel. He had not eaten lunch and an examination of the fuel tank revealed it was  $\frac{3}{4}$  full when the incident occurred. Under normal operating conditions this time frame suggests the incident occurred around 10:00 am. The width of the trench was the width of the bulldozer blade, 12 feet with a depth of 17 feet. It appears the pond side of the trench was too thin. This allowed the vibration of the bulldozer to vibrate the side of the trench enough to make the top of the dam by the pond partially collapse. The backend of the bulldozer had moved off the track it had been making in the trench from the force of the water, mud and sludge pushing the right side against the outside trench wall. This impeded the operator from opening the right side door and escaping. The cab filled with water, sludge and mud because of the blown-out window. The pressure from the outside may have been too great for the trapped operator to break out the front window. By the time the cab filled with the water/sludge/mud mixture, it was too late for the operator to escape. Typically when repairing dams, the pond water is drained down to a level below the top of the bulldozer. When excavating begins into the dam wall, a "keyway" is made. A keyway is a pathway excavated in the outside trench wall that will allow water to escape should the pond side of the trench collapse. This creates a drain so the pond water can drain out of the trench instead of filling it up. Had the bulldozer operator excavated a keyway in the earthen dam, the water/sludge would have drained out of the trench when the dam collapsed and the bulldozer operator may have been able to escape.

Where the pond side of the trench gave way, flooding the trench with mud, sludge and water.

Whenever an operator is repairing a pond, the water in the pond should be drained. The level to be drained is determined by how deep the cut needs to be to find and repair the leak. For instance, the top of the pond water should not be over the top of the bulldozer.

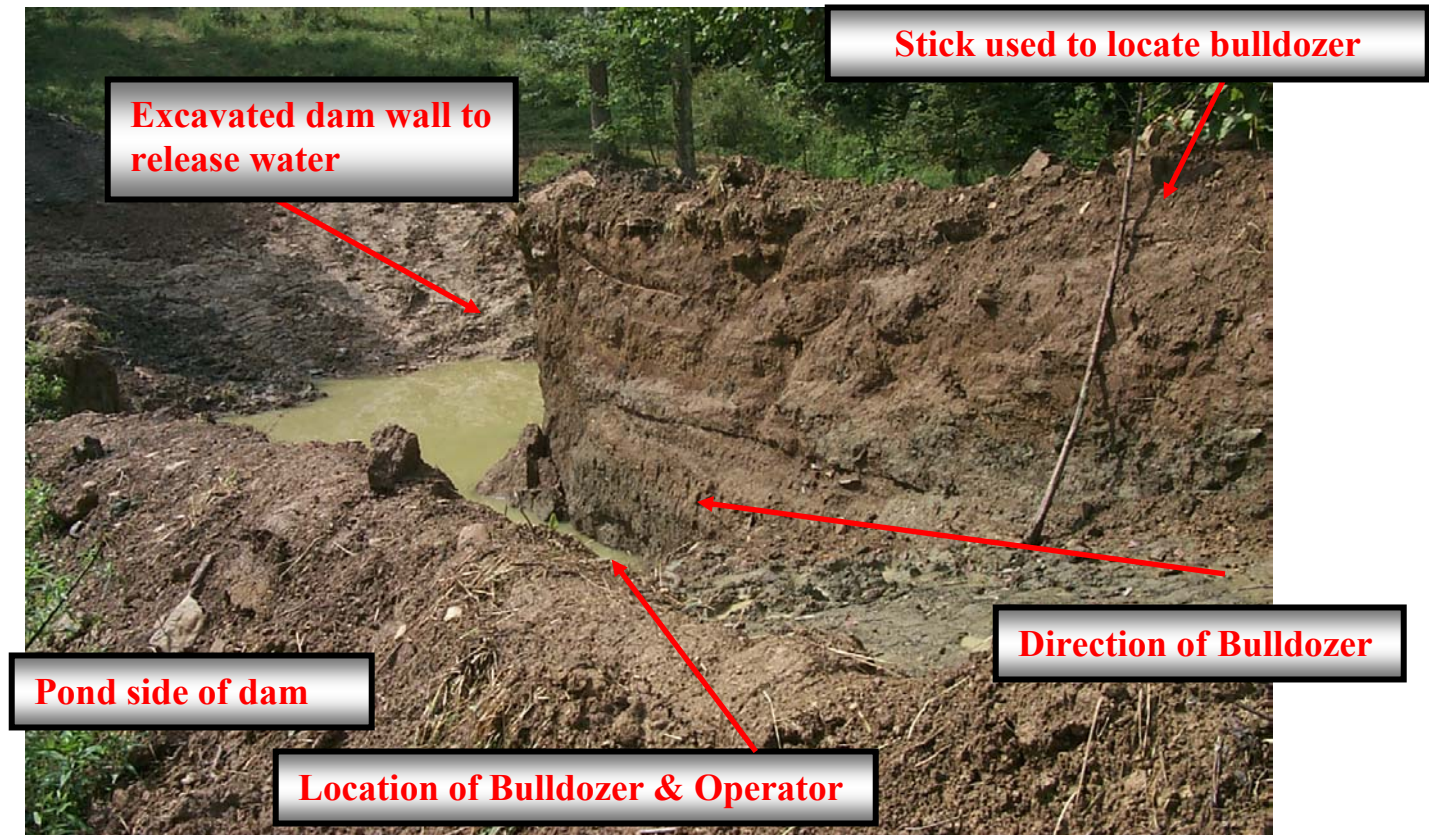
The trench where the bulldozer was. The far wall is 17 feet high and extended to the hillside. One of the responding bulldozers excavated the dam wall away to release the water in the trench. The stick is the one used to poke in the water to try to determine the depth of the water and if the bulldozer was there.

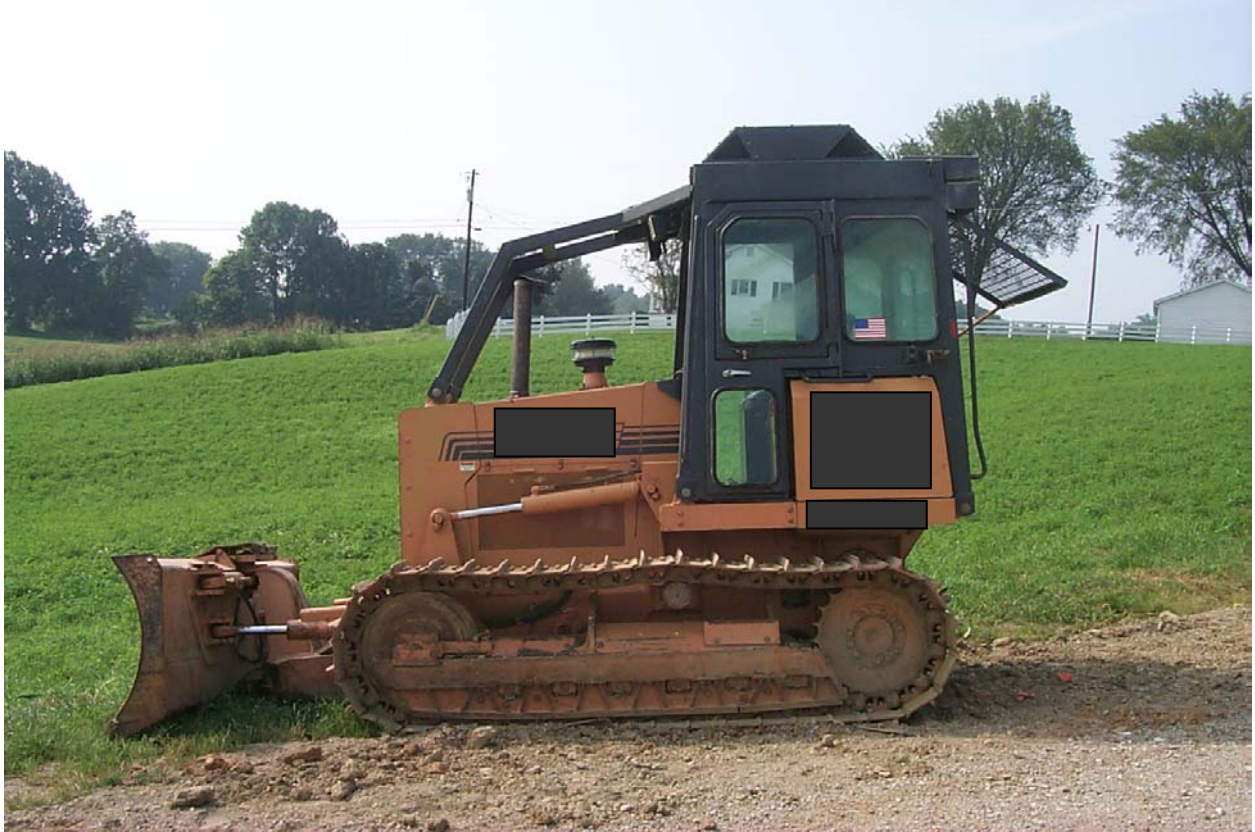
A picture of the bulldozer after it had been partially cleaned up and repaired. Notice the diagonal line on the window. This line shows the amount of pond water that remained in the cab after the decedent had been removed from the cab.
