**Laborer Dies When Caught in
Arms of a Skidsteer Loader
Incident Number: 03KY087**

Kentucky Fatality Assessment and Control Evaluation (FACE) Program

Incident Number: 03KY087
Incident Date: September 19, 2003
Release Date: November 5, 2004
Subject: Laborer Dies When Caught in Arms of a Skidsteer Loader

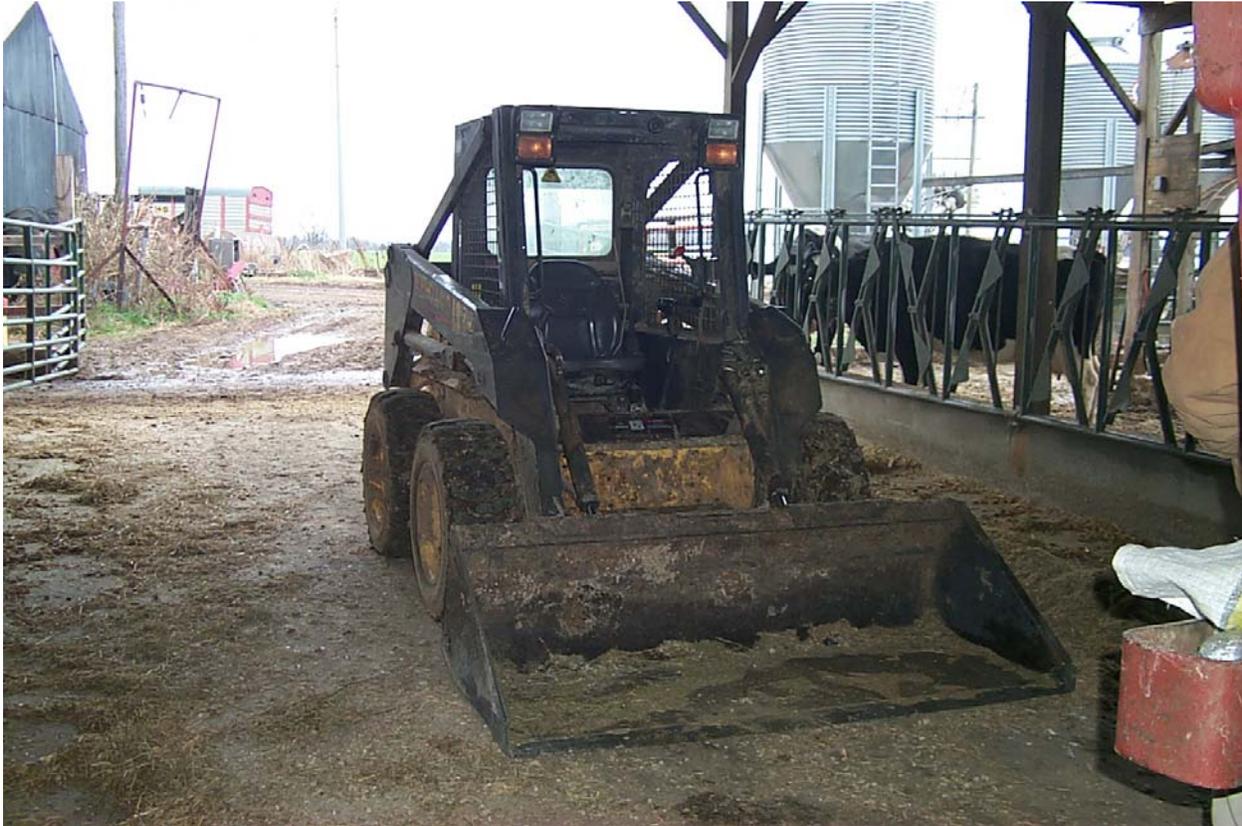
Borrowed skidsteer involved in fatality.

The decedent proceeded to drive the skid-steer with the bucket in the up-right position to the gate. When he arrived at the gate, he left the bucket up in the air and exited the machine to open the gate. He was either entering the machine or exiting the machine when the bucket arms were activated which caused the bucket to descend and crush the victim between the bucket arms and the machine. The contractor heard the skidsteer idling for too long; then he and the crew noticed the skidsteer was still by the gate and had not moved. They ran to the skidsteer 200 yards away and found the decedent pinned inside the arms of the machine. He had been squeezed on the left side of his body with his right side near the controls of the machine and his right foot inside the machine near the controls. The bucket hit his chest, left arm and rib cage. The farmer noticed the situation and ran to the skidsteer to help remove the decedent from the machine. Emergency response services were immediately contacted. Upon arriving several minutes later and assessing the situation, they contacted the coroner.

No one responding to the scene remembers if the gate was open or closed after the incident occurred. If the gate was closed, the accident occurred as he exited the machine; if the gate was open, it occurred as he entered the machine. This incident raises several unanswered questions regarding how the arms became activated. The skidsteer was programmed to only start if there was sufficient weight in the seat and the seatbelt was fastened. No one can remember if the seatbelt was fastened or not at the time of the accident. The coroner verified that the seatbelt worked (but did not know if it was fastened at the time of the fatal incident) and a weight limit had been programmed at the time of the accident. However, no one knew what the weight limit of the seat was set at; or if the limit set was below or above the weight of the decedent. To exit the machine, the bucket should be on the ground, the parking brake set and the machine turned off. Then the operator should then use a three-point system to exit: step-up out of the cab onto the top of the bucket; turn around and use the hand grips (one on each side of the machine); step down into the bucket; then turn around and step out of the bucket. It is possible the seatbelt had been improperly fastened with the bucket in the air. This would make exiting the cab more difficult and clumsy; the victim may have used one hand grip and used the seat for balance. This could apply enough pressure on the seat switch to activate the controls. If the victim was half-way in or out of the cab, his foot could have been on the control pedal and activated the bucket to descend.

Recommendation No. 1: Employers should ensure that employees are adequately trained on proper operation of and safety mechanisms of material handling equipment.

The decedent had used the contractor's identical skidsteer and was familiar with its operation and safety features; however, the decedent did not have formal training on the skidsteer. When operating a skidsteer, operators should follow manufacturer's specifications. According to the National Institute of Occupational Safety and Health's publication 98-117, on safe skidsteer operation, it is important, when exiting/entering the cab of a skidsteer, to have the bucket in the downward position on the ground and to use three-point contact with the machine. There are several KY OSH regulations which pertain to training of employees that operate material handling equipment such as skidsteer loaders. They are: 1910.178(l) which states that employers shall ensure that the operator is competent to operate a powered industrial truck [material handling equipment] and has been trained by a competent individual; Employees will be trained in: 1910.178(l)(3)(i)(A) - "Operating instructions, warnings, and precautions for the types of material handling equipment the operator will be authorized to operate"; 1910.178(l)(3)(i)(C) - "Truck controls and instrumentation: where they are located, what they do and how they work"; 1910.178(l)(3)(i)(M) - "Any other operating instruction, warnings, or precautions listed in the operator's manual for the types of vehicle that the employee is being trained to operate"; 1926.602(a)(2)(i) - "Seat belts shall be provided on all equipment covered by this section and shall meet the requirements of the Society of Automotive Engineers, J386-

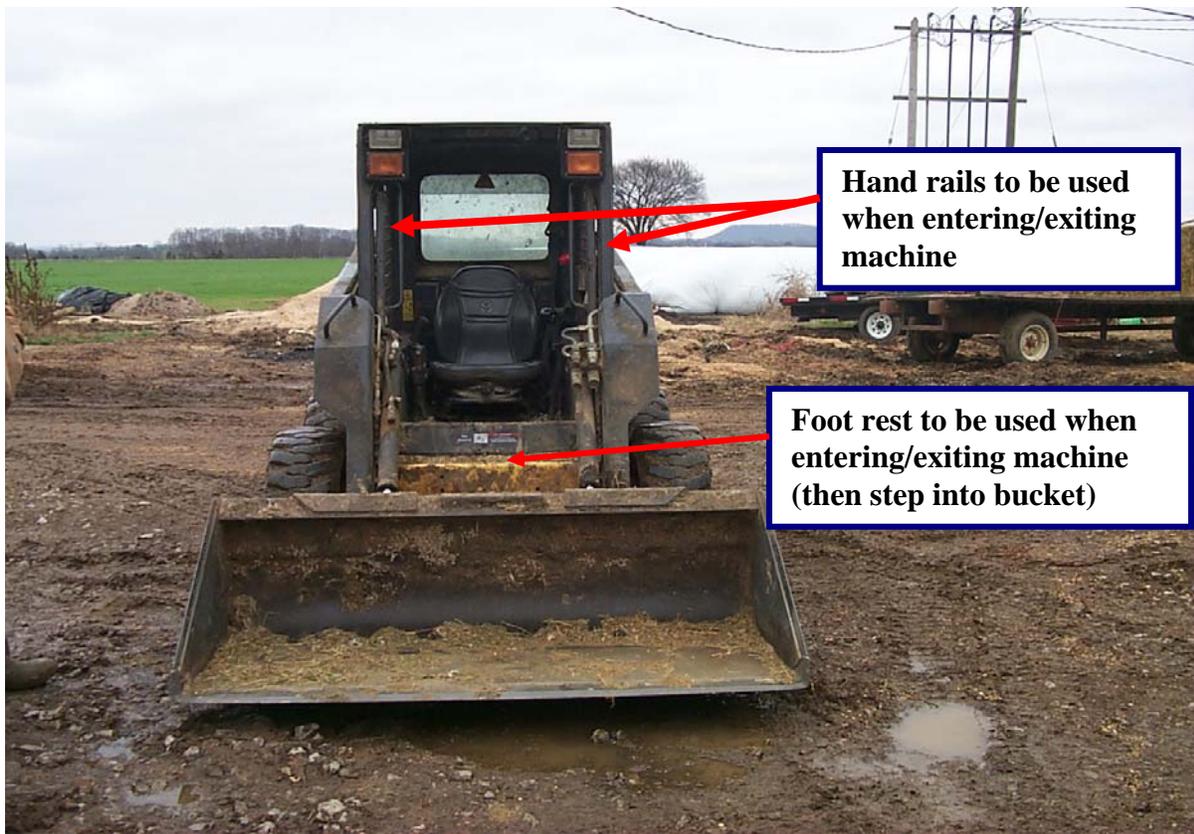
The operator should always have the bucket in the downward position, the parking brake set and the machine turned off and use three-point contact when entering or exiting a skidsteer.

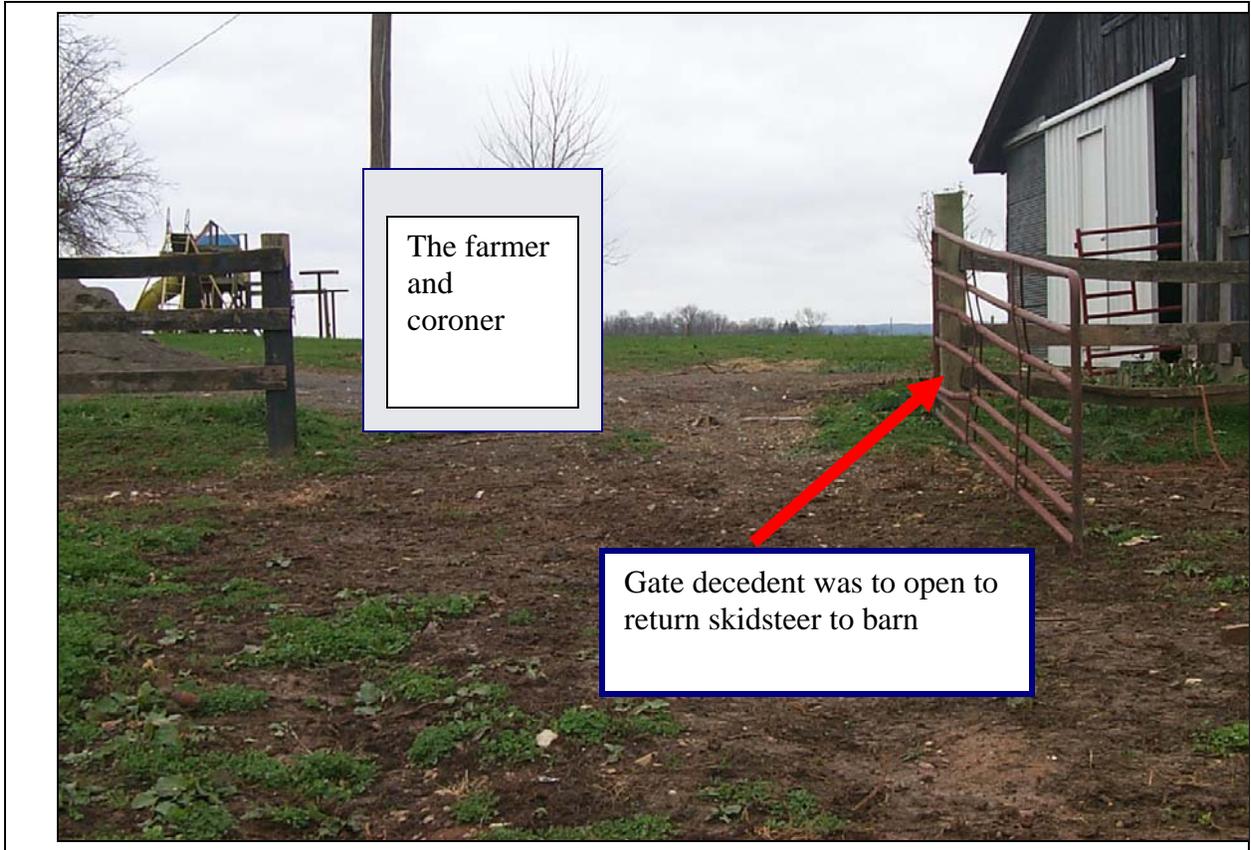
Late that afternoon (a little after 4:00 PM), the farmer had requested the skidsteer be returned to the barn so that the late afternoon feeding could be done. The contractor instructed the decedent to return the skidsteer to the barn which entailed driving the machine approximately 200 yards through a pasture secured with a closed gate, then on to the barn lot.

Gate decedent was to open to
return skidsteer to barn
