Dump Truck Driver Crushed Between Trackhoe and Dump Truck

Incident Number: 04KY101

Kentucky FatalityAssessment and Control Evaluation (FACE) ProgramIncident Number:04KY101Incident Date:November 11, 2004Release Date:November 1, 2005Subject:Dump Truck Driver Crushed Between Trackhoe
and Dump Truck

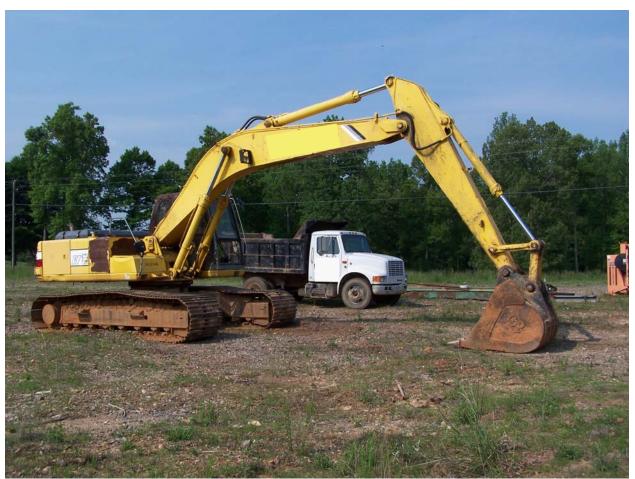
Picture of dump truck and trackhoe involved in fatal incident.

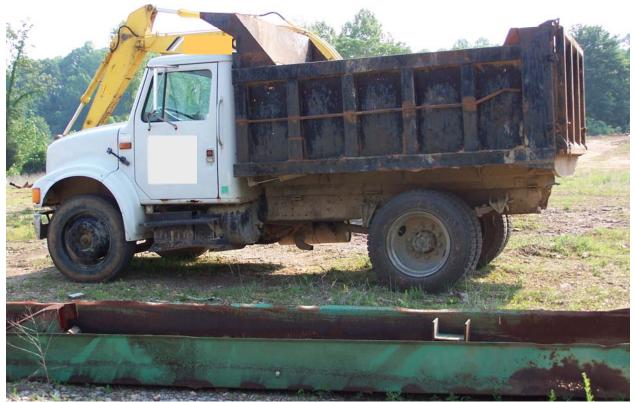
bulldozer blade. Then, one of two things probably occurred: 1) he attached the chain to the dump truck and it slipped off, so he exited the truck cab to re-attach the chain; or, 2) he was beside the dump truck looking for a place to attach the chain to the dump truck. That is when the trackhoe, loading the pan, swung around and the counter-weight of the trackhoe pinned the dump truck driver between the trackhoe and the dump truck door. The owner (not being able to see the ground or the cab of the dump truck), thought the chain was attached and began to back the bulldozer away from the dump truck. After backing the bulldozer a few feet, the owner expected the chain to tug but it did not. The owner tried to get the trackhoe operator's attention (he wanted the trackhoe operator to look and see if the chain had slipped off either the dump truck or the front-end loader bucket). The trackhoe operator had heard the bulldozer engine begin to accelerate, looked at the front-end loader and dump truck through the mirrors, and saw the dump truck driver on the ground. The trackhoe operator then looked at the owner and motioned that something was wrong and for him to get off the bulldozer. Both men exited their equipment and went to the driver's side of the dump truck where they found the truck driver on the ground. Another employee in the area went to the office building several hundred feet away and informed the office workers to call emergency services. Emergency services received the call at 10:55 AM. They responded at 10:57 AM and arrived at the scene at 11:07 AM to find the trackhoe operator holding the dump truck driver in his arms. Upon examination, emergency services found no vital signs and contacted the local coroner. The coroner arrived and at 11:30 AM, declared the truck driver dead at the scene.

Measurements were taken at the scene by Kentucky Occupational Safety and Health, and the local police. The distance between the counter-weight and the dump truck's door measured six inches.

Side of dump truck where decedent was pinned by trackhoe.

29 CFR 1926.550(a)(9) requires the swing radius of the trackhoe to have been barricaded. When operating heavy equipment in close proximity to each other, cones, caution tape, physical barricades, or another method should be used to indicate safety zones for workers. A safe distance outside the trackhoe's radius should have been marked off so the dump truck driver would know where the dump truck was in relation to the trackhoe. This barrier would have reminded the dump truck driver not to be inside the swing radius of the trackhoe.

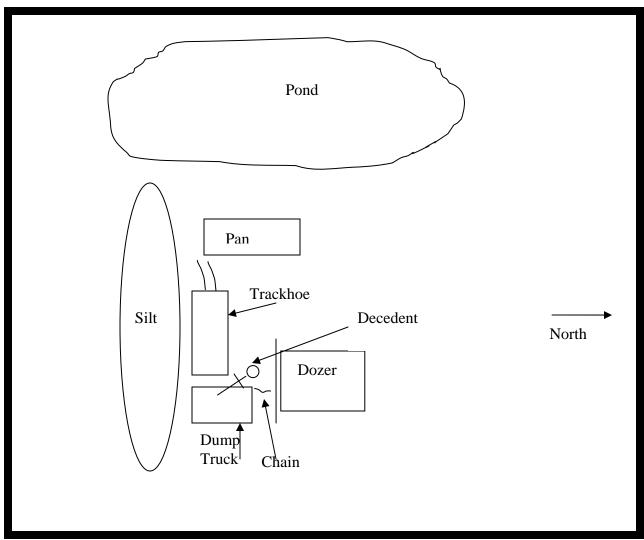
Schematic of scene. Not to scale.
