# **Worker Crushed To Death by Falling Steel Coil**

**Incident Number: 05KY015**

## **Kentucky Fatality Assessment and Control Evaluation (FACE) Program**

**Release Date: February 21, 2006**

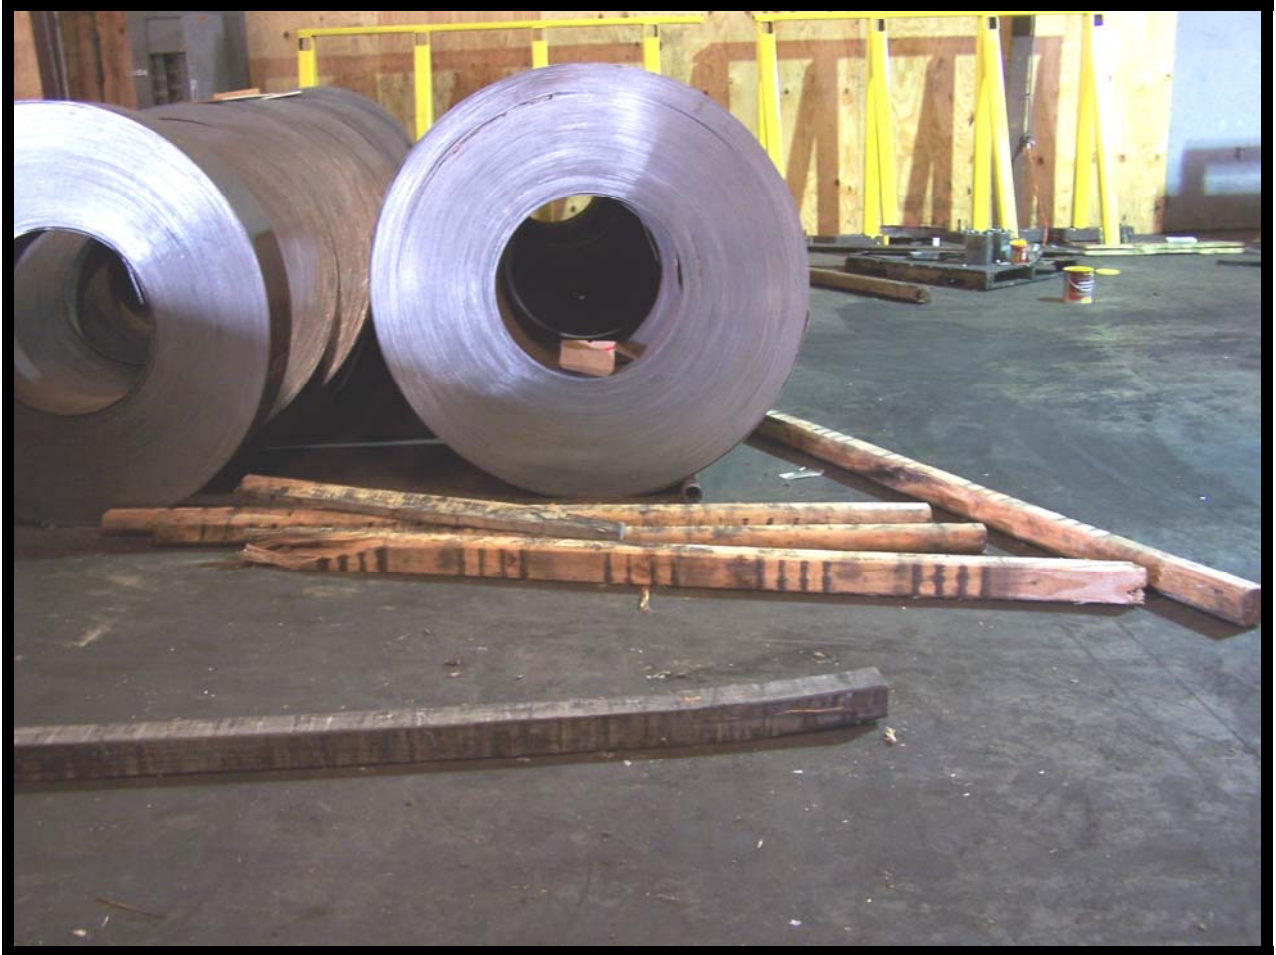
Photograph showing coils of slitted steel with boards to be used as chocks.

Recommendation No. 3: Coils should be kept from rolling or falling by use of chocking materials.

Since the incident, procedures on moving and storing steel coils have been changed. Now, coils of steel stacked on edge are chocked and there are boards placed between the coils, whereas previously they were not. This allows the chain to be placed through the middle of the coil without having to sit the coil on its narrow edge, thus reducing the risk of the coil falling over. 29 CFR 1910.176(b) states "for secured storage of materials, they must be stacked, blocked,

chocked or interlocked so that they are stable and secured against movement, sliding or collapse”.

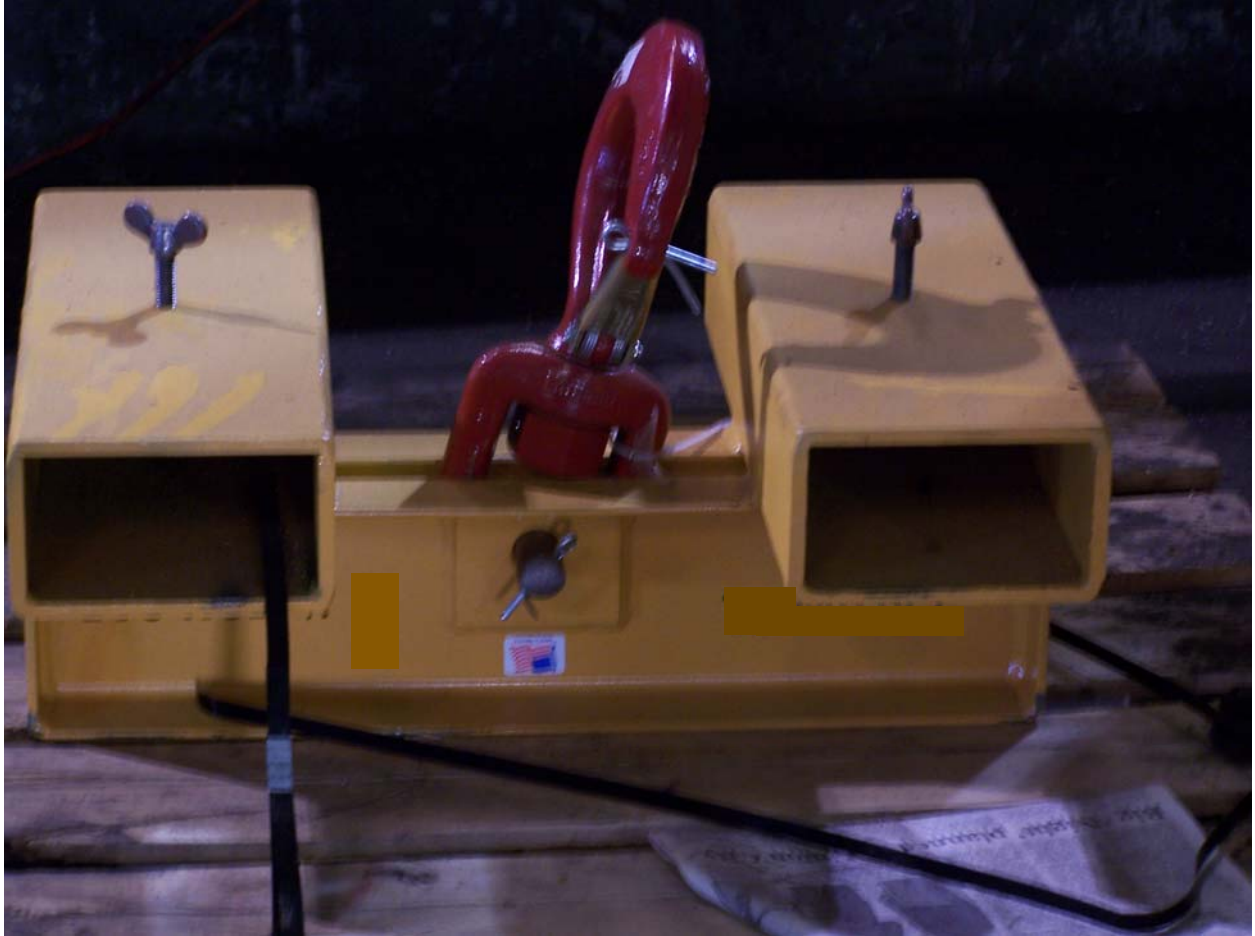
Picture of device workers should have been using with the forklift to transport coils of steel.

To accommodate the size of the steel coils, the homemade device was placed at a 36 inch load center instead of the 24 inch load center. The forklift was designed for a 24 inch load center. Placing the device at 36-inches on the forks changed the forklift center of gravity, load distribution, and carrying capacity. This load distribution change and handmade device were not approved by the forklift manufacturer. Equipment had been modified by the workers at the plant to enable them to transport the coils of steel to different locations within the facility. The modifications made to the forklift changed its center of gravity, load distribution, and carrying capacity from the manufacturer's original design. 29 CFR 1910.178(q)(6) prohibits modifications not approved by the manufacturer. Also, 29 CFR 1910.178(o)(2) prohibits handling loads greater than the capacity of the forklift. After the incident, a device, approved by the forklift manufacturer and KY OSH, was purchased which allows a chain to be attached safely to the forks of the forklift.

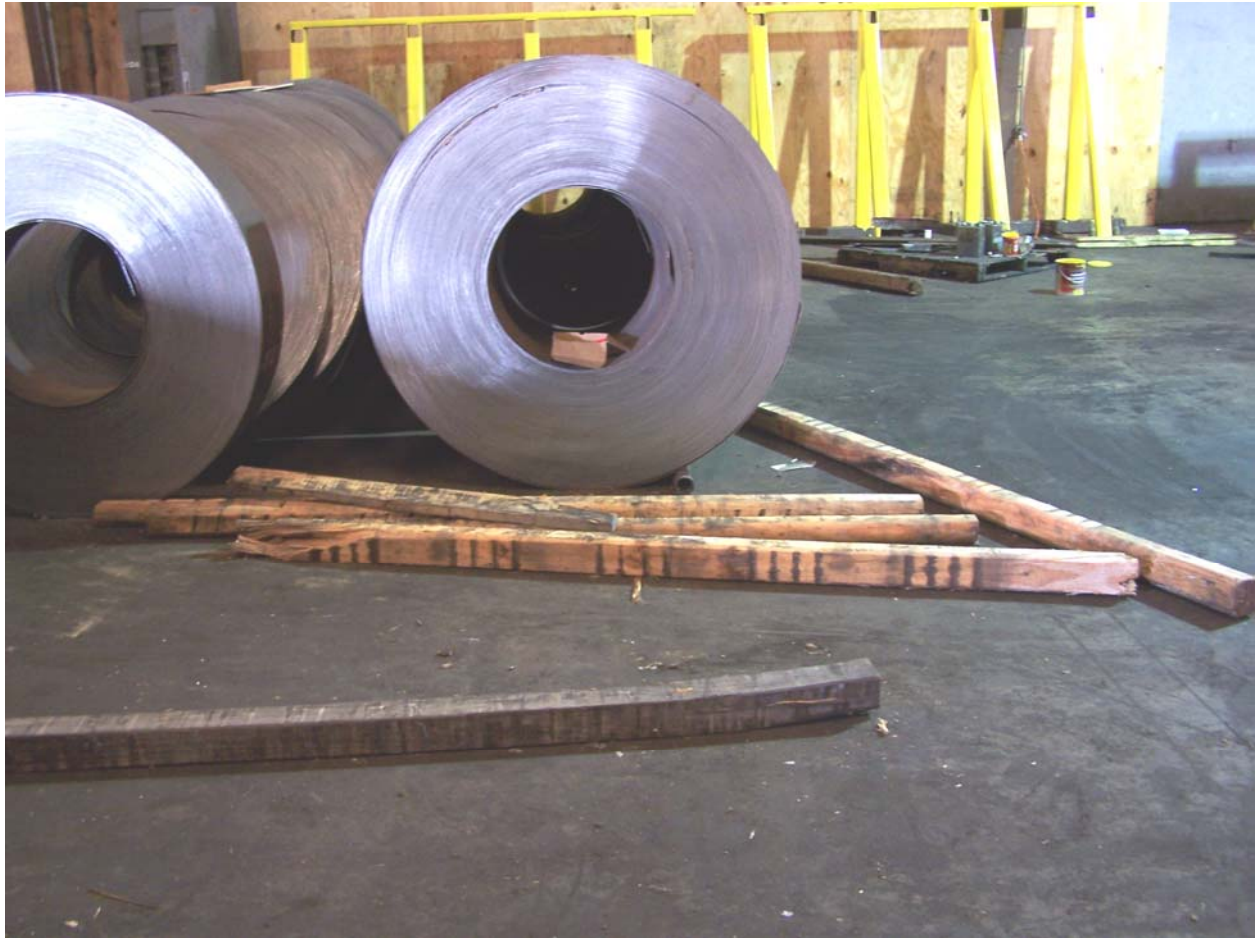
Picture of coils of slitted steel in the storage area waiting to be transported to the holding area before being taken to the pipe mill.
