# **Dump Truck Driver Dies After Unintentional Release of Asphalt**

**Incident Number: 05KY036**

## **Kentucky Fatality Assessment and Control Evaluation (FACE) Program**

**Subject: Dump Truck Driver Dies After Unintentional Release of Asphalt**

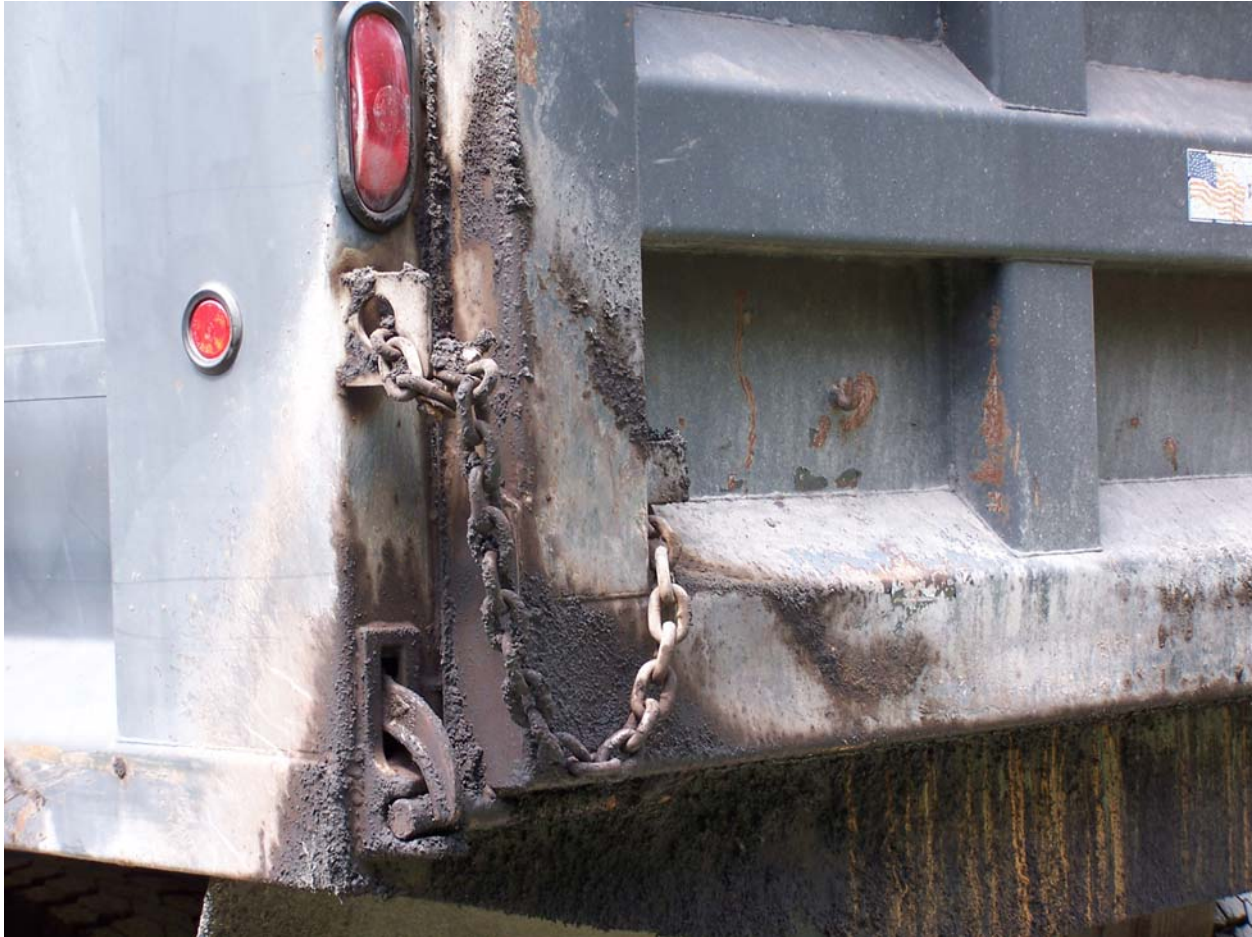
Picture of tailgate which released unexpectedly and dumped hot asphalt onto a driver. Chains were not secured at time of incident.

Recommendation No. 1: Tailgate chains should always be secured to the dump truck.

According to several dump truck drivers, chains on tailgates of dump trucks can be used to regulate the volume of rock when it is unloaded. The driver can choose to not hook the chains and dump the full load into one big pile, or hook the chains and spread the rock slowly in a line. When asphalt is unloaded, chains are not usually used. The tailgate is released, and the bed raised in increments to allow the asphalt to slide out of the truck bed. As a backup safety mechanism when hauling asphalt or any other material including rock, the chains should be secured tightly to the side of the truck. Chains should be secured before the bed is loaded with

material and unsecured when the truck reaches its destination and is preparing to dump its load. Securing the chains would provide the driver a backup safety feature if the tailgate trip handle failed.

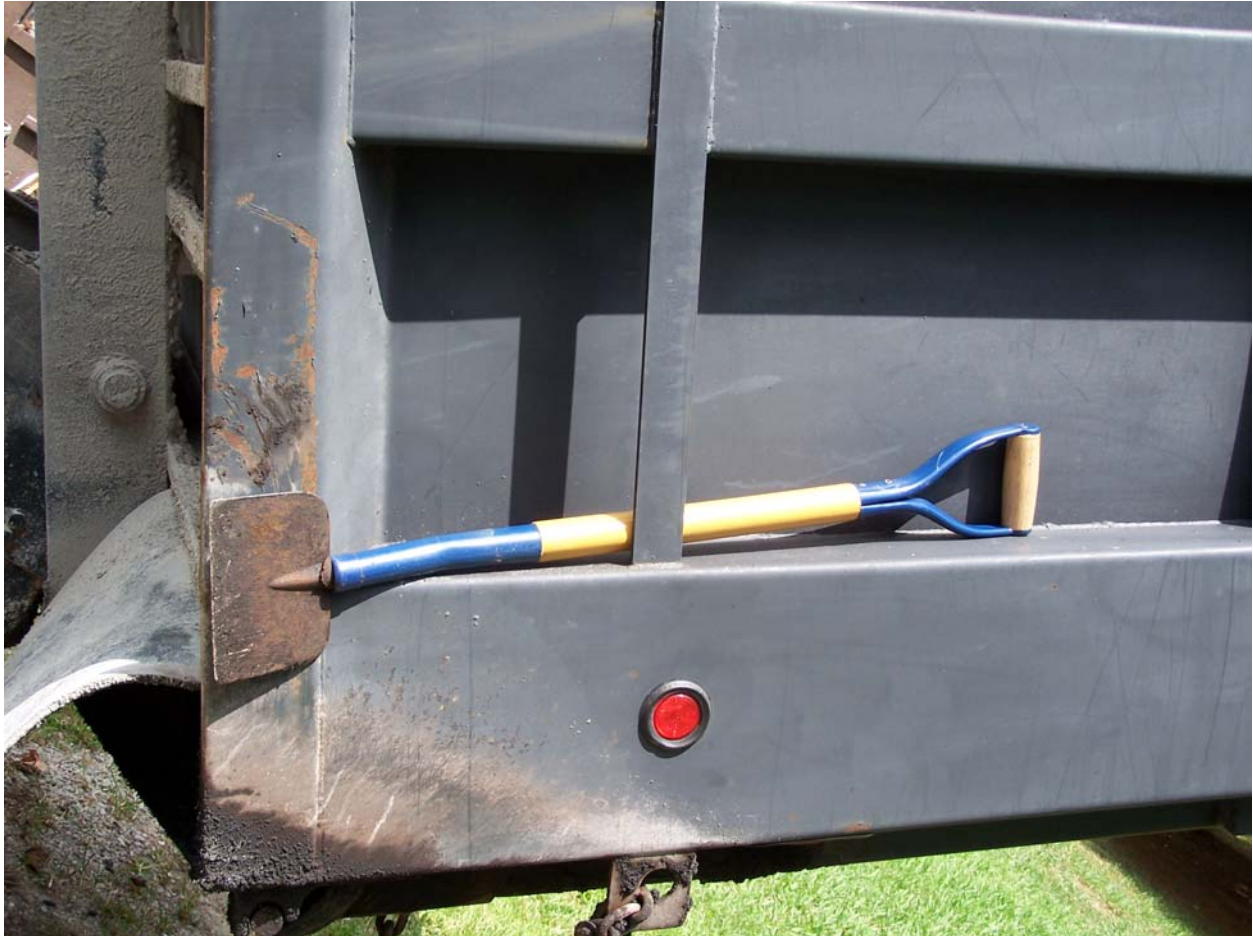
Driver 2 was an independent dump truck driver who had been driving for approximately 20 years. He had purchased the 1984 used dump truck involved in this incident in 2004. After the purchase, Driver 2 had the truck bed redesigned so the tailgate section of the bed was flat instead of lipped. This design eliminated the lip so that tar, rock, etc. could not build up and hamper the closure of the tailgate. The lack of a lip eliminated the need to scrape asphalt or rock when closing and securing the tailgate. Instead of having a shovel on the truck, Driver 2 had a scraper (Photo 1). Driver 2 was a mechanic and performed the maintenance on his dump truck.

Photo 1: Picture of scraper.

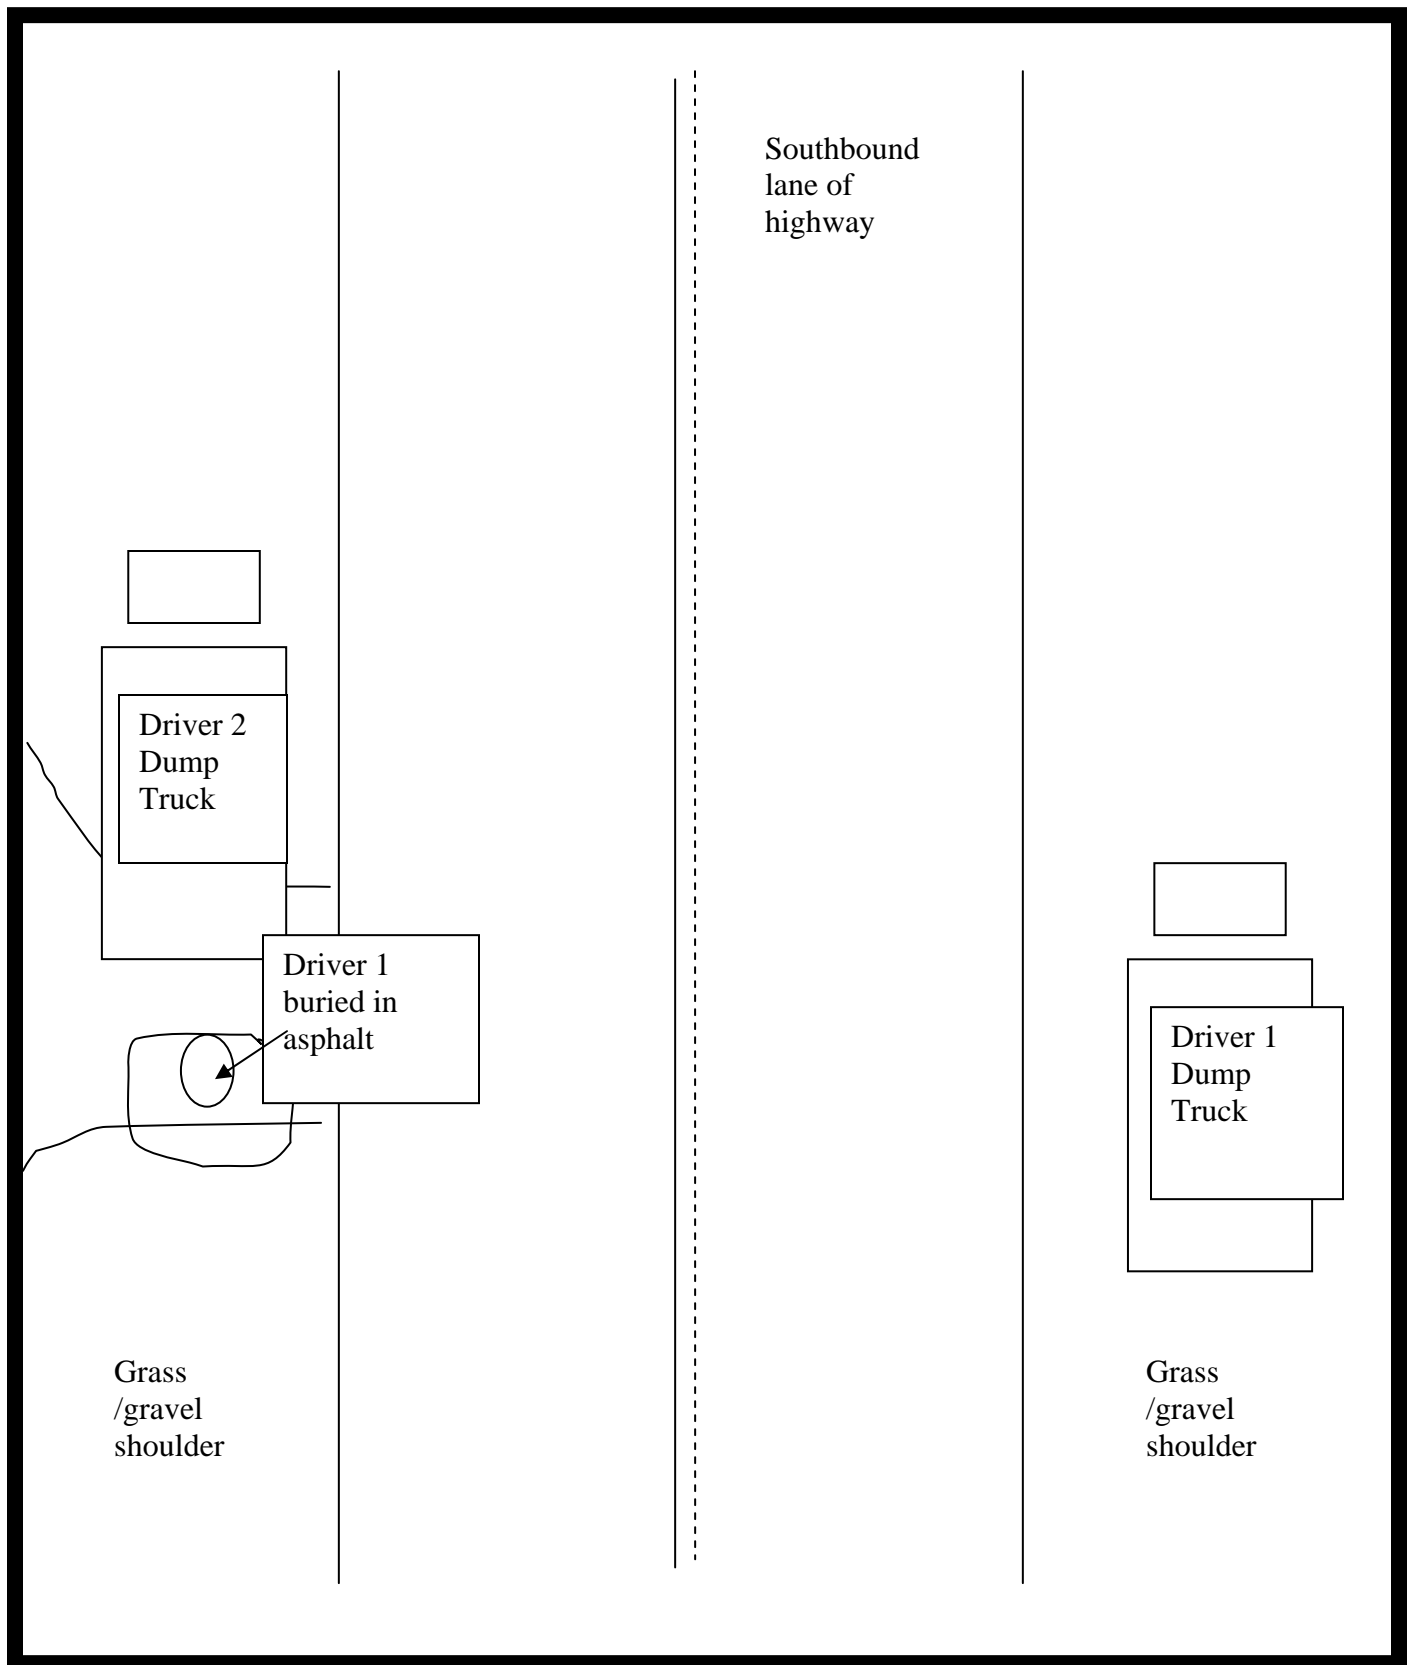
Diagram 1: Diagram of scene. Not to scale.

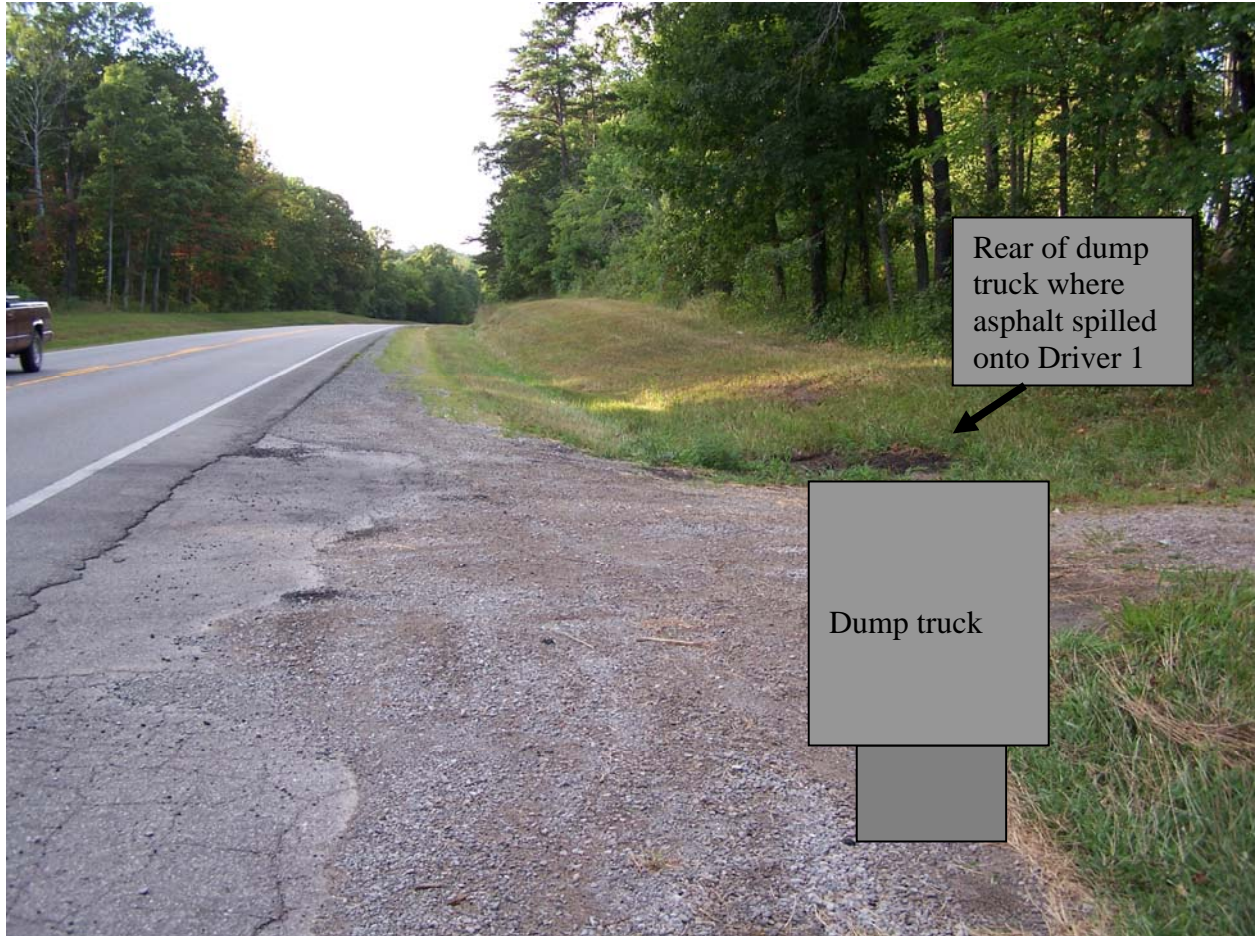
Photo 2: Northbound shoulder where Driver 2 parked dump truck. The dump truck was facing south.

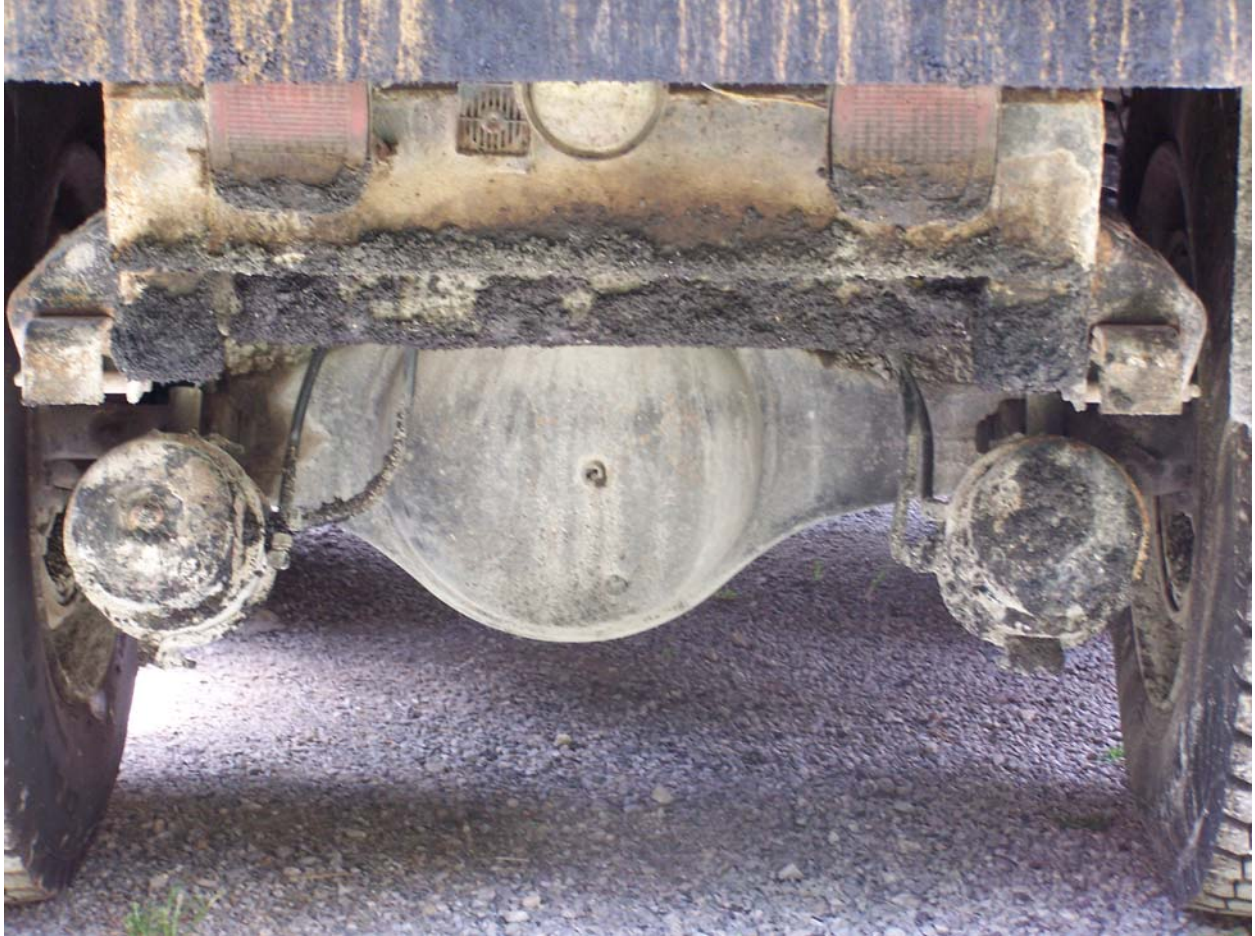
It was discovered that the air line connection for the brake line at the back of the truck had loosened, causing a loss of air pressure in the braking system. This is what caused Driver 2's truck brakes to lock up and forced Driver 2 to pull off the road. According to Driver 2, the brake system shared an air tank with the tailgate system. According to a manufacturer, this is common practice. The tailgate air line had a hold back valve located at the air tank. A hold back valve prevents loss of air in the tailgate system by preventing loss of air in the air tank. As the two men were inspecting the connections at the back of the truck, they heard air release out of the cylinder and knew the tailgate was going to open. According dump truck drivers and mechanics, when air releases from the cylinder, the automatic trip handle releases. After the incident, the truck was inspected by two separate inspectors. One inspection stated, "Found air tailgate latch to have blacktop build-up on latch not allowing it to lock properly." The other inspection states, "Found air system to be OK at this time; but tailgate was not latching properly due to black top build up in latch area of tailgate which allowed tail gate to open when lost all air. Mechanism on right rear brake chamber was leaking and was being repaired at time of incident." Pneumatic brakes and tailgate systems should have separate air tanks.

Photo 3: Picture of brakes and pneumatic lines at rear of truck. Truck bed is flat.

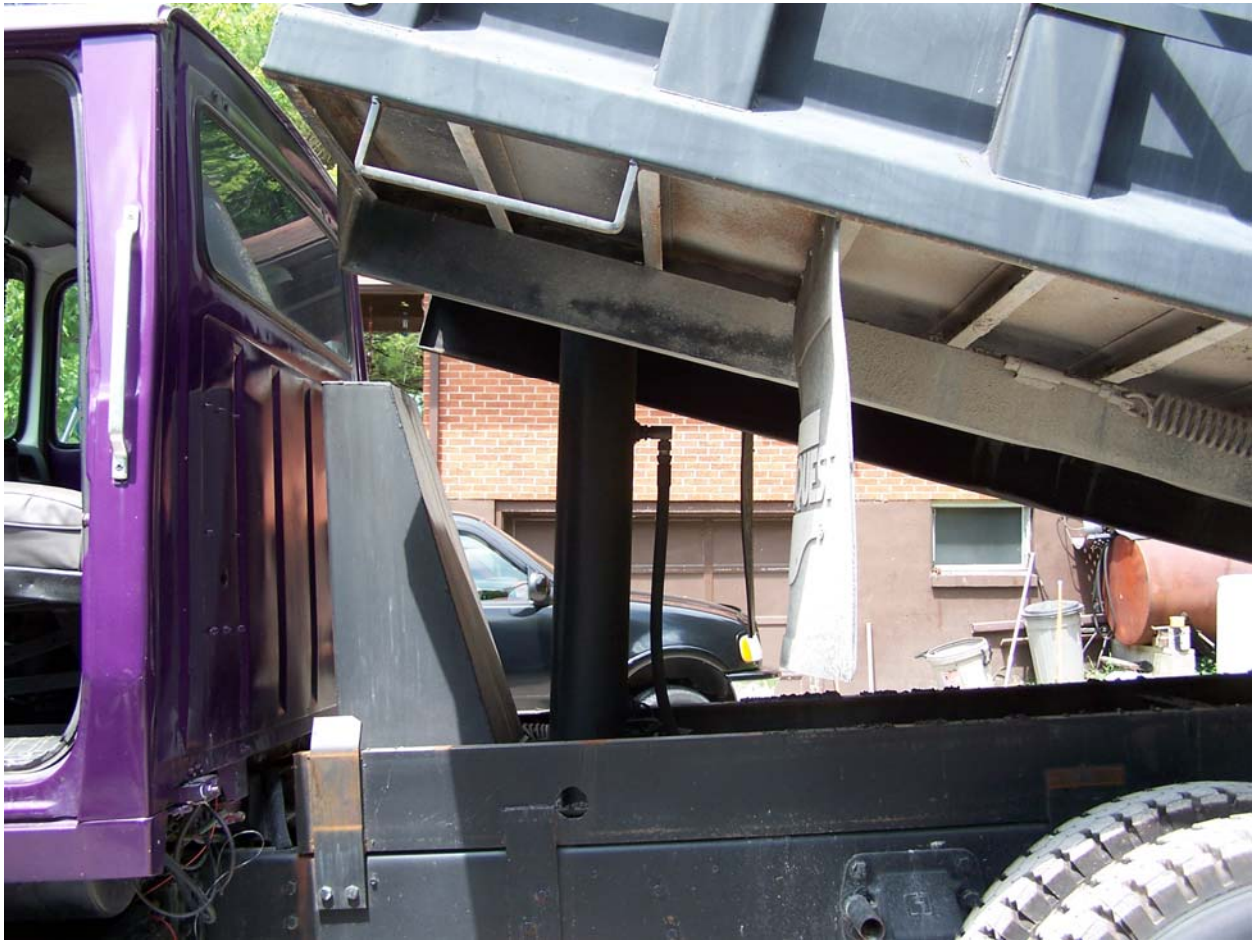
Photo 4: Picture of bed raised at the approximate height when it was raised for Driver 1 and Driver 2 to examine pneumatic connections.

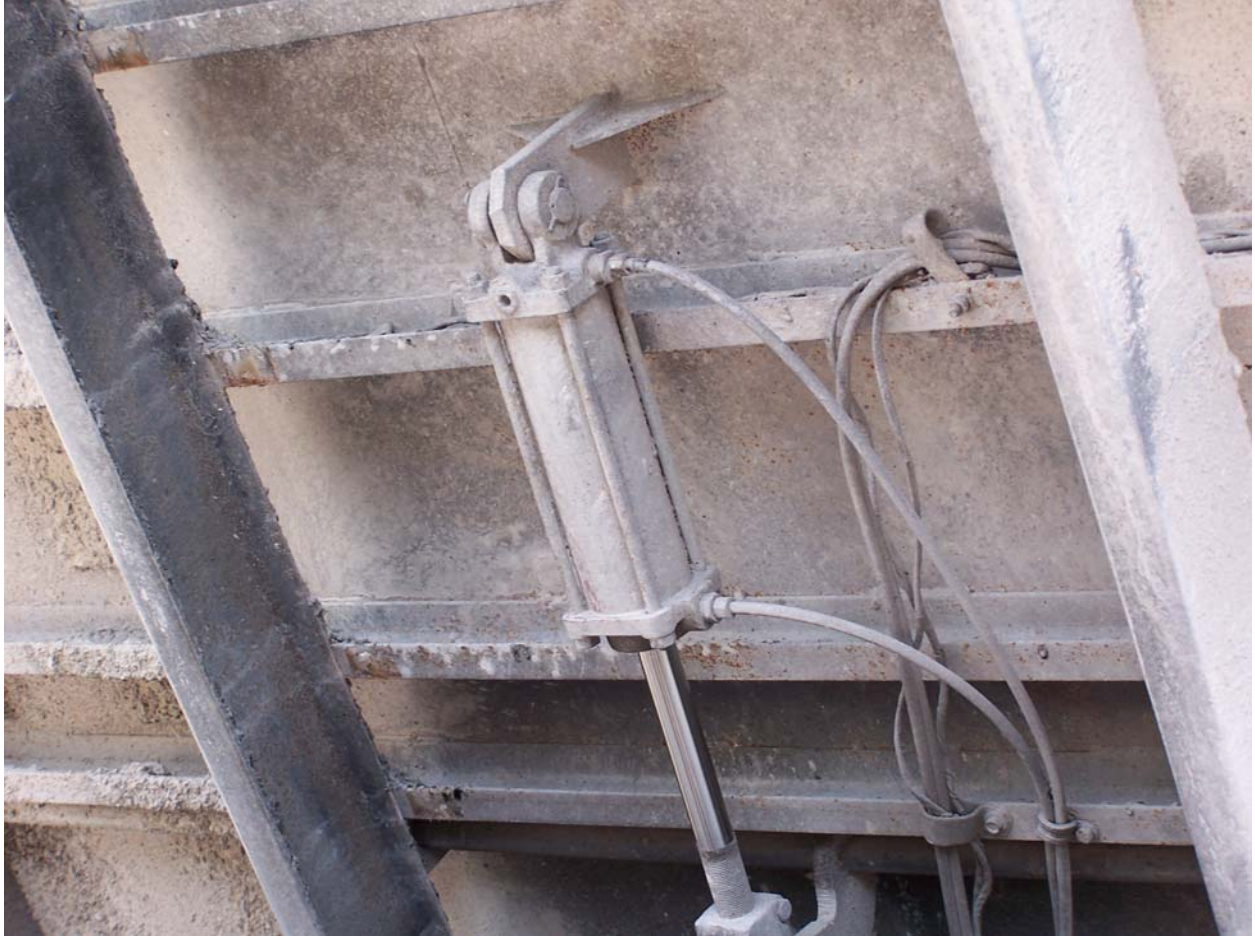
Photo 5: Picture of cylinder and pneumatic lines for tailgate trip handle system. One line goes to air tank; the other to a switch in truck cab.

When the surfactant is sprayed on the dump truck bed, the trip handles on the back of the truck should also be sprayed. This should help prevent tar from sticking and building up in the trip handle area. Trip handles should be inspected after the truck is loaded in order to ensure complete closure. This inspection should be performed when the chains are being secured to the side of the truck.

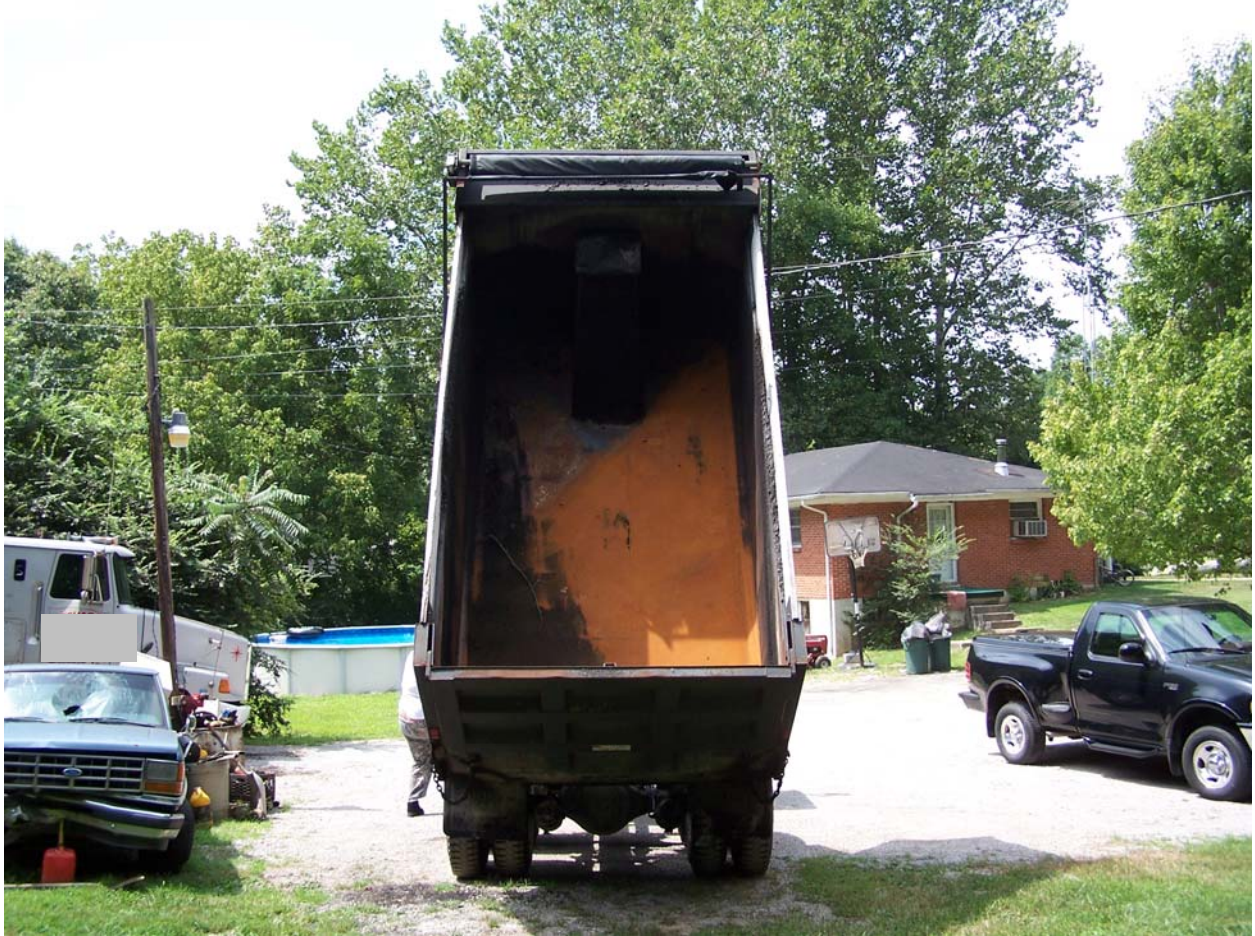
Photo 6: With truck bed raised, there was not room to inspect pneumatic line connections at the rear of dump truck.

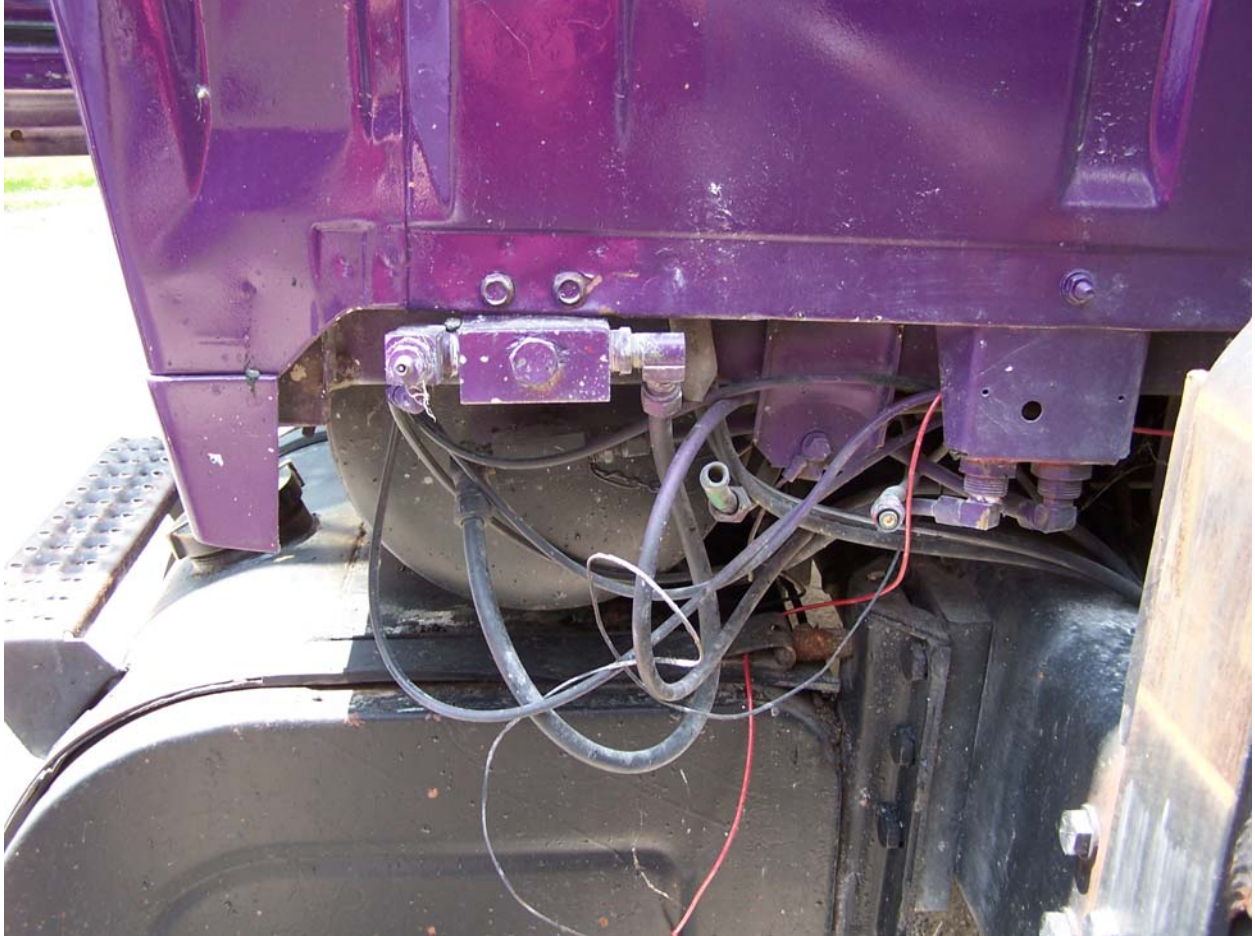
Driver 2 raised the bed of the dump truck, exited the cab of his dump truck and began examining the airline connections located behind the cab on the driver's side. One tank provided air for both the brakes and tailgate systems (Photo 7). As Driver 2 was examining the pneumatic connections, Driver 1 arrived and began to assist. Both drivers checked brakes and tailgate connections, and found all connections to be secure. They decided to examine the air line connections at the rear of the dump truck. With the front of the bed raised, there was less overhead room at the back of the truck. To make more room under the rear of the truck, Driver 2 lowered the bed of the dump truck to its flat position. This created more space at the back of the dump truck to observe where the air lines tied into the brakes and tailgate systems (Photo 3). Driver 2 crawled under the rear of the dump truck to examine the pneumatic connections from the underside. Driver 1 leaned down under the tailgate of the truck to examine the pneumatic connections from the top side. As the two men examined the connections, they heard air release from the cylinder for the tailgate. Driver 1, realizing the tailgate was going to open and asphalt would come out, tried to kick Driver 2 further under the truck to save him. According to an emergency report, approximately two tons of asphalt fell out from the tailgate, burying Driver 1 up to his waist in the hot asphalt. Driver 2 crawled out from under the truck and with his bare hands, tried to remove Driver 1 from the asphalt. Realizing rescuers needed more space and to try and stop more asphalt from falling on his friend, with both arms and hands severely burned, Driver 2 got back into the cab of the truck and moved it forward a few feet. By this time, Driver 3 had stopped and helped extract Driver 1 from the asphalt by using a shovel. At 7:10 AM a passing motorist called emergency services who arrived at 7:18 AM. Emergency rescuers used shovels to remove Driver 1 from the asphalt and performed CPR and took vital signs for about 20 minutes. The emergency report states Driver 1 was awake but confused and talking to his rescuers for 5 – 10 minutes before passing out. As emergency personnel were trying to save him, Driver 1 died at the scene. The local coroner was summoned. The coroner arrived and at 8:00 AM, declared Driver 1 dead at the scene. Driver 2 was taken to a hospital in another state and treated for severe burns on both arms and hands.

Photo 7: Picture of air tank shared by brake lines and tailgate system
