Dump Truck Driver Dies After Being Entangled In Power-Take-Off Drive Shaft

Incident Number: 06KY079

Release Date: January 22, 2008

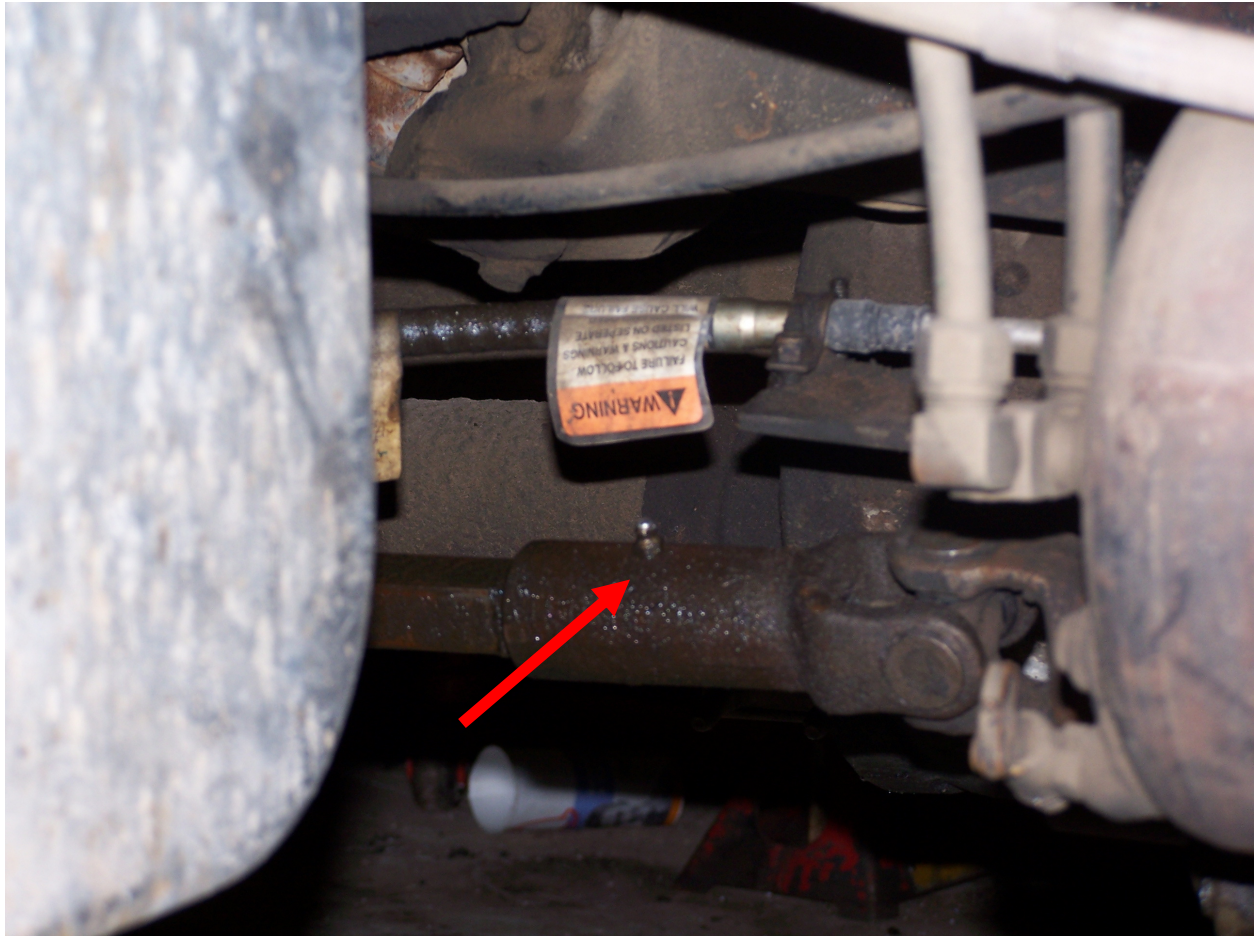
Photograph of grease fitting on universal joint power-take-off drive shaft that caught worker's coat

As Driver 3 lay under the idling truck's spinning PTO shaft, his coat sleeve became entangled in the grease fitting on the front universal joint. He was twisted onto the shaft and under the bed of the dump truck. When Driver 1 returned to his truck to wait for assistance from the company mechanic, he found the decedent caught in the PTO drive shaft underneath the truck. Driver 1 yelled to Owner 1 in the tower to call emergency medical services to the scene. While Owner 1 called 911, he called Owner 2 to the scene. Owner 2 found the decedent entangled in the PTO shaft and with the assistance from Driver 4, they proceeded to cut his clothing to free him from the shaft. Owner 2 tried to resuscitate Driver 3 (decedent) while EMS was enroute. Emergency medical services arrived six minutes later, determined the driver was in critical condition, and notified emergency air care. As emergency medical personnel placed Driver 3 in an ambulance and transported him to a nearby field where the air ambulance waited, he died. Air transport was cancelled and the local coroner was contacted who arrived and declared Driver 3 dead at the scene.

Recommendation No. 3: Loose clothing should not be worn while repairing machinery.

Recommendation No. 6: Consideration should be given to engineering machine guards for truck power take-off; equipment should be designed or retrofitted to shield any open, unguarded power take-off drivelines.

Currently, the model of truck involved in the incident does not have any guarding for the PTO. Consideration should be given to developing a guard that would prevent inadvertent contact with moving parts of the PTO. Although the primary prevention strategy for this fatality should be separating drivers from the hazard by eliminating unnecessary exposures, guarding would provide an added level of protection for mechanics, who cannot entirely avoid exposure to PTO's. For example, in this instance, the PTO had to be rotating in order to diagnose the problem. A simple metal covering could act as an effective shield for exposed parts of the PTO, thereby reducing the potential for PTO-related injuries. Since the year this truck was manufactured, the PTO shaft design has been changed and is now located where it is shielded and more difficult to be an entanglement hazard.

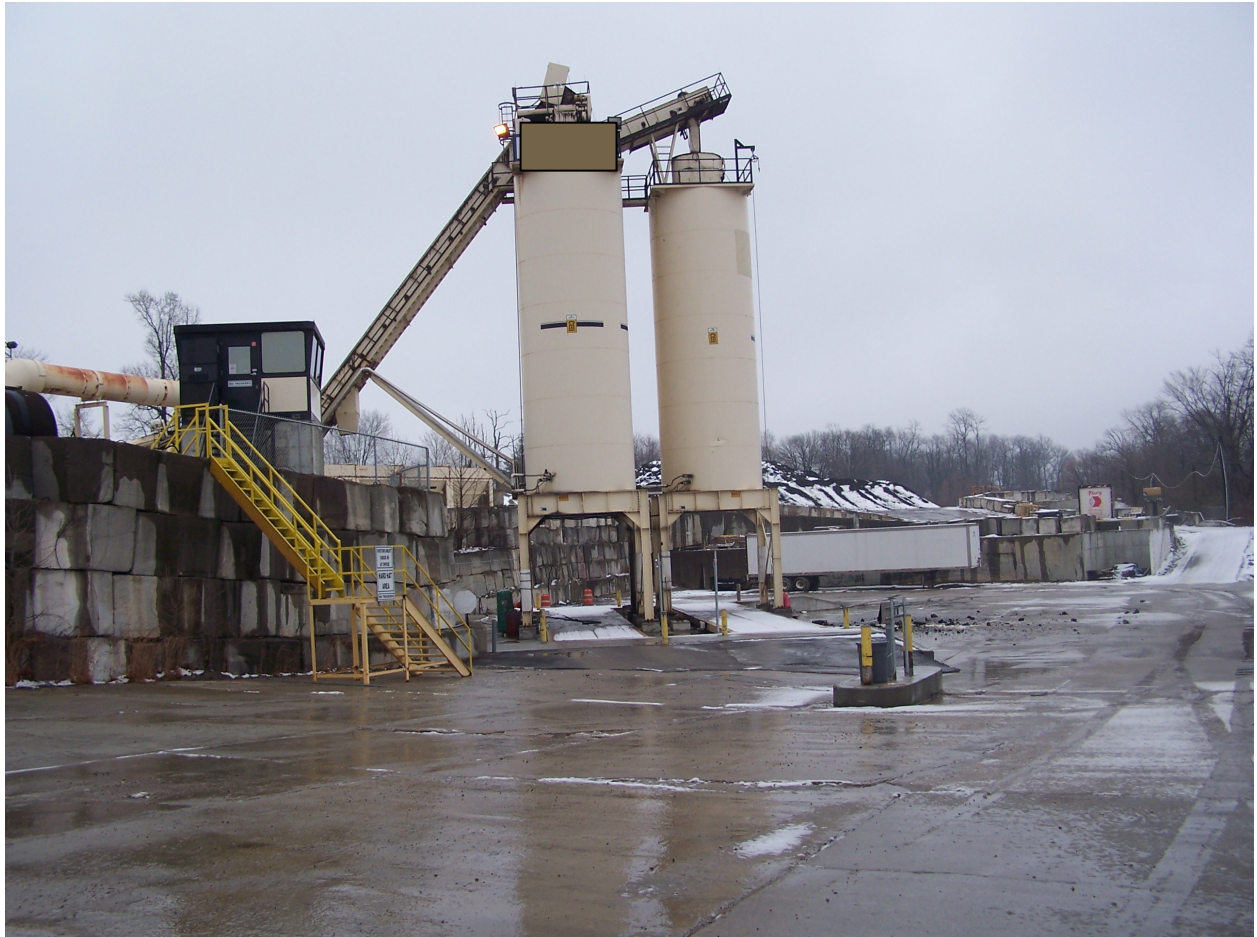
Attachment 2: Photo of asphalt plant. Diagram of how trucks were lined up on next page.

On this particular morning, at approximately 7:30 AM, the decedent and four other drivers arrived at the garage, inspected their respective dump trucks, and drove to the asphalt plant two miles away. Once at the asphalt plant, the drivers lined up their dump trucks in two lines and waited to be loaded (see Attachments 2 and 3). As they waited for the asphalt to be loaded, the
