# Hispanic Carpenter Dies After Falling From Homemade Platform

Incident Number: 07KY008

**Release Date: January 22, 2008**

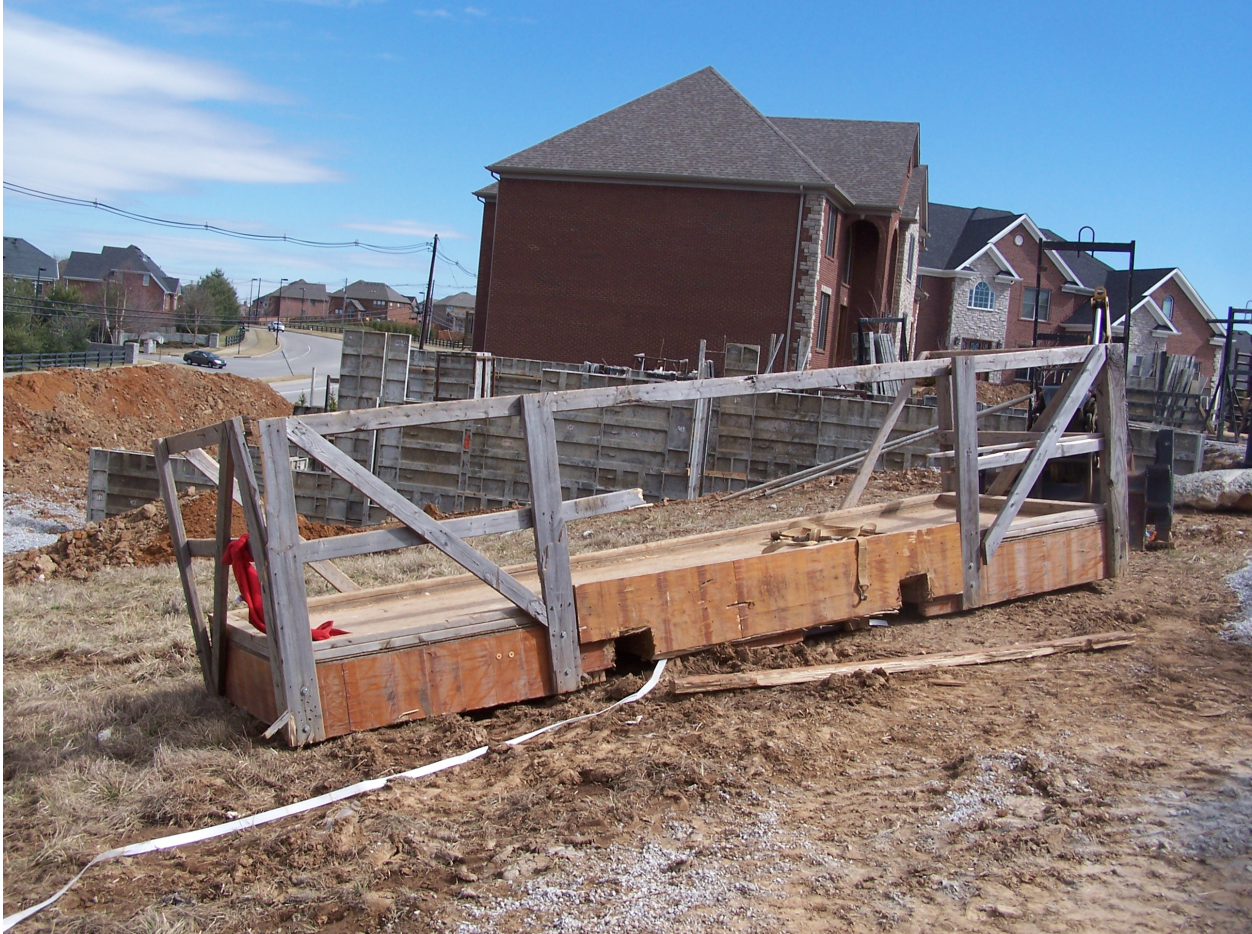
Picture of homemade platform involved in this incident. Notice railing and cleats.

On the morning of the fatality, three Hispanic carpenters were framing a new, multi-story, single-family house. The terrain of the building lot was hilly, steep and rough with the backside of the lower level of the house open out of the slope. At approximately 7:30 AM, the three men were to erect a section of wall above the foundation of the lower level in the back left side of the house. According to an employee, the carpenters typically would have used ladders to reach the area to be framed. Because the terrain was rough and steep, and the work area was higher than the ladders could reach, it was decided to use a homemade materials platform to perform the task. The platform was constructed of wood, had railing on three sides with cleats on the bottom of the long side with railing. The cleats had been inserted on the railing side for stability when lifted. The operator of the forklift had inserted the forks under the long side of the platform without the cleats. This caused the platform to rest on top of the forks and be more unstable. The platform was not secured to the forklift.

**Recommendation No. 1:** Companies should not attempt to build any "homemade" type personnel platform for a forklift; all personnel platforms must comply with ANSI / ASME standards and the OSHA regulations.

ASME standards allow a company to construct and attach a personnel platform to a rough terrain forklift. There are rigorous guidelines for this, and it is, therefore, preferred that individuals consult with the forklift manufacturer for assistance, or better, purchase a factory-made and approved personnel platform designed for their particular machine.

Requirements for an approved personnel platform include proper size, approved guard rails, rated anchor points for attachment of lifelines, and a safe method to secure the platform to the forklift. OSHA frequently writes citations for inadequate / home-made personnel platforms, deferring to the restrictions written into machine operator's manuals, which usually forbid using a homemade personnel platform on a forklift. Usually, the manufacturer's operator manual provides some guidance on this issue, therefore, companies desiring a personnel platform for a forklift should to study their options carefully. In addition, personnel platforms must be securely anchored to the forks of a machine.

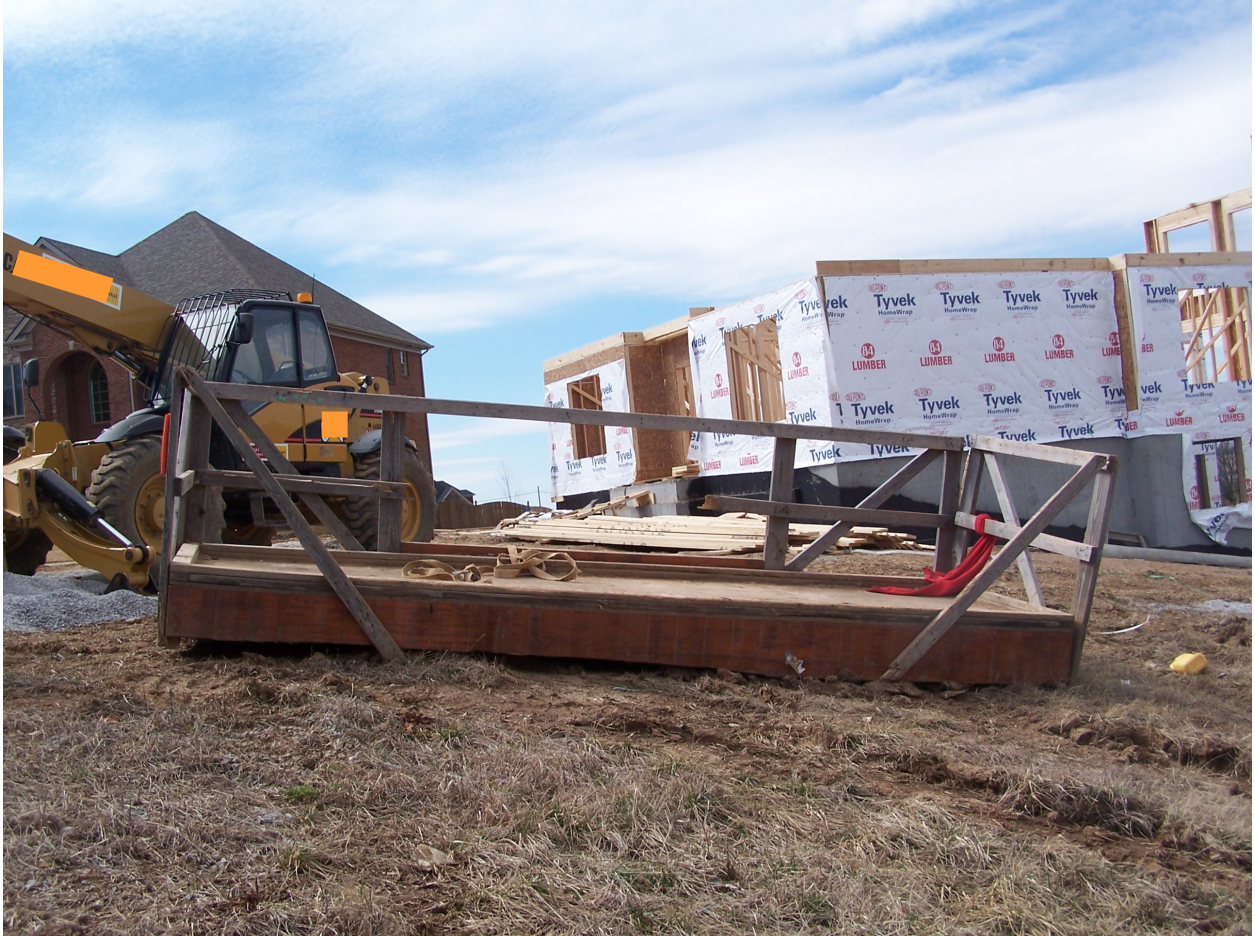
The forklift operator elevated the three carpenters on the platform while they were holding the wall to be set in place. When the platform reached approximately seven feet high, it slipped off the forks and tumbled the three men to the ground. Two of the carpenters fell close to the house under the right side of the platform which fell on the edge of the foundation of the house. The third carpenter was struck by the left side of the platform as it slid to the ground. One of the workers called emergency medical services. The fire department and police arrived. Upon their arrival, they found the two carpenters alive and the third carpenter without vital signs. Both of the injured carpenters were transported to a nearby hospital where they were treated for their injuries. The local coroner arrived and declared the third carpenter dead at the scene.

Picture of side used to lift homemade platform. Notice there are no cleats for forks on this side.

Forklift operators should be trained to recognize proper weight distribution of the loads they are elevating with the forks. This would include recognition of unstable weight at the end of the forks of the forklift and the hazardous condition this creates. Forks should be opened as wide as possible to provide stability to the platform. Forklift operators should be trained to recognize the hazards of not securing personnel platforms being elevated by forklifts. 29 CFR 1926.602(1)(viii)(A) states that when personnel are being elevated on a platform, it should be “firmly secured to the lifting carriage and/or forks”. Therefore, forklift operators should be trained to ensure platforms being used to elevate workers are properly secured to the mast. Also, the platform should be equipped with an appropriate guardrail with a locking gate. Elevated personnel should have controls on the platform that allow them to shut off power to the forklift. And, the forklift operator should not leave the controls of the forklift so that the elevated personnel can give instructions to the operator.

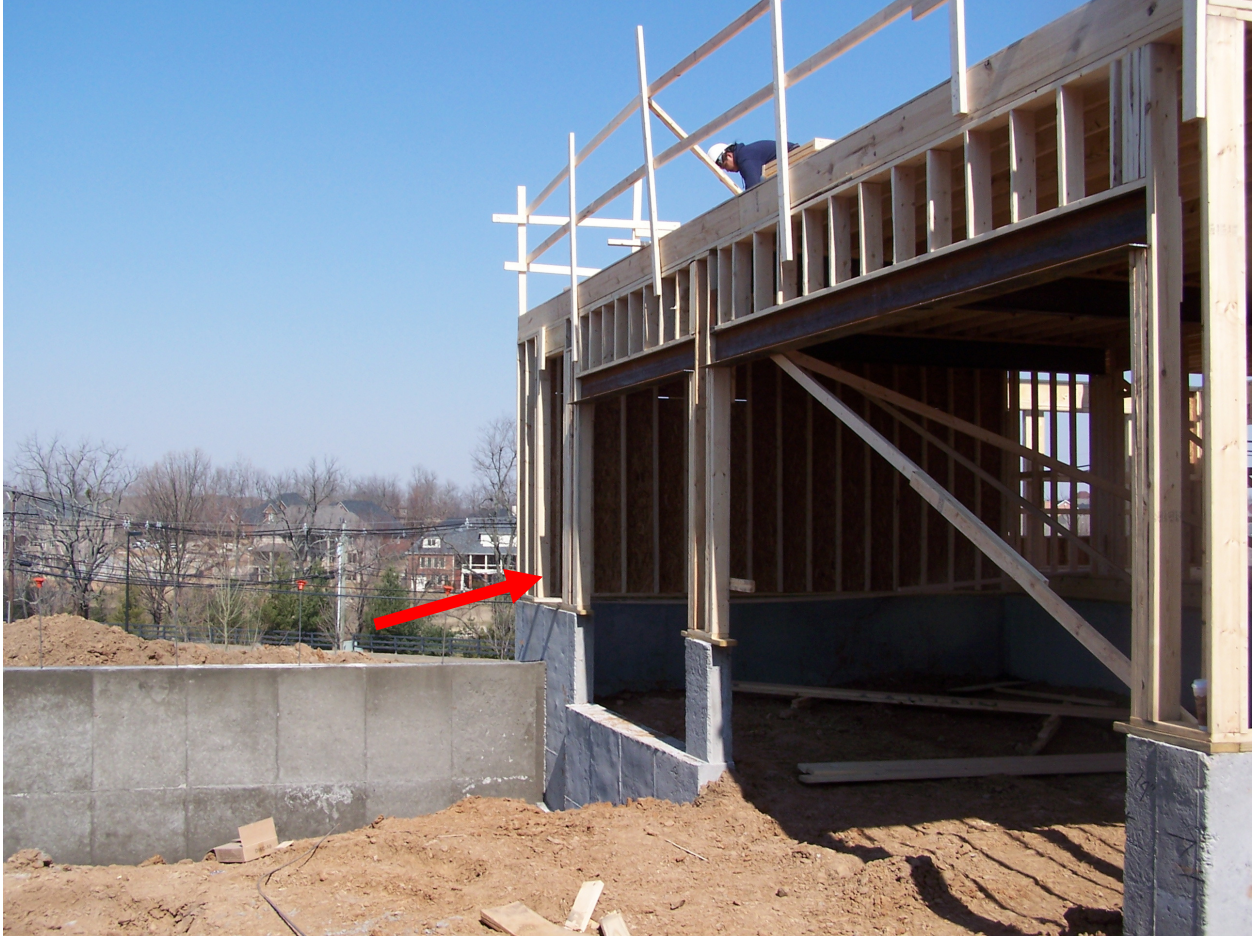
Corner of house where carpenters were to erect the wall. The concrete wall was not there at time of incident.

Construction workers should use appropriate tools to perform tasks. In this case, properly erected scaffolding would have provided an appropriate, safe and secure platform for the carpenters to frame the wall of the house. Some common types of scaffolding the workers could have used are system, or tubular. Scaffolding should only be erected under the guidance of a
