Semi-Tractor Trailer Driver Hauling Chicken Dies After Striking A Rock Wall

Incident Number: 07KY070

Kentucky Fatality Assessment and Control Evaluation (FACE) Program

**Subject: Semi-Tractor Trailer Driver Hauling Chicken Dies
After Striking A Rock Wall**

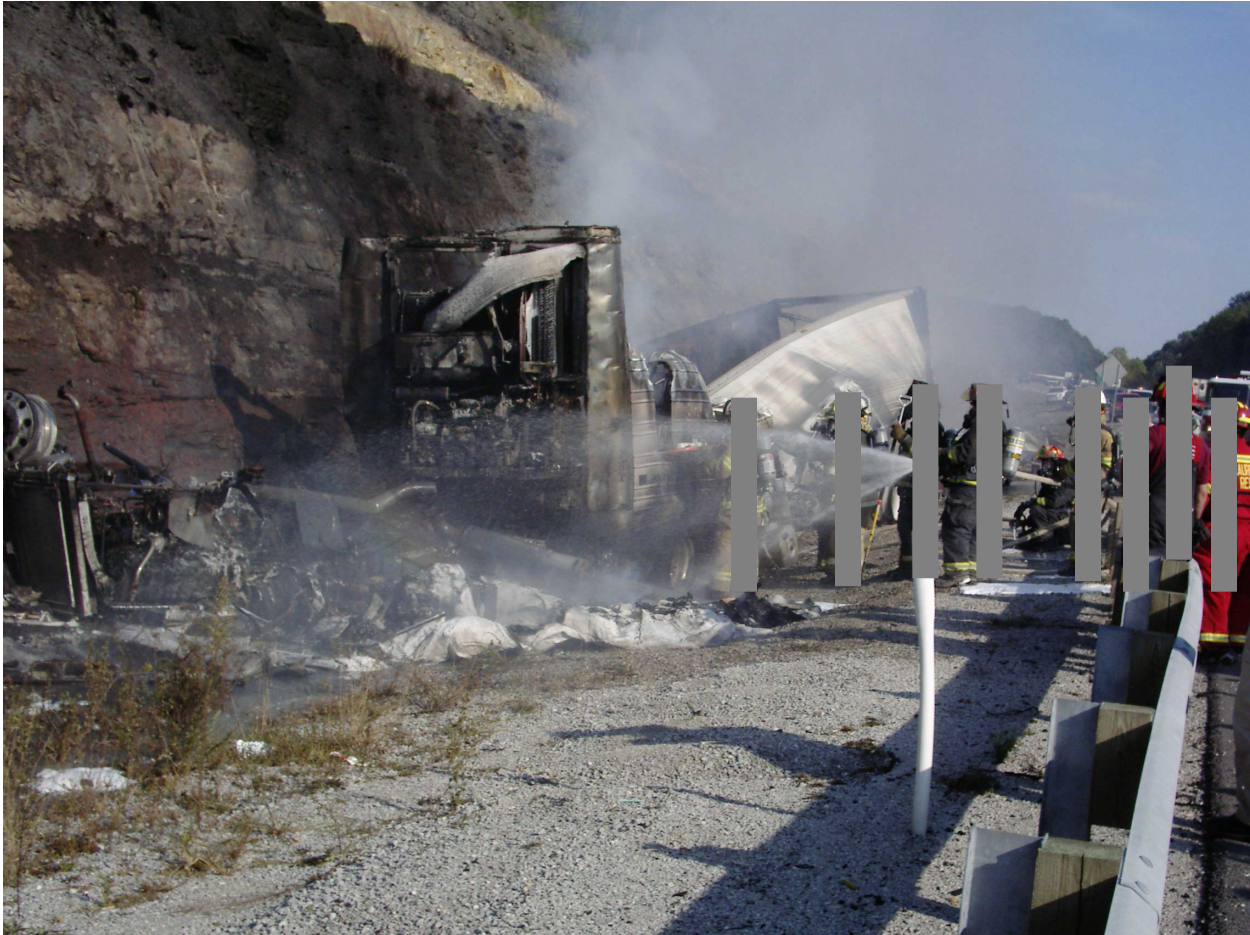
Photograph of motor vehicle crash involving a semi tractor-trailer. Photograph courtesy of Kentucky Vehicle Enforcement

On a sunny fall day in 2007, a 50-year old semi truck driver hauling processed frozen chicken in a refrigerated trailer, died when his semi crashed into a rock wall. The driver was north bound on an interstate highway when witnesses saw the semi in the left lane contact the concrete median barrier then veer over to the right across one traffic lane and the shoulder, then strike a rock wall. The impact caused the cab to overturn onto the driver's door while the refrigerated trailer remained standing upright. An exhaust pipe located on the back of the cab was horizontal facing skyward on the cab. The fuel line to the refrigeration unit was damaged in the crash allowing fuel to drip onto the hot exhaust pipe and ignite a fire. Numerous calls reporting the crash were placed to 911 emergency medical services. A man and woman reportedly driving behind the semi witnessed the fire start between the cab and trailer.

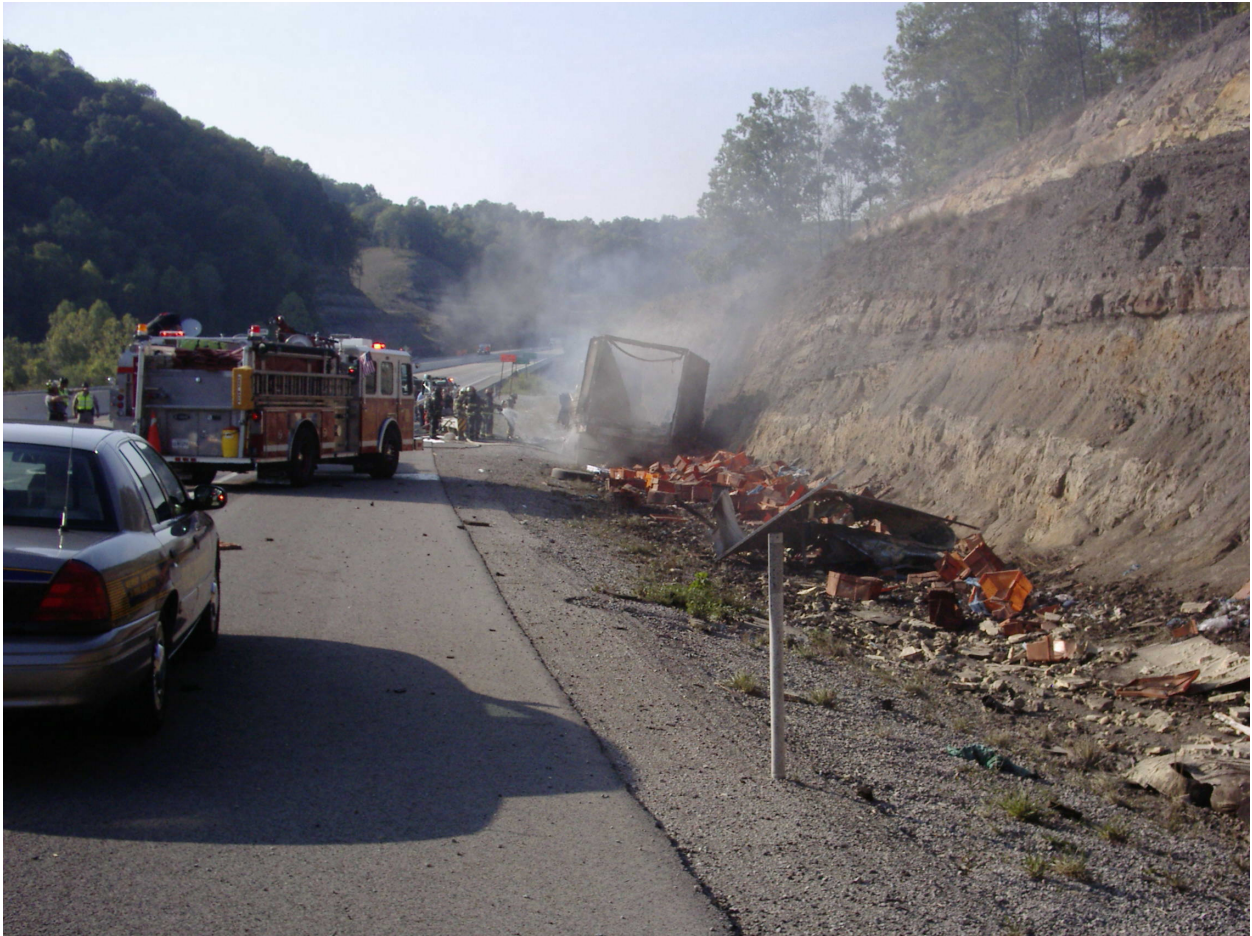
The incident photograph of the refrigeration unit shows a line dangling from the middle of the unit to the ground. According to a motor carrier transportation professional, this line appears to be a cable. There are two possibilities as to why the cable was there. One possible reason for the

addition of the cable was if there was an electrical problem (e.g.: alternator failure). If this occurs while a driver is en route, it is common for the driver to clip one end of a cable to the alternator and clip the other end to the battery located at the back of the semi. This scenario allows the driver to complete the route and upon completion, address the failure of the refrigeration unit with the company mechanic. Another possibility is the battery on the tractor had failed and the driver used the cable to keep the battery charged to keep the tractor operating, thus allowing the driver to successfully complete the route and then have the company mechanic make the necessary repairs. These two possibilities are typically used by drivers in order to continue driving to the delivery destination and allow repair by the company mechanic. Either situation is dangerous. If the cable clip loosens and comes in contact with metal (such as the frame of the semi), a reaction could occur creating sparks that may ignite the coating of the cable or other nearby flammable material on fire. Companies should have a network of mechanics on-call along delivery routes so drivers have an efficient and reliable safe source to have mechanical repairs made when necessary.

Photograph of rear of motor vehicle crash involving a semi tractor-trailer. Photograph courtesy of Kentucky Vehicle Enforcement.

Recommendation No. 3: Long-haul semi tractor-trailer drivers should have a network of mechanics along the routes they travel in case mechanical problems arise.

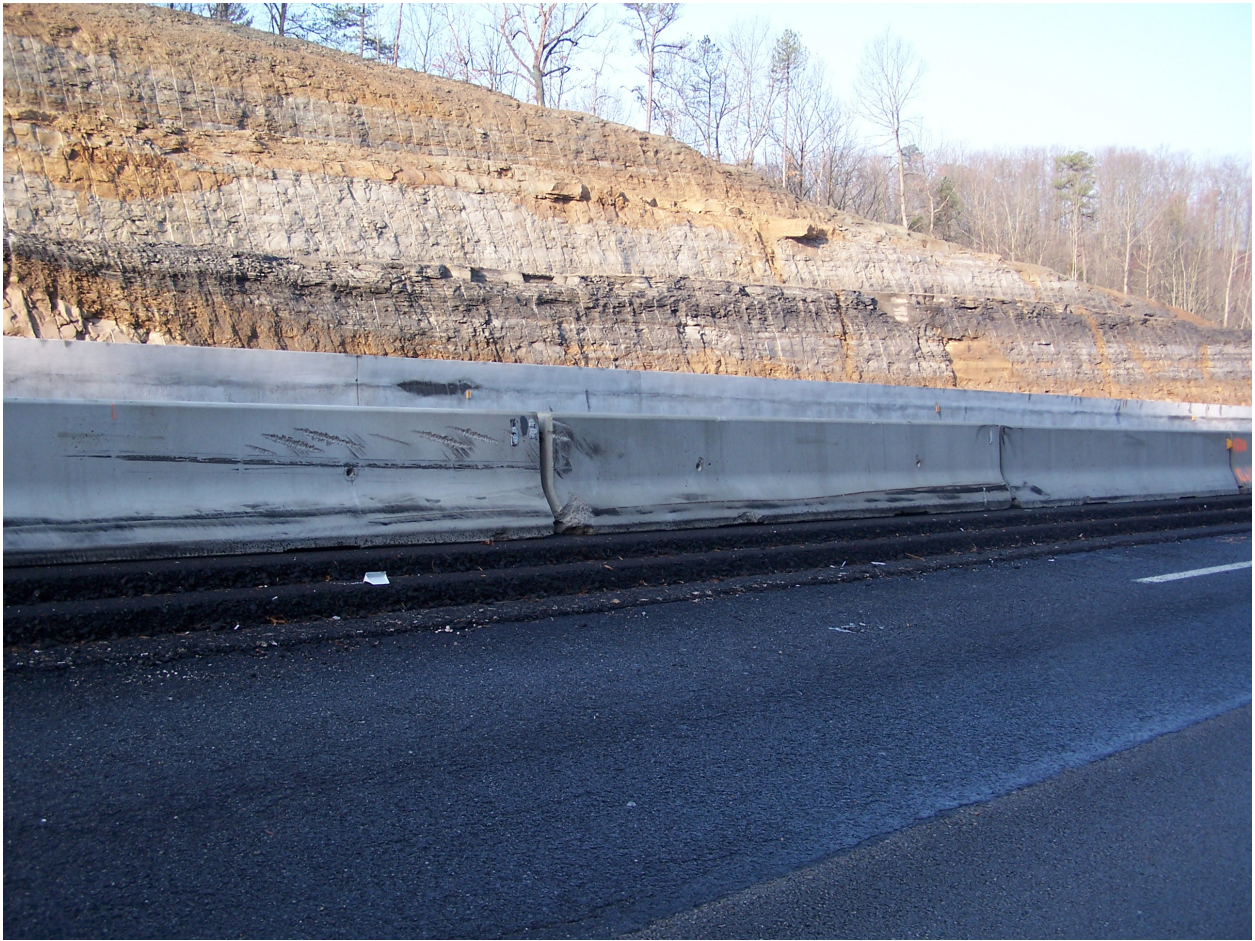
While driving in the construction zone, witnesses saw the semi in the left lane strike three of the 20 foot sections of the temporary concrete barrier weighing 5,000 pounds each and moving each a foot toward the median. Witnesses then saw the semi fishtail for $\frac{3}{4}$ of a mile, veer into the right and shoulder lanes, and strike a rock wall. The impact caused the cab to turn over onto the driver's door while the refrigerated trailer was left standing upright. An exhaust pipe located on the back of the cab became horizontal facing skyward on the cab. The return fuel line to the refrigeration unit was very narrow and was damaged in the crash allowing fuel to drip onto the hot exhaust pipe and ignite a fire. Calls placed to 911 emergency medical services began at 4:23 PM. Emergency personnel were dispatched at 4:24 PM. A call was received by emergency services at 4:25 PM stating the unit semi had crashed and was on fire and they did not see the driver get out of the truck. Emergency personnel began arriving at the scene at 4:33 PM. A man and woman driving behind the semi witnessed the fire start between the cab and trailer.

Photograph of the three temporary barrier sections semi driver struck. Marks are from the semi. Photograph courtesy of Kentucky Vehicle Enforcement.

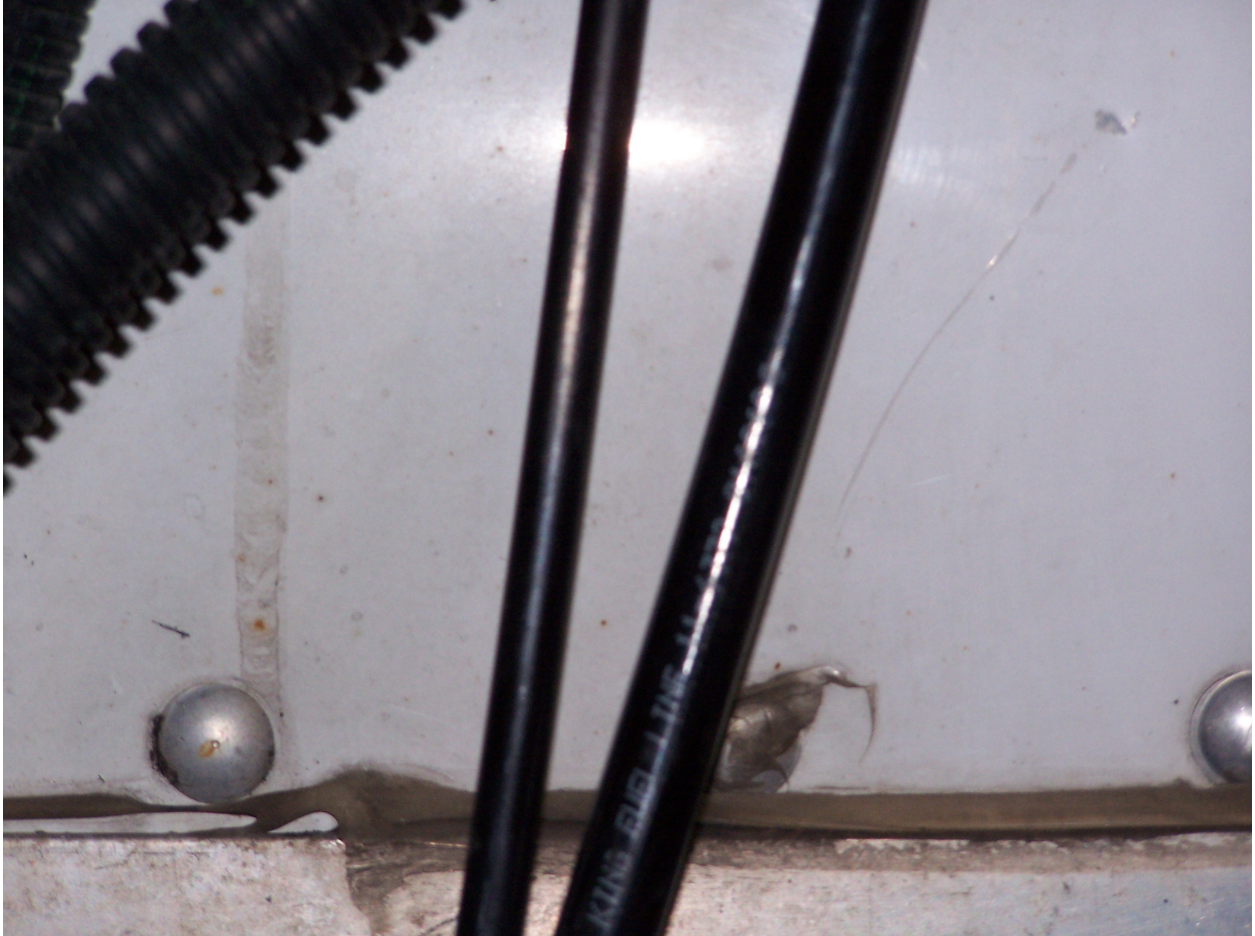
Refrigeration units on tractor-trailers operate on diesel fuel. Refrigerated unit fuel tanks are typically located 1/3 of the way back on the driver's side of the trailer, but are occasionally located on the passenger side. Tanks come in three sizes: 20 gallons, 30 gallons, and the most common is 50 gallons. The fuel line, 1/4 inch in diameter, is pressurized and feeds diesel fuel

from the fuel tank to the refrigeration unit. A second line, 3/8 inch in diameter, returns unused fuel from the unit back to the fuel tank to be used later. The second line is not pressurized. Thus, diesel fuel is used and circulates through the system. Pressure in the first line fuels the refrigeration system while the second line uses gravity and drains unused diesel fuel back into diesel tank. If the second line is compromised, pressure from the first line will feed diesel fuel through to the second line until the diesel tank is empty. Due to the narrowness of the second line, the draining diesel fuel is almost aerosolized. It is in this state that diesel fuel is volatile. According to the accident reconstructionist, the fire was caused when the second fuel line was compromised and the aerosolized fuel drained onto the hot exhaust pipe, catching fire. The fire consumed the semi, destroyed the trailer, and the chicken cargo. Refrigeration units should be manufactured with switches on the fuel lines that will shut off the flow of fuel if either of the lines becomes compromised. This redesign could prevent fire from occurring, or if fire is caused by another source, limit fire intensity and damage.

Photograph of the diesel fuel lines on the refrigerated trailer.

Recommendation No. 5: Manufacturers of commercial refrigerated trailers should consider a sensor design that shuts off the fuel supply to the refrigeration unit when the fuel line is compromised.
