**Coal Truck Driver Fatally Injured in Collision
With another Coal Tractor-Trailer
Incident Number: 08KY010**

Kentucky Fatality Assessment and Control Evaluation (FACE) Program
Incident Number: 08KY010
Release Date: February 13, 2008
Subject: Coal Truck Driver Fatality Injured in Collision Involving with another Coal Tractor-Trailer

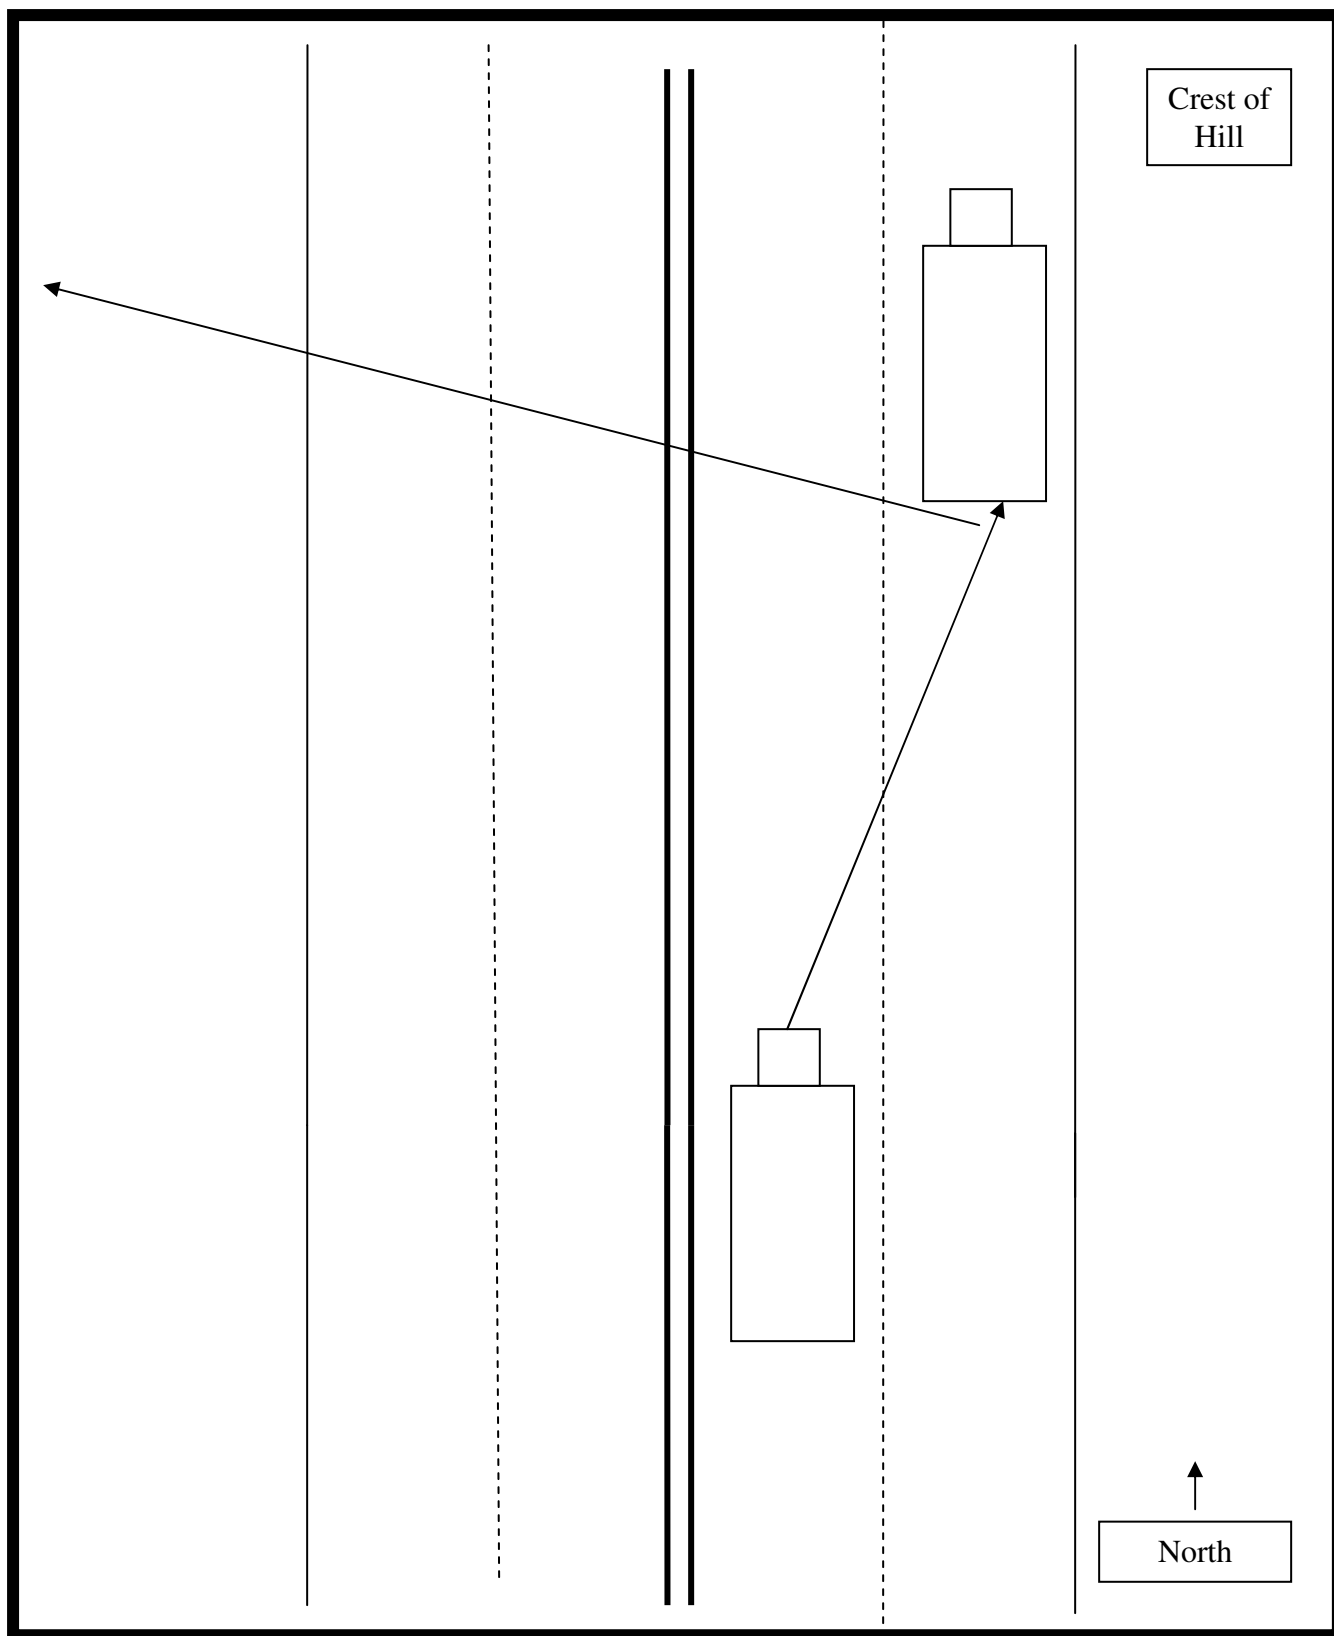
Schematic of incident; not to scale

Truck 1 was in the right lane traveling north. Truck 2 was traveling behind Truck 1 in the left lane. The lane Truck 3 was traveling in is unknown. The three tractor-trailers were traveling down a hill approximately 1/10 of mile long with a 2.5% - 4.4% grade. They approached an intersection where a two lane state highway connects with a stop light at the bottom of the hill. Upon approach to the intersection, there was a flashing yellow caution light alerting oncoming vehicles of traffic signal changes from green to yellow to red. The caution light was part of a signage unit which read "When Flashing Prepare To Stop." Drivers of Trucks 2 and 3 had been conversing via citizen band radio but had ceased communications before reaching the intersection.

Truck 1 was required to stop at the red light. When the light changed to green, Truck 1 proceeded up the next hill; Truck 1's vision up the hill was clear and unobstructed. Truck 2, driving in the left lane, approached the intersection while the light was green. Truck 2 drove through the intersection followed by Truck 3 approximately three tractor-trailer lengths behind. The next hill after the traffic light was approximately 1/10 of a mile long with a 0.5% - 2.4% grade.

Truck 1, traveling approximately 40-45 miles an hour, was in the right lane approaching the top of the hill. The speed of truck 2 is unknown. Trucks 2 and 3 were also approaching the top of the hill. The driver of Truck 3 stated that Truck 2 appeared to engage in a normal lane change into the right lane when the driver's side tire of Truck 2 hit the right rear of Truck 1's trailer. Upon impact, the driver of Truck 1 looked in the driver's side mirror and saw Truck 2 veer across the southbound lanes of the highway. Truck 2 crossed over a gravel ditch beside the road, immediately hit an earth embankment, overturned and caught fire. Upon impact with the embankment, the cab separated from the frame of the truck, the fuel tanks were torn open, and the driver was thrown into the passenger side of the sleeper compartment.

The crash investigation revealed that the impact of the two trucks flattened the right rear tires of Truck 1 and broke #5 and #6 suspension hangers on the trailer's right hand side axles. The main drive line of Truck 2 dropped down and left several pavement gouge marks in the direction of the right shoulder and there were skid marks across the southbound lanes toward the embankment. The impact force of Truck 2 hitting the embankment was enough to drive the tractor's motor block approximately four feet left and five feet forward from the correct position. The axles on Truck 2 were shifted forward approximately seven inches and the suspension mounts and spring hangers were broken. The impact also knocked the cap off the universal joint of Truck 2. It was recovered by the crash investigator from Kentucky State Police.
