Semi-truck Driver Dies After Striking A Bridge Abutment

Incident Number: 08KY025

Kentucky Fatality Assessment and Control Evaluation (FACE) Program

Release Date: February 13, 2009

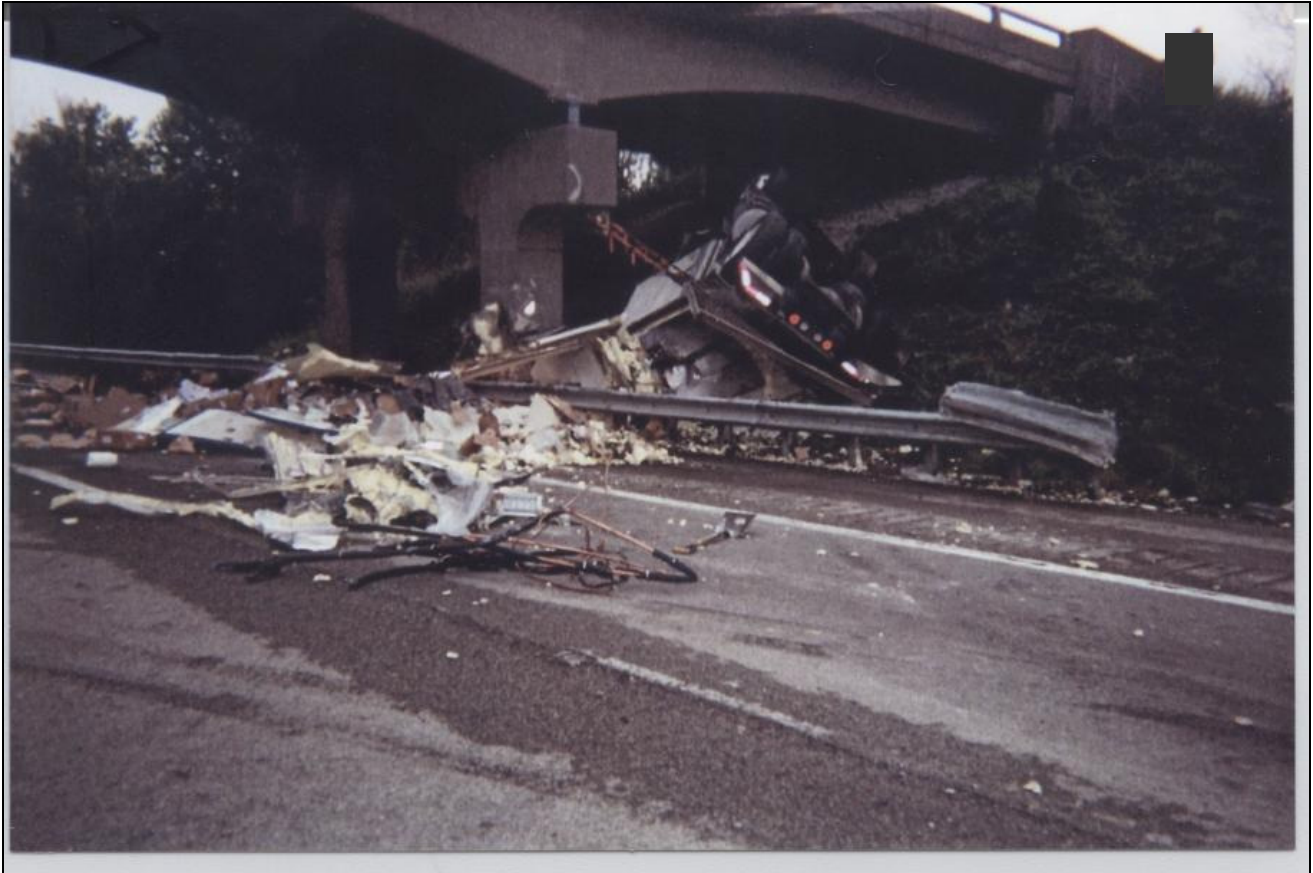
Photograph of crash scene. Photograph courtesy of private company.

As the northbound pickup truck and semi-tractor trailer approached the mini-van resting across the right hand lane, they switched from the right lane to the left lane and observed the witness to the previous incident in the median with the lit flares. While passing the mini-van, the pick-up driver slowed and attempted to return to the right lane when the semi truck driver drove by the mini-van, noticed the pick-up truck had slowed, struck the pick-up truck on the left rear bumper and applied the brakes. The semi-tractor trailer then jackknifed; the trailer over turned onto its right side and the semi turned over on its left side and both units slid across the right lane and shoulder in a northerly direction. The semi-tractor trailer flipped over a guard rail and struck the bridge abutment while the trailer split open spilling its contents on the roadway. The trailer

disengaged from the semi-tractor and continued to slide along the pavement where it came to rest in the right-hand lane. The driver trainee was ejected from the semi onto the embankment by the bridge.

Recommendation No. 4: Bridge abutments should be eliminated next to interstate highways.

As bridges that cross over interstates are replaced, new bridges should incorporate and be built with as few abutments as possible. When abutments are necessary, they should be located outside of the Clear Zone, which is, according to the American Association of State Highway and Transportation Official Guidebook, on high speed highway, is "the unobstructed, relatively flat area provided beyond the edge of the traveled way for recovery of errant vehicles. The travel way is the portion of the roadway not including shoulders. It is desirable to provide a roadside clear of hazardous objects or conditions for a distance consistent with speed, traffic volume and geometric conditions of the site. The greater the width of the clear zone, the greater element of safety provided" and is 30 feet from the right travel lane. If bridge designs cannot place abutments outside the Clear Zone, abutments should be shielded by appropriate barriers. Also,

appropriate barriers should be installed by certified installers to deflect traffic when necessary away from abutments.

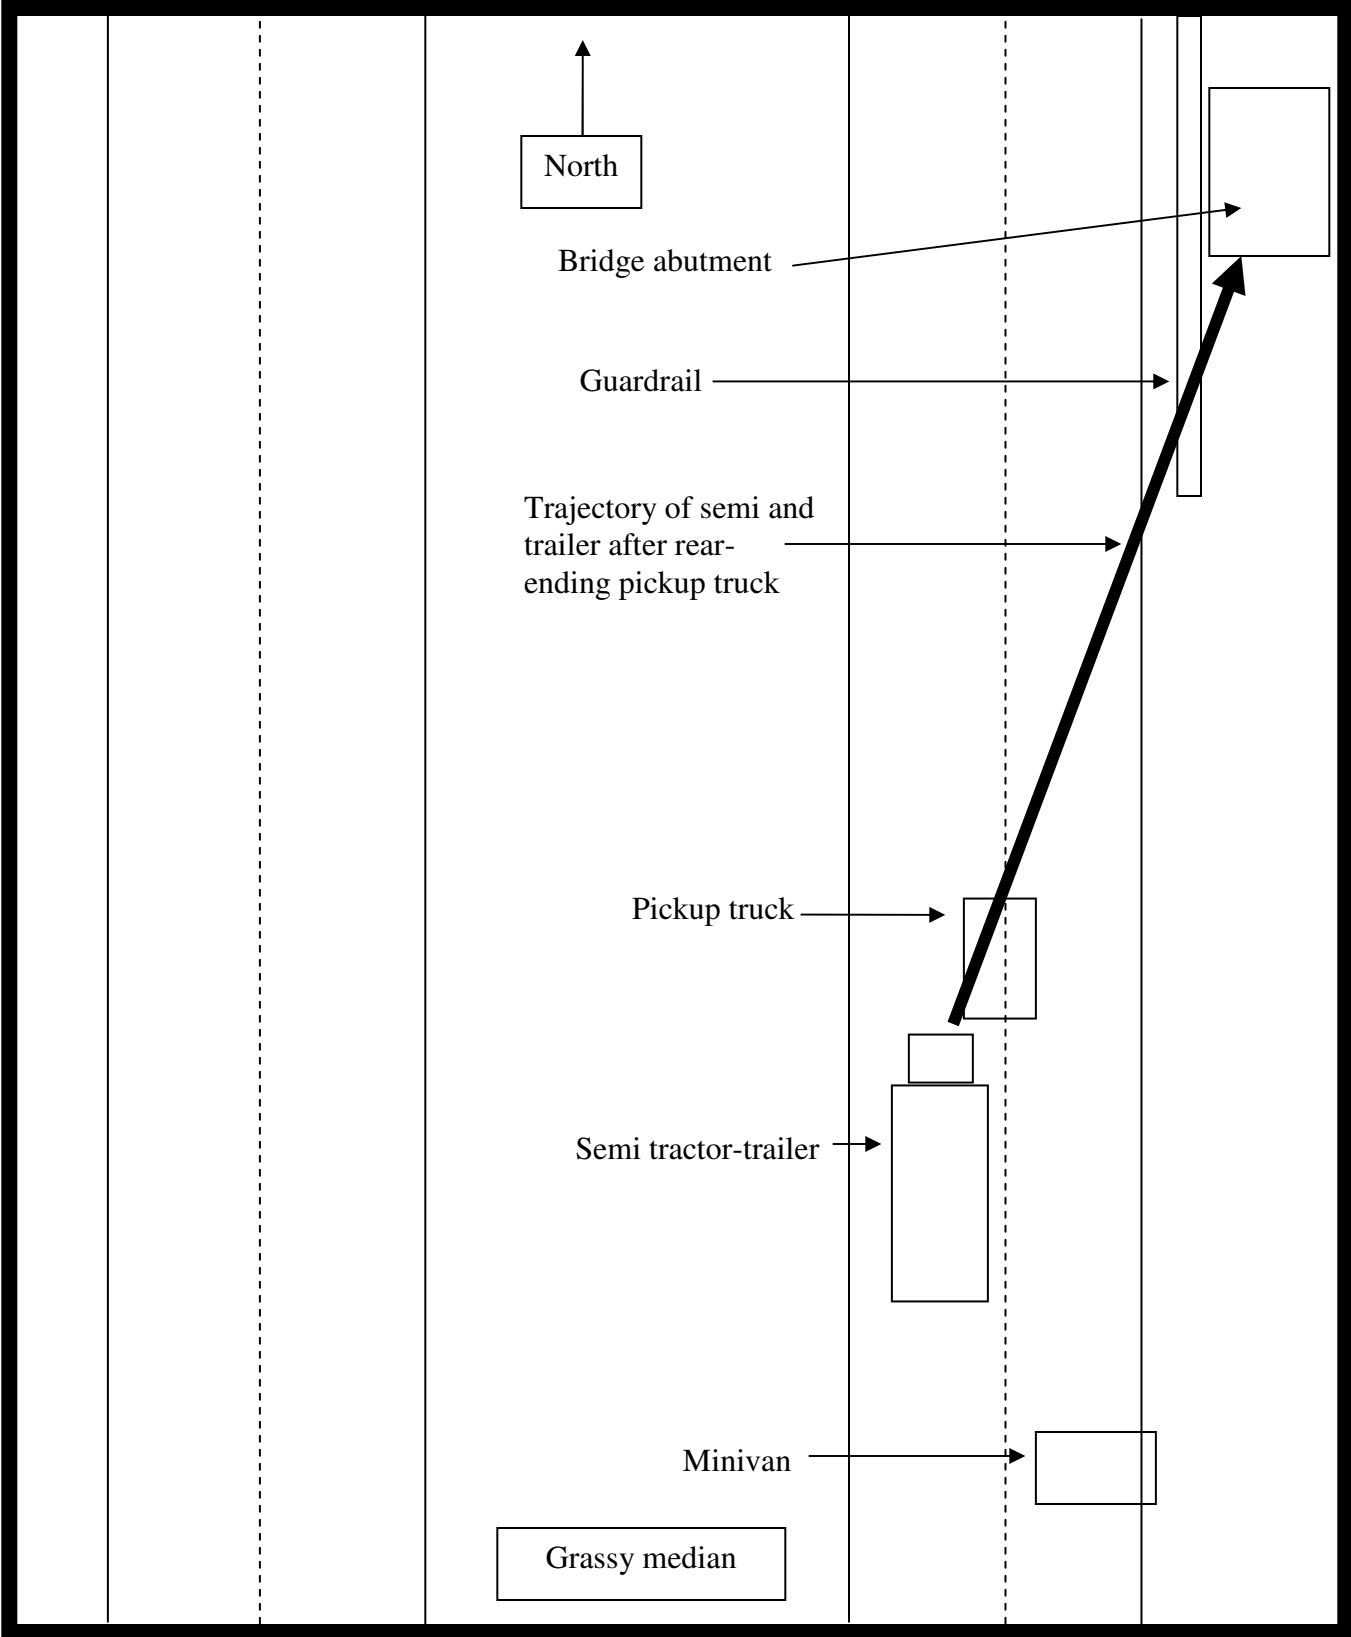
At approximately 12:40 AM, the semi driver was driving behind a pickup truck in the right northbound lane of a four-lane interstate highway. It was divided by a soft grassy median and the posted speed limit was 70 miles per hour. The concrete roadway surface was dry, unlit and the weather conditions were cloudy. As the vehicles traveled northward, they came upon a crash scene that had occurred previously. A southbound mini-van had been struck in the rear by a southbound car. The minivan crossed the grassy median and came to rest across the right northbound lane. A witness to that crash called emergency medical services, parked his truck in the median of the interstate, walked across the northbound lanes, and checked on the occupants of the mini-van. After checking on the occupants of the minivan, the witness returned to his truck and retrieved flares from his vehicle. He lit the flares and was in the median walking toward the mini-van with the lit flares when he heard a semi truck brake and skid.

Schematic of crash scene; not to scale.
