Driver of a Semi-Tractor Pulling Twin Trailers Fatally Injured in Single Vehicle Crash

Incident Number: 08KY029

Kentucky Fatality Assessment and Control Evaluation (FACE) Program

Subject: Driver of a Semi-Tractor Pulling Twin Trailers Fatally Injured in Single Vehicle Crash

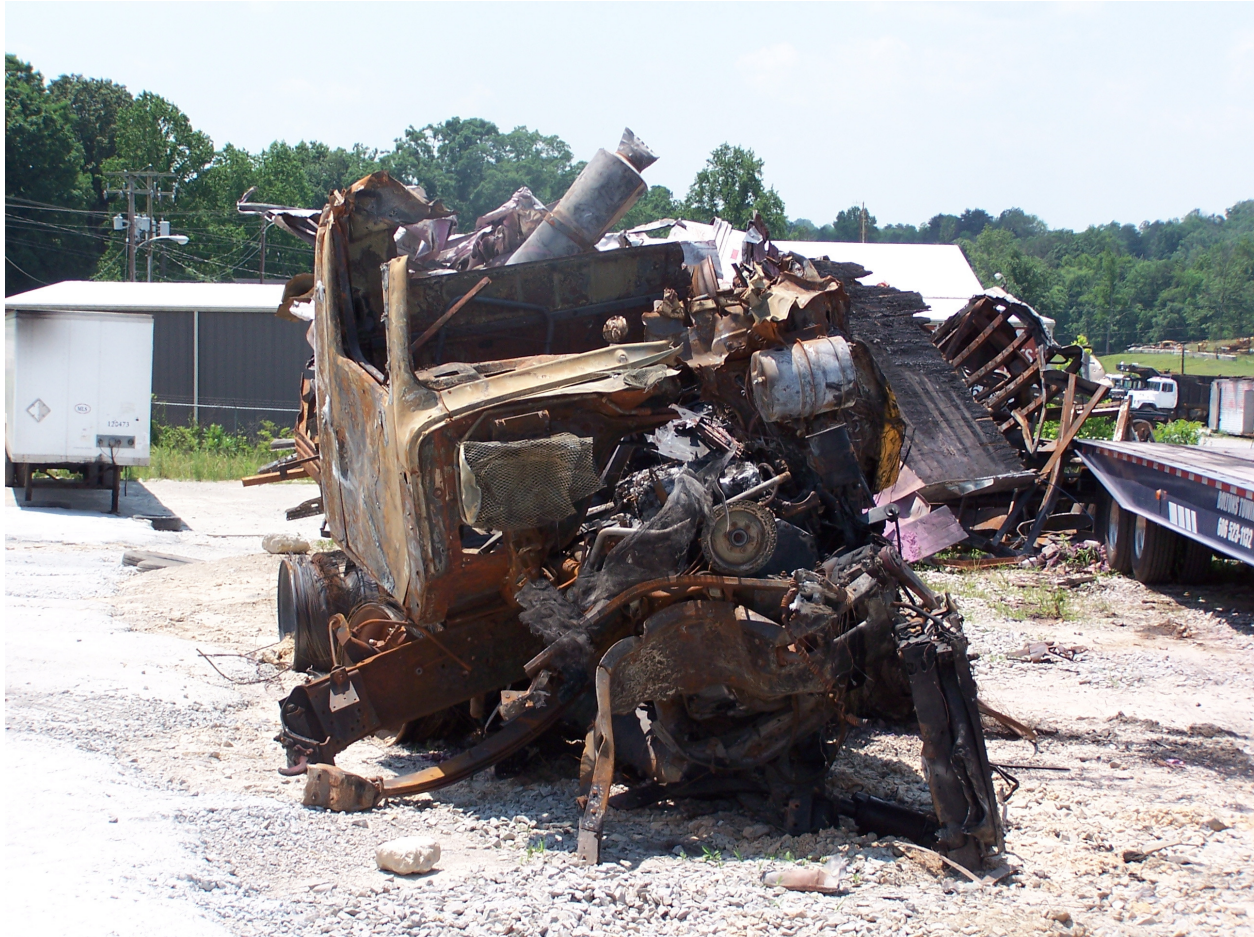
Picture of semi involved in fire from a single motor vehicle crash. One of the trailers pulled by the semi can be seen in the background.

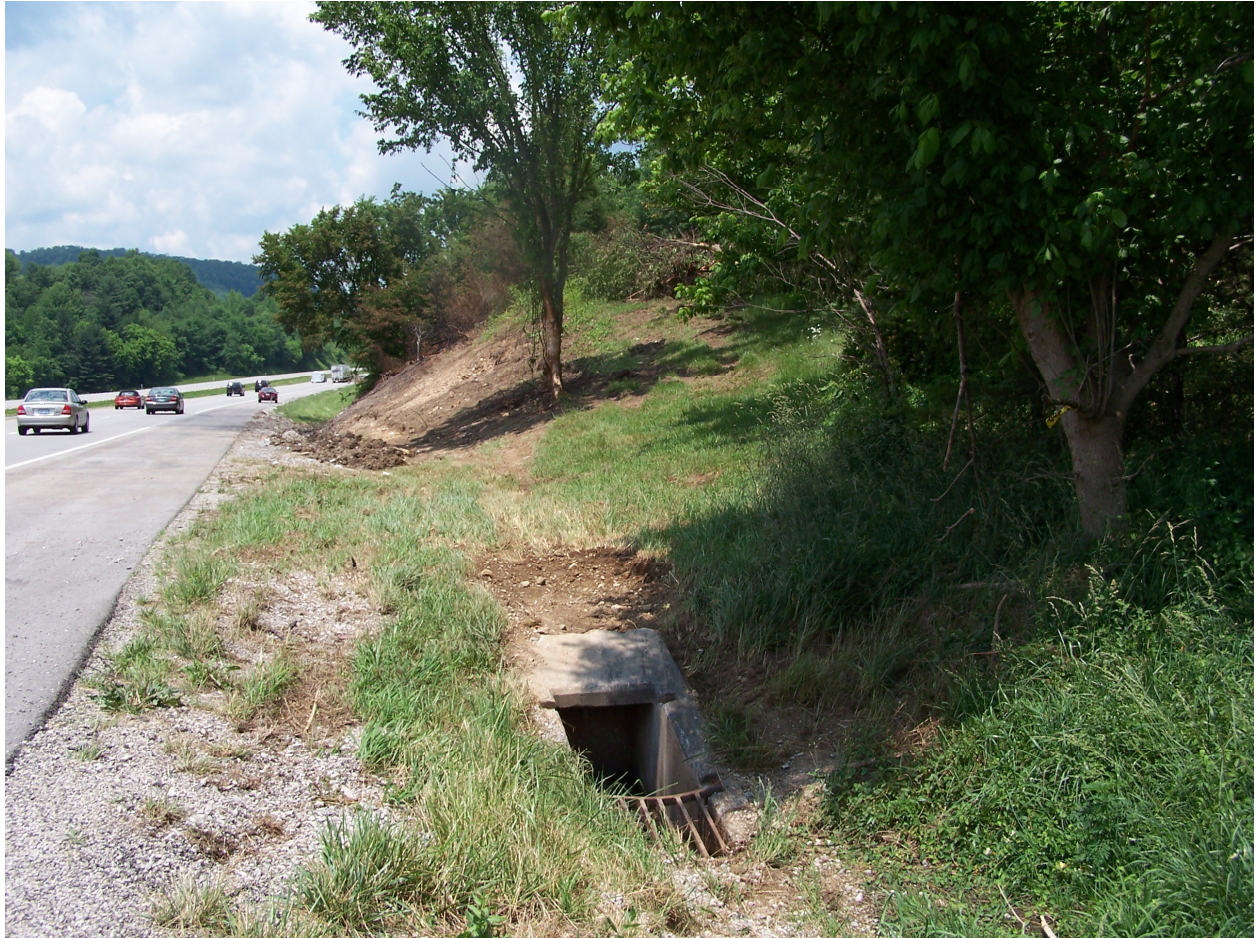
The driver drifted over the fog line, rumble strip, and onto the emergency shoulder. Skid marks indicate that when the tractor hit the rumble strip the driver engaged the brakes, which locked-up. With the brakes locked-up, the tractor and trailers skidded fifty-six feet on the paved shoulder then left the shoulder and continued to slide sixty-four feet in the grass before striking a concrete culvert. After hitting the culvert, the unit continued to travel up a steep earthen embankment for eighty-eight feet and swiped a small tree with the right-side of the tractor. Continuing up the embankment the tractor hit another tree head-on. At this point the truck and trailers skidded down the embankment where they came to rest approximately 130 feet from contact with the first tree. The tractor and lead trailer overturned on the driver's side while the rear trailer uncoupled from the first trailer but remained upright and attached by safety chains. During the crash, both trailers caught fire and were completely engulfed. Some of the trailers'

Photograph of: culvert struck by tractor pulling two trailers, and the two trees struck by the tractor. This photograph taken by KY FACE personnel and is the property of KY FACE.

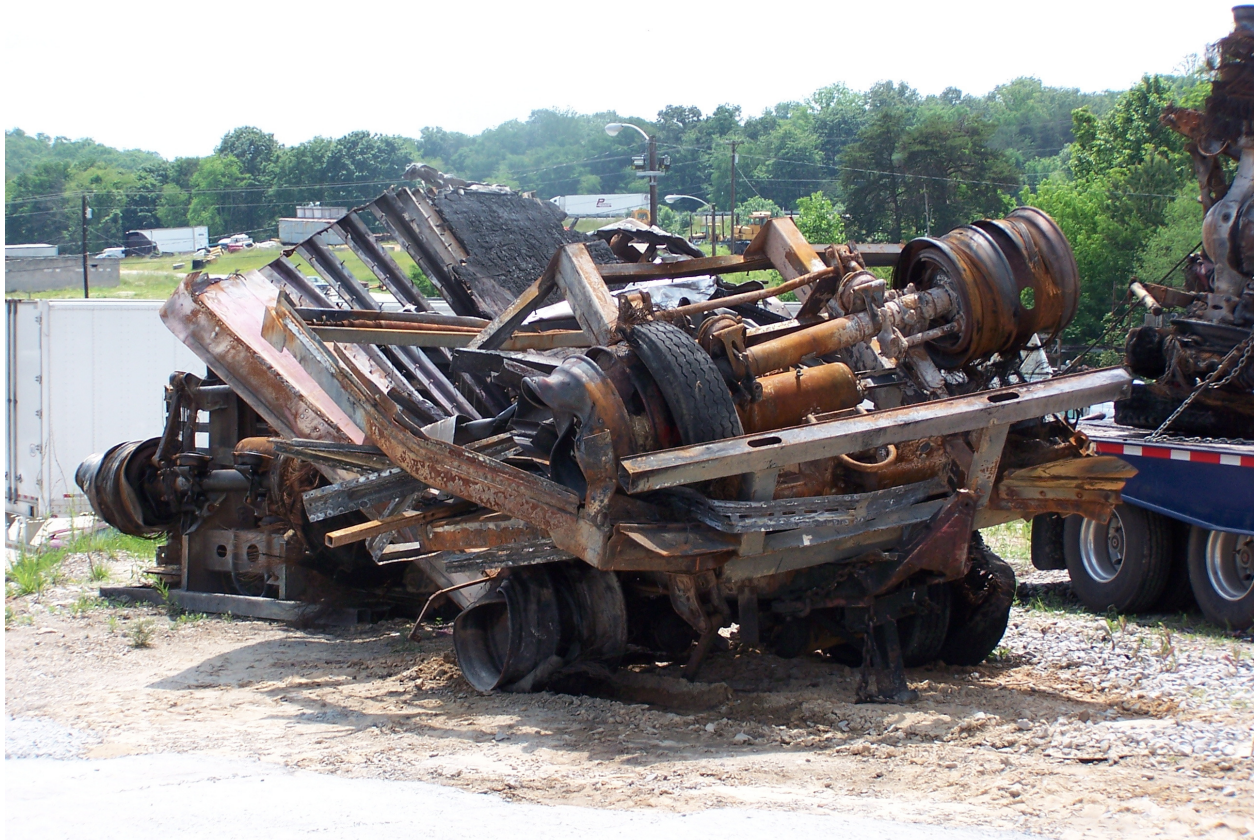
Photograph taken of trailers consumed in fire due to crash. Photograph taken by KY FACE personnel.

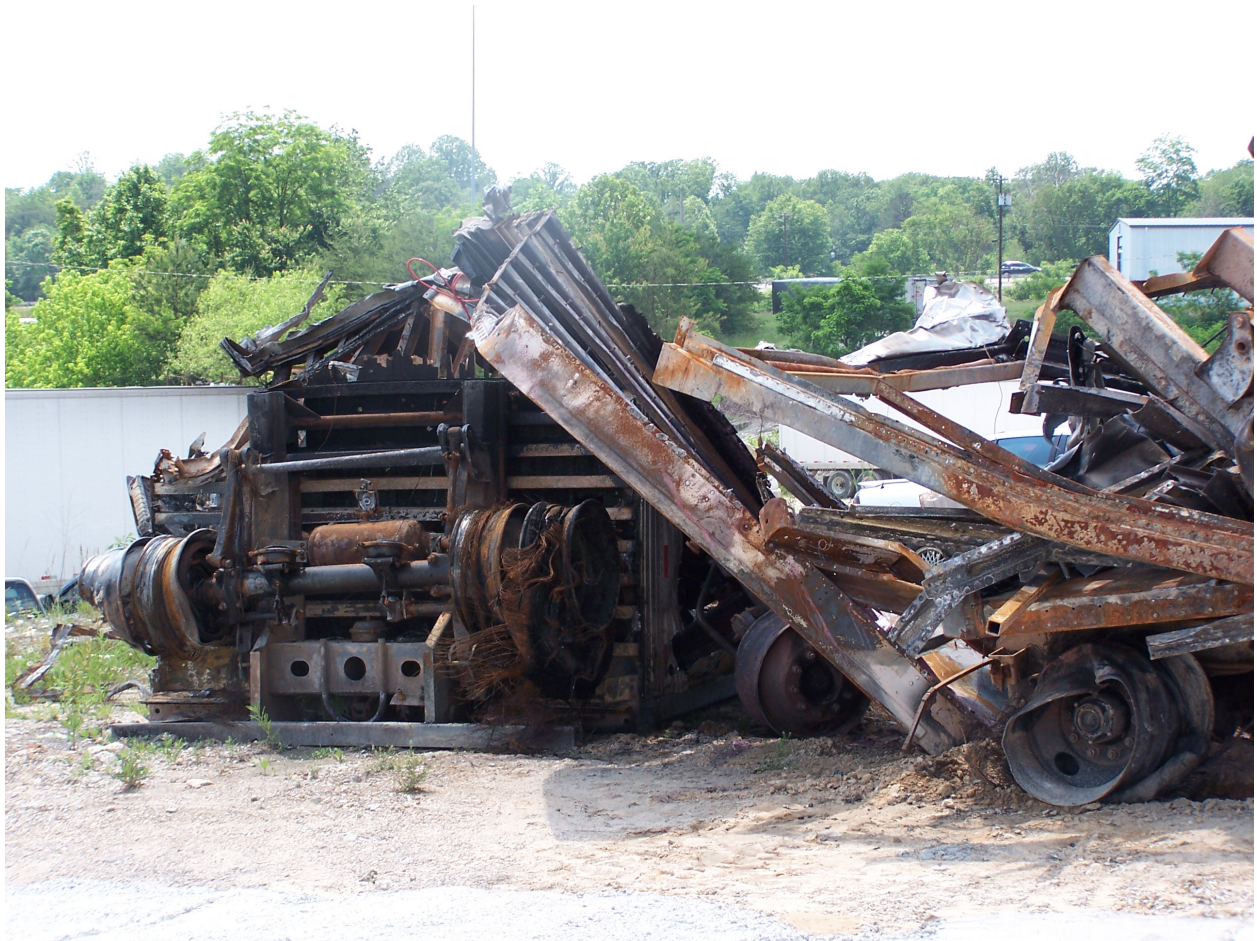
Photograph of trailers consumed in fire and crash. Photograph taken by KY FACE personnel.

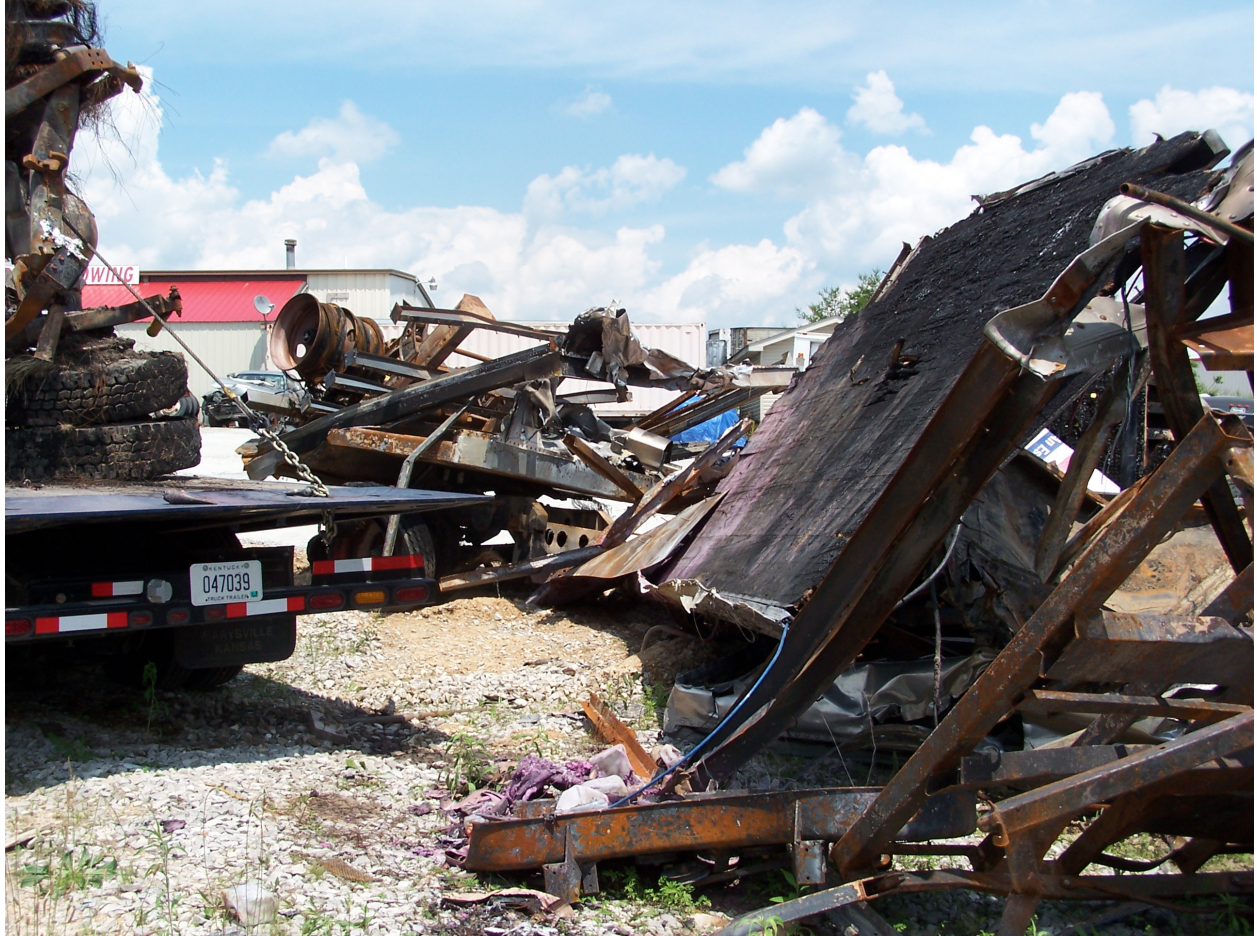
Photograph of the two trailers involved in crash. Semi involved is on the flatbed. This photograph taken by KY FACE personnel and is the property of KY FACE.
