**Service Technician Working Alone  
Dies after being Assaulted  
Incident Number: 09KY078**

**Kentucky Fatality Assessment and Control Evaluation (FACE) Program**  
**Incident Number: 09KY078**  
**Release Date: September 30, 2010**  
**Subject: Service Technician Working Alone Dies after being Assaulted**

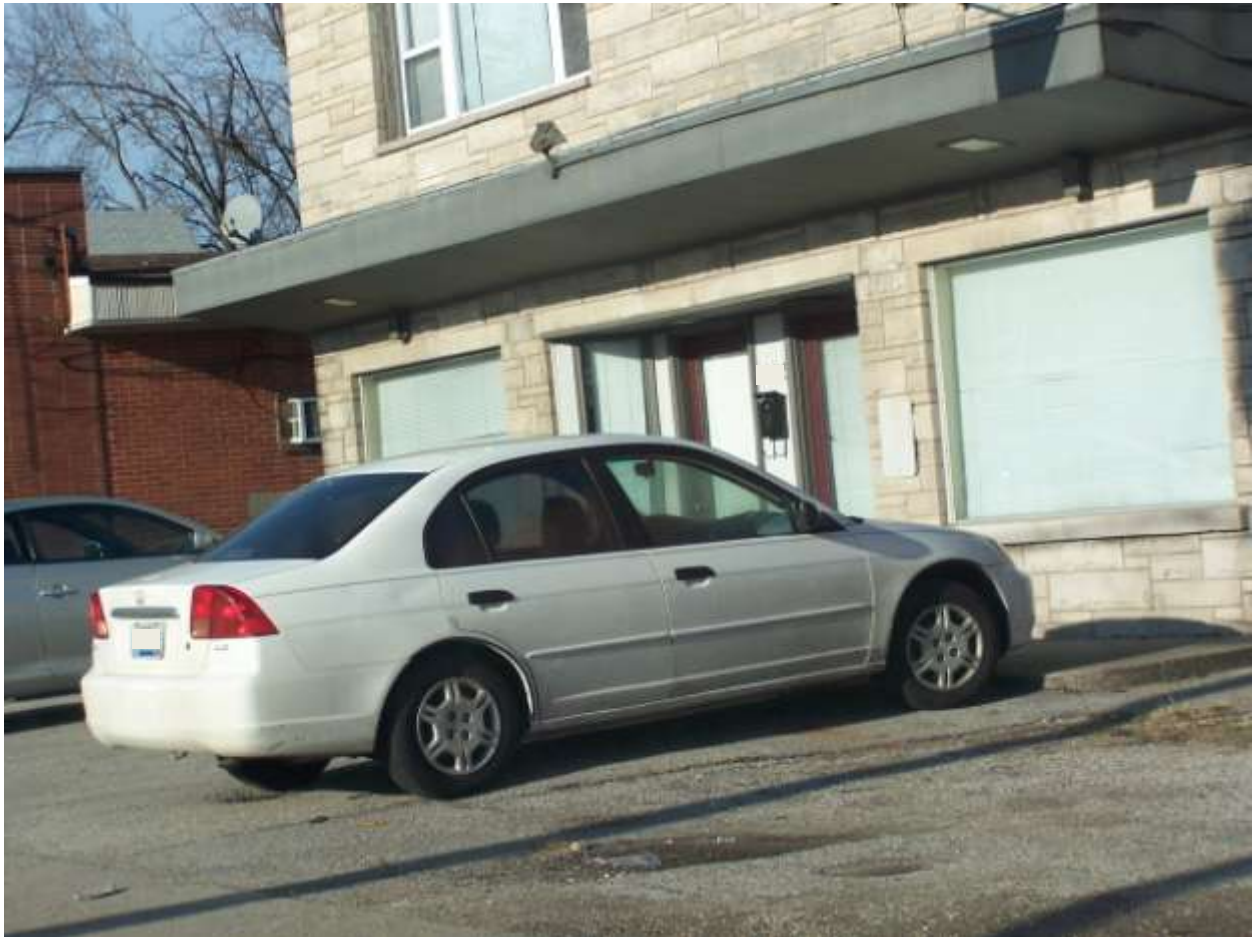
Photograph of shop. Photograph courtesy of KY FACE.

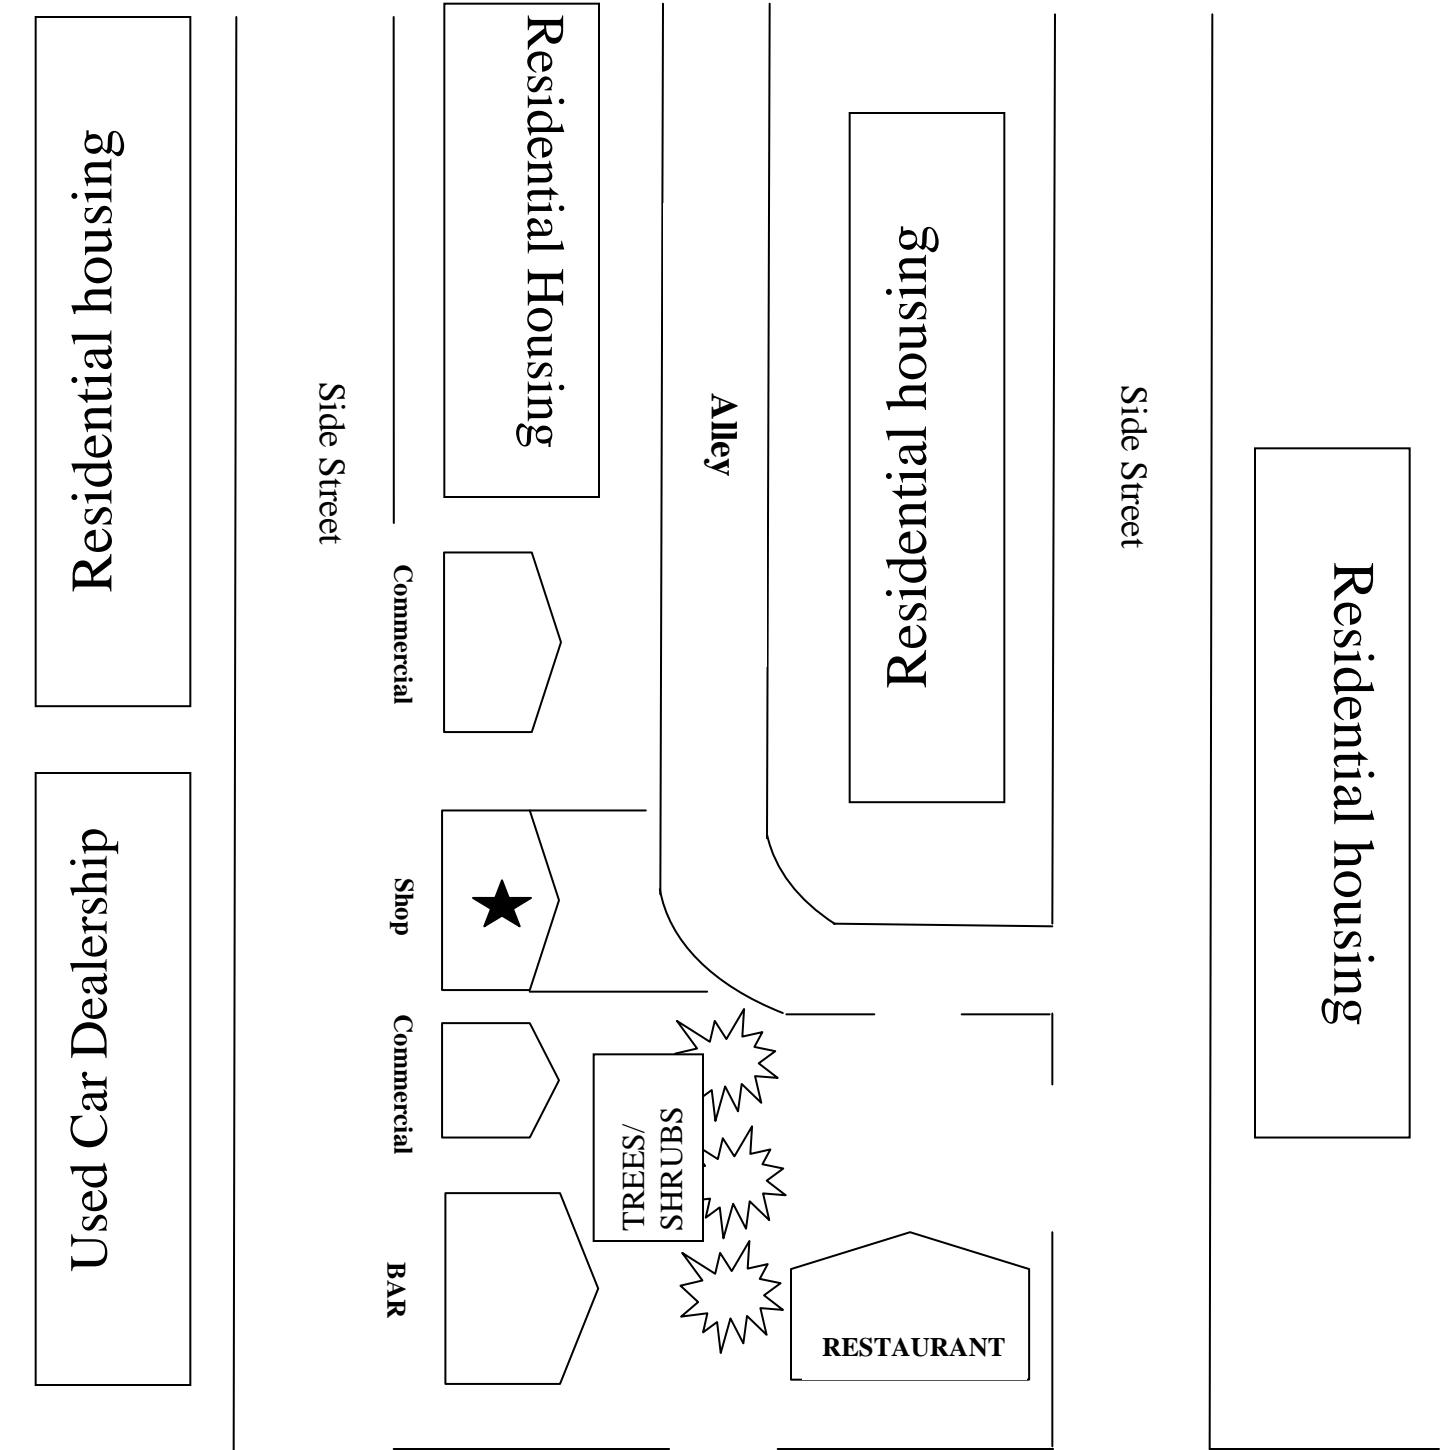
Diagram 1

The shop was the only occupant of a two story building located on a side street next to a major four lane highway in a neighborhood that was zoned residential and commercial. It was the third building north of the corner and on the east side of the street. On the southeast corner was a neighborhood bar and liquor store. Behind the business was a paved parking lot with company-restricted access where company-owned trucks were parked. The lot was enclosed, and secured by chain-link fence with privacy webbing. A gate surrounded the back lot of the shop, faced east, was secured with a chain and padlock, and opened into a curve in an alley that ran behind the shop. The alley behind the shop ran from a cross street to the north (left) of the lot, made a curve to the east, and ended at the next street (Diagram 1). To the north of the gate, another commercial building and private residences backed up to both sides of the alley; east of the gate, a fast-food establishment's parking lot had ingress/ egress to the alley. The corner bar did not have ingress/ egress to the alley.
