**Land Surveyor Struck and Killed
By Passenger Vehicle
Incident Number: 09KY079**

Kentucky Fatality Assessment and Control Evaluation (FACE) Program
Incident Number: 09KY079
Release Date: January 11, 2011
Subject: Land Surveyor Struck and Killed By Passenger Vehicle

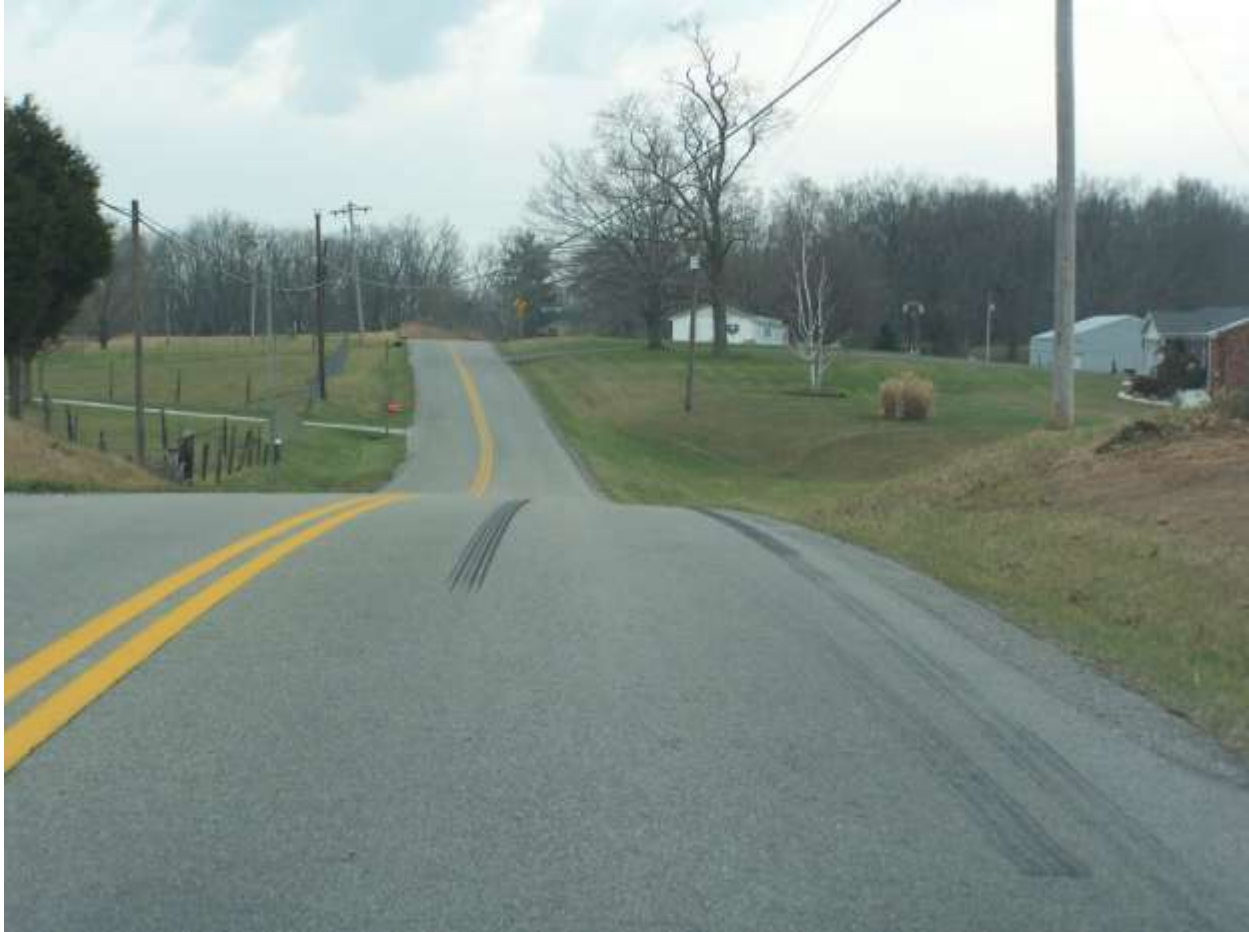
Photograph of location where car topped hill and lost control. Picture property of KY FACE.

The police report stated the pavement was asphalt, roadway conditions were straight and hillcrest, rural, dry, and the weather was clear. Human factors contributing to the incident were "speeding, inattention, and overcorrecting/ oversteering". Environmental factors were "view obstructed/ limited". No vehicle factors contributed to the incident. There were no obstacles in the roadway. The survey vehicle was parked in a field west of the highway.

Recommendation No. 1: When surveying on land near roadways, safety cones and warning signage should be erected to slow down motorists.

The Manual of Uniform Traffic Control Devices provides guidance on where to place warning signage when working on roadways. Since the land surveyors were not surveying along the roadway, signage and/ or orange cones warning motorists of workers on the roadway was not required. However, to be prudent, signage and/ or orange cones warning motorists of workers working near roadways should be placed prior to and at the work site. Position additional signage before hills, curves, or other obstacles to warn drivers of the work site located on the blind side of the hill, curve, etc.
