Semi Team Driver Dies After Being Ejected from Sleeper Berth

Incident Number: 09KY081

Kentucky Fatality Assessment and Control Evaluation (FACE) Program
Incident Number: 09KY081
Release Date: May 27, 2010
Subject: Semi Team Driver Dies After Being Ejected from Sleeper Berth

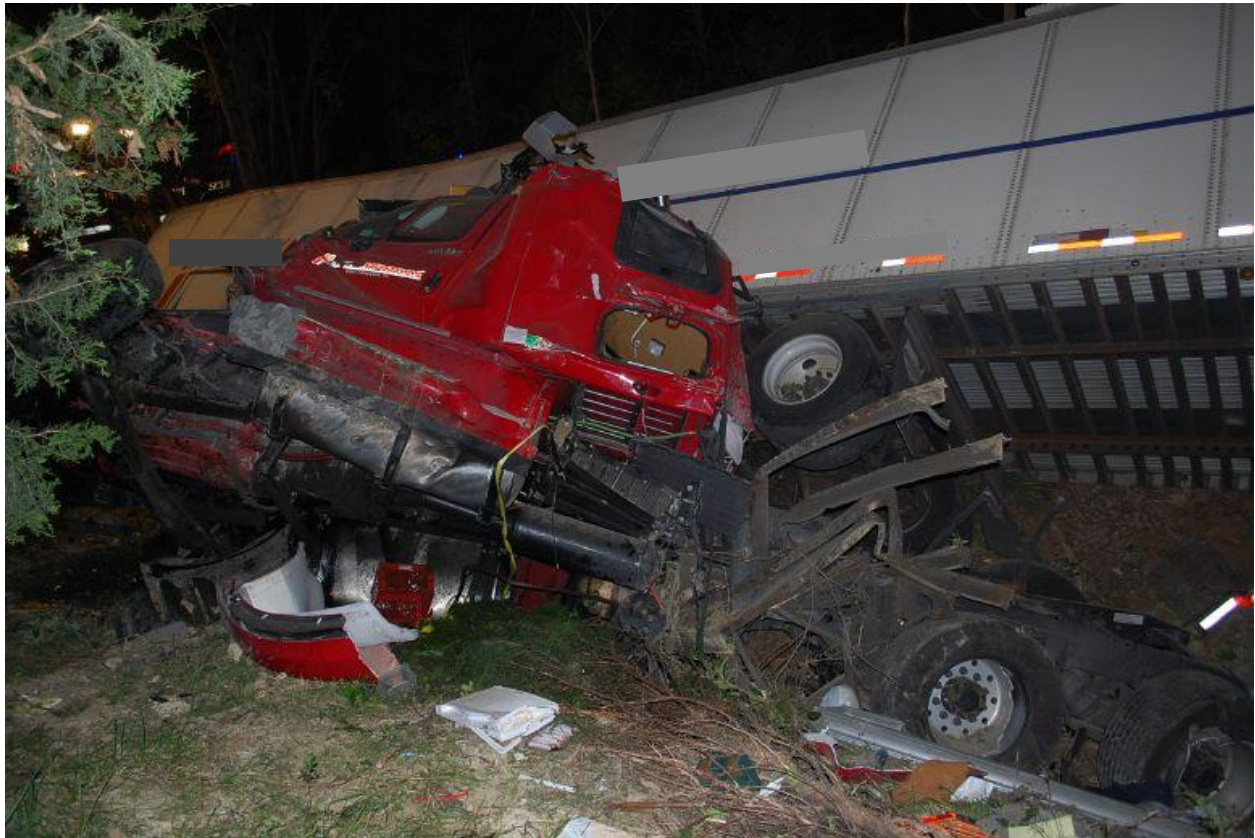
Photograph of semi trailer involved in crash. Courtesy of local coroner.

For an unknown reason, the driver crossed the fog line on the right, and with the right front of the semi, sideswiped an unoccupied car parked on the right shoulder (three feet, eight inches to the right of the fog line), pushing the car approximately 19 feet along the shoulder. The semi-tractor trailer traveled approximately 217 feet, struck a guard rail on the right shoulder, then continued approximately 215 feet down an earthen embankment toward a county road below the interstate. During the trajectory of the semi-tractor trailer down the embankment, the unit jackknifed, causing the trailer to detach from the fifth-wheel and strike the tractor. The top of the cab was ripped open, and both the husband and wife were ejected. At 2:23 AM, a witness to the crash called emergency services. Emergency responders arrived at 2:31 AM and found the husband alive on the embankment approximately 12 feet behind the rear of the trailer, and the wife without vital signs, on the embankment under debris from the crash, approximately 20 feet behind the rear of the trailer. As the husband was transported via helicopter to the nearest trauma hospital, the coroner was contacted, and upon his arrival, declared the wife dead at the scene.

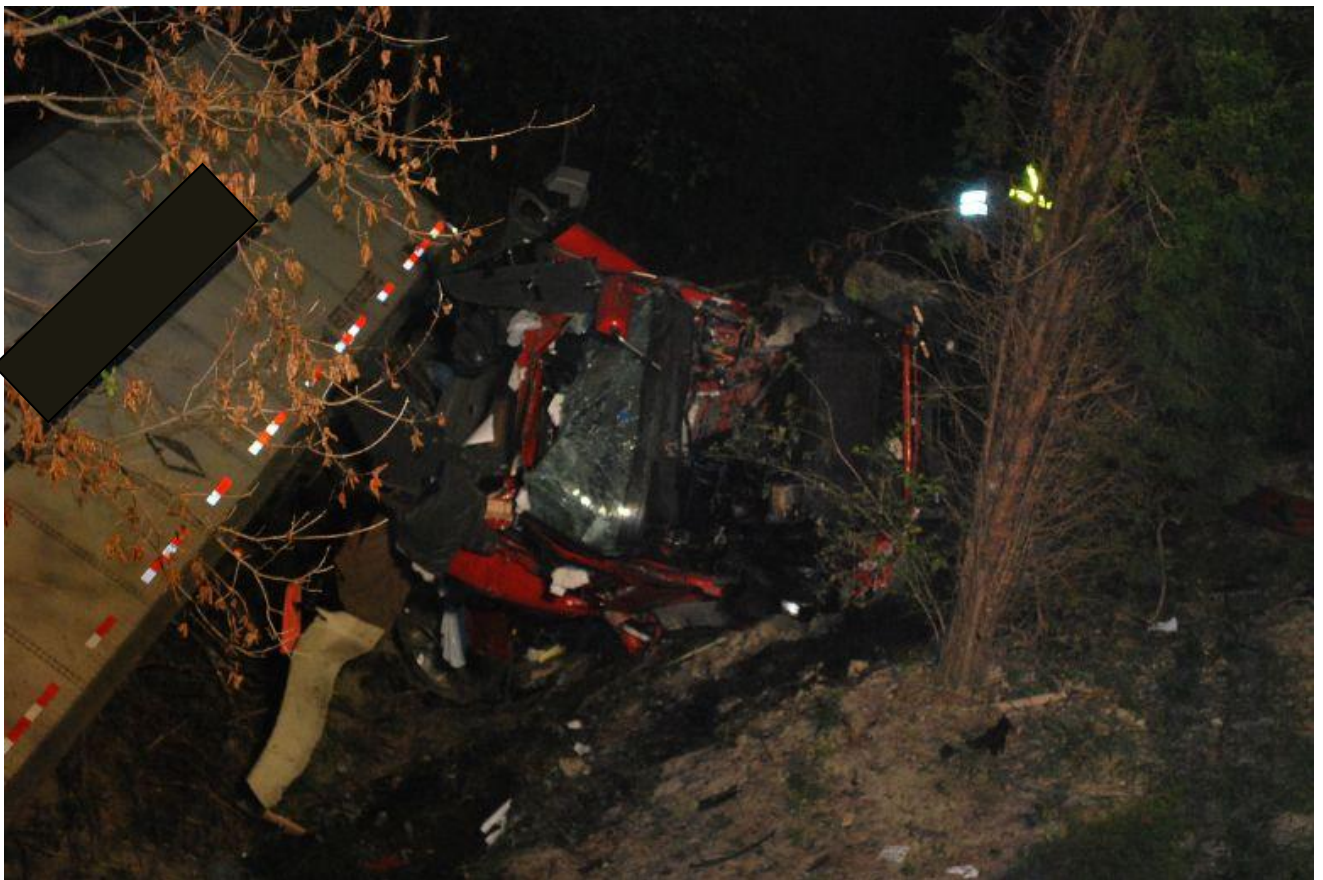
Photo of wreckage on embankment. Courtesy of coroner.
