Steel Worker Falls from Highway Bridge and Dies

Incident Number: 10KY043 Revised

Kentucky Fatality Assessment and Control Evaluation (FACE) Program
Incident Number: 10KY043 Revised
Release Date: November 29, 2011/ March 30, 2012
Subject: Steel Worker Falls from Highway Bridge and Dies

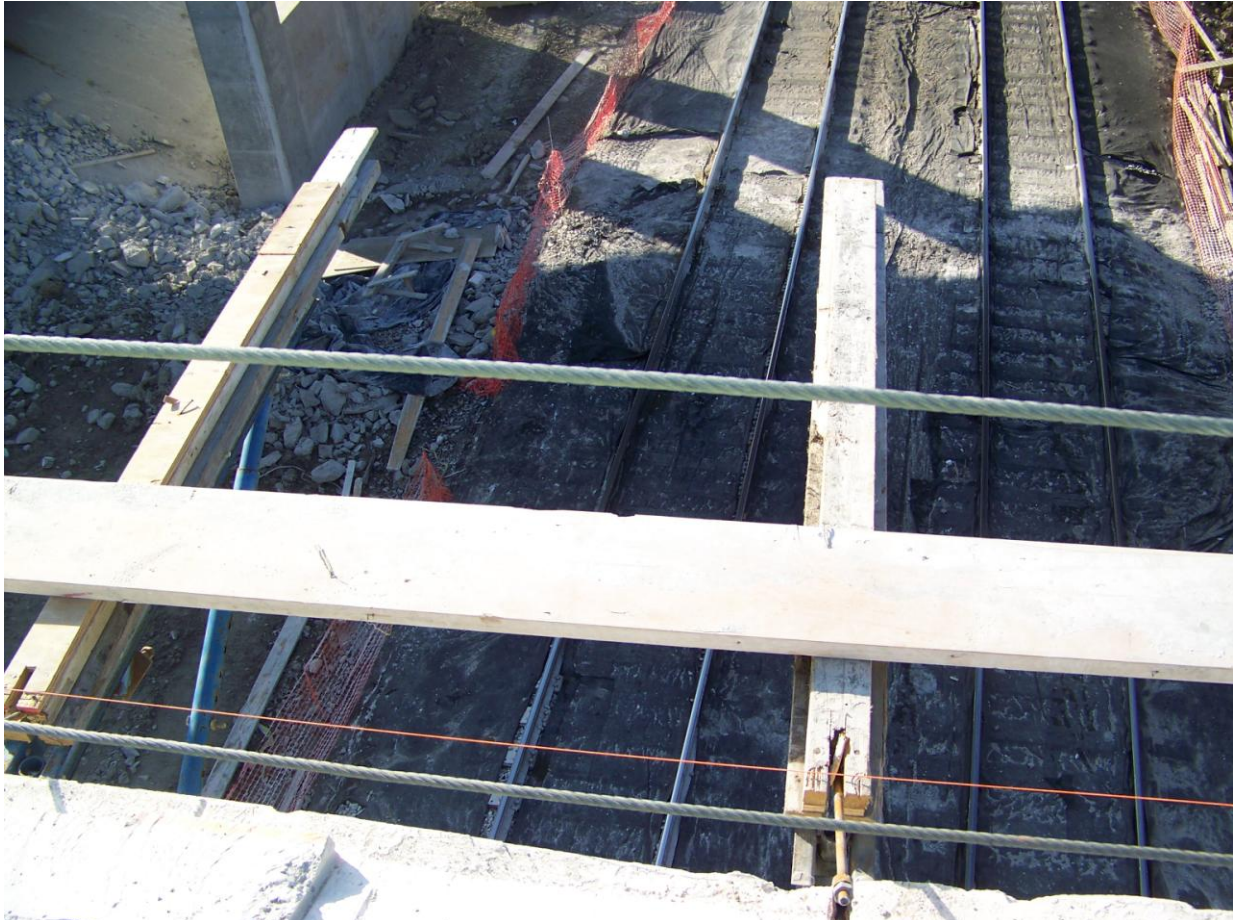
Bridge where worker fell from. Photograph donated by, and property of, Kentucky State Government.

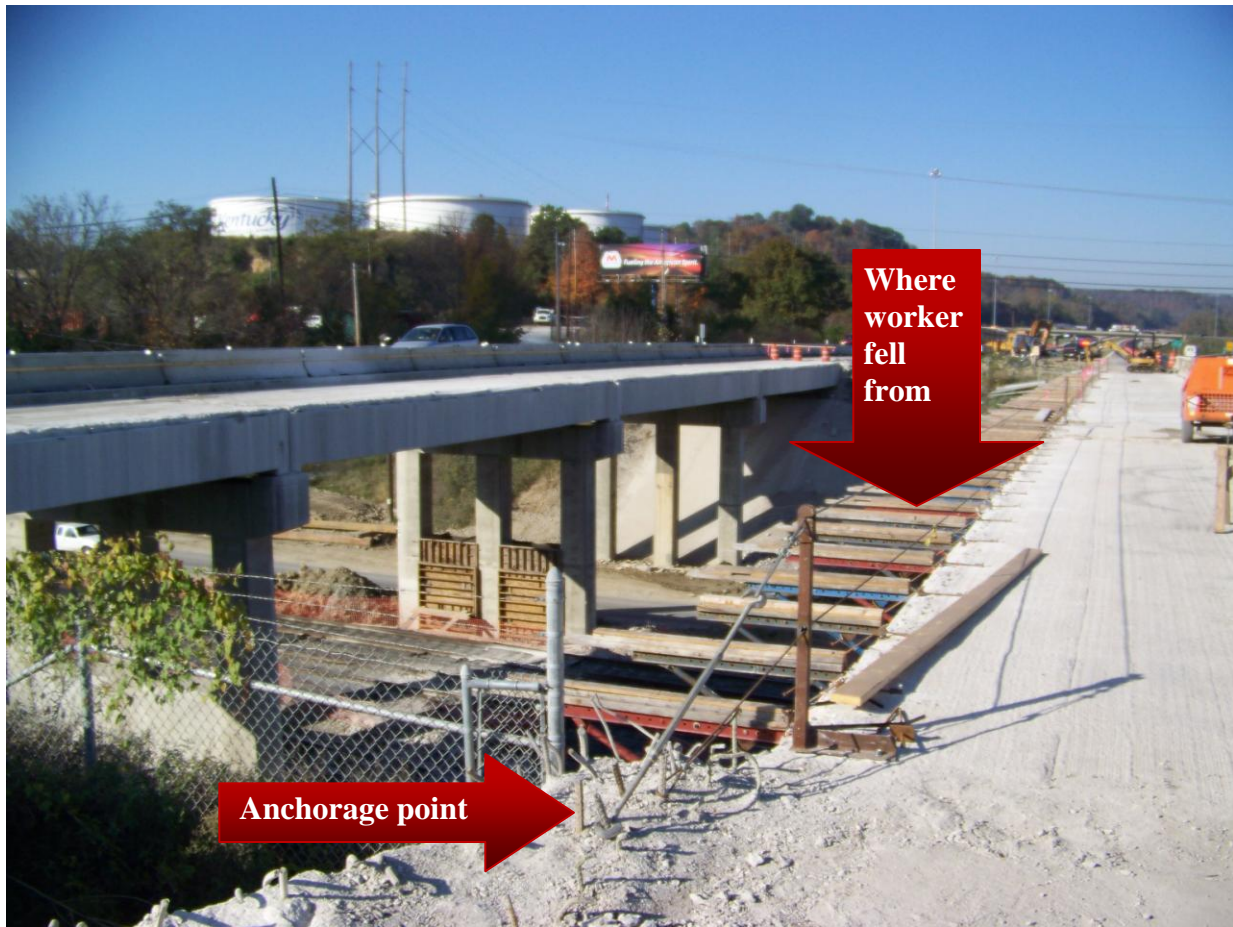
The process for leveling the jacks involved the worker stepping over a 42" high cable lifeline located at the edge of the bridge deck and onto a 2"x10" wooden board that sat across thinner wooden boards which rested on the jacks. None of the boards were secured to the jacks or the bridge; nor was the wider board secured. This situation created a potential situation for a worker to slip while stepping from a firm surface onto an unstable surface.

Lifelines should be anchored in such a way as to prevent the lifeline from coming unanchored if a fall should occur and be able to withstand at least 5,400 pound dead weight. Non-continuous strands of lifeline should be properly attached to each other. The lifeline used in this instance was non-continuous and improperly anchored.

Photograph of anchorage point at east end of bridge and location where worker fell from. A 2"x10" board was across the jacks. Photograph donated by, and property of, Kentucky State Government.

According to the Code of Federal Regulation 1926.20(b)(2), employers are to designate a competent person to frequently conduct inspections of the job site. The Competent Person has the authority to cease work in hazardous situations. To abate this situation, a manlift should be used by the worker to level the jacks. A manlift would eliminate the need for the worker to step onto or walk on an unsecured board 37' in the air.

Another safety procedure would be to locate the cable away from the edge so the worker can safely step over the cable onto a secure surface, then onto the 2"x10" board.

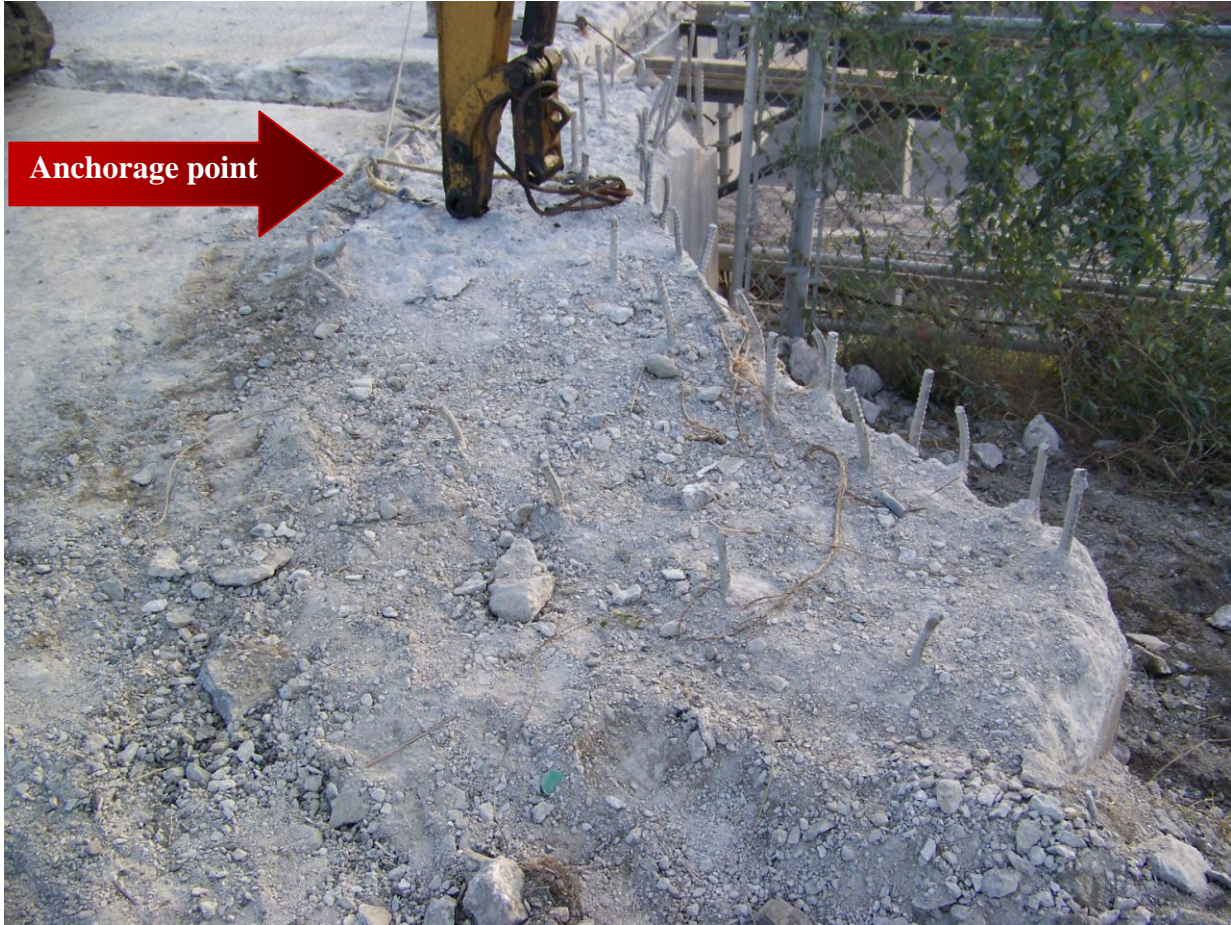
Anchorage point at west end of bridge. Photograph donated by, and property of, Kentucky State Government.

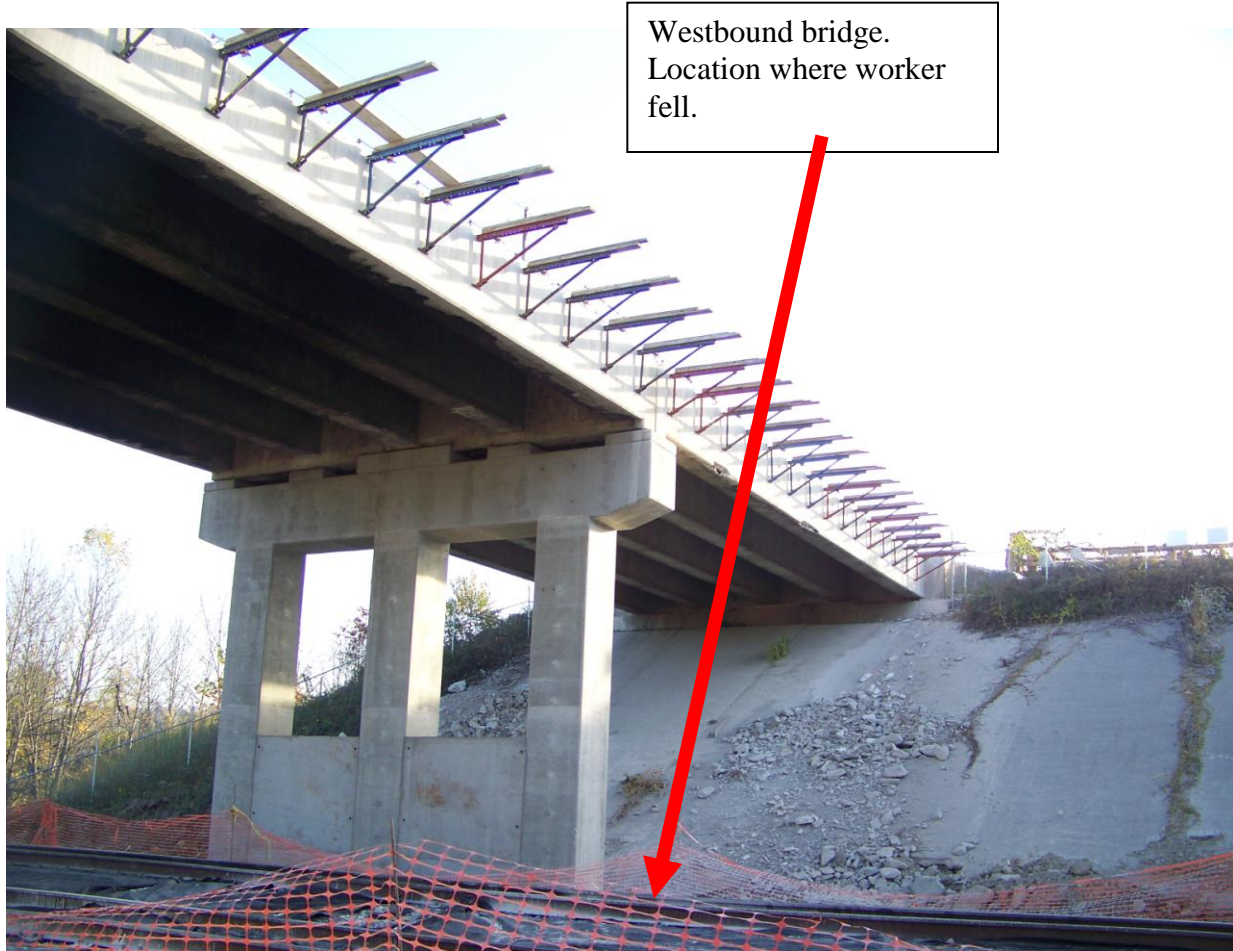
Westbound bridge.
Location where worker
fell.

Bridge that worker fell from. Photograph donated by, and property of, Kentucky State Government.
