Semi-Truck Driver Dies After Being Struck by Flatbed Driver in Crossover Collision

Incident Number: 11KY001

Kentucky Fatality Assessment and Control Evaluation (FACE) Program
Incident Number: 11KY001
Release Date: January 16, 2013
Subject: Semi-Truck Driver Dies After Being Struck by Flatbed Driver in Crossover Collision

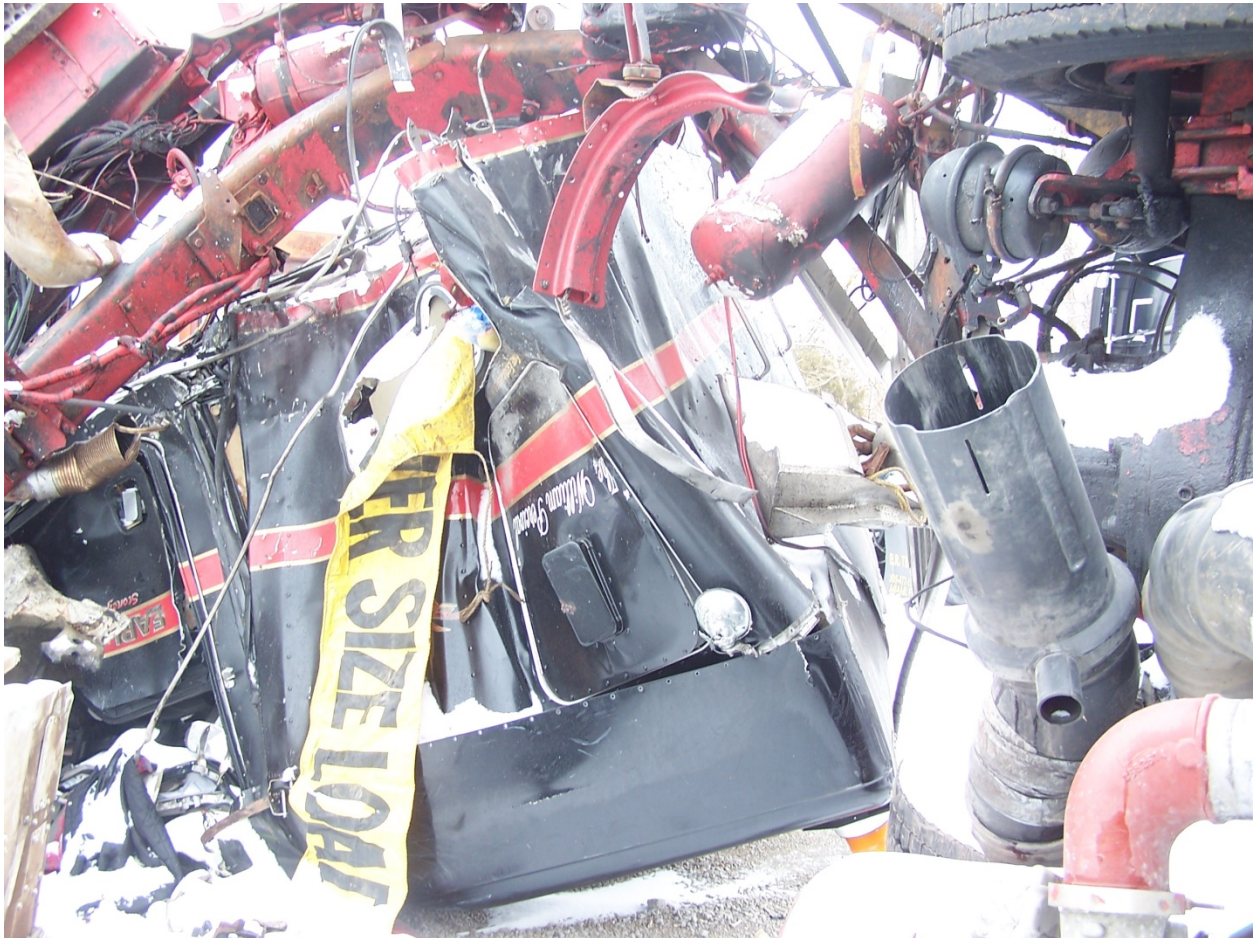
Semi that crossed median then struck by another semi of which the driver died. Photograph property of KY FACE

According to the police report, D1 did not apply the brakes after leaving the northbound travel lanes. A forensic mechanic inspected D1's semi and found the right brake defective. That defect caused the semi to veer to the left when the driver initially applied the brakes. Speeding was not a factor in this incident. D2 was the only fatality in this incident. Driver 2 had utilized the passenger restraint system.

Recommendation No. 5: Brakes on commercial vehicles should be maintained in proper working order.

According to the police report, the right brake on D1's semi was defective and when applied hard, this defect caused the semi to veer left. Guidance for proper brake alignment and inspections can be found on the Federal Motor Carrier's website, <http://www.fmcsa.dot.gov/rules-regulations/administration/rulemakings/Proposed/Brake-Readjustment-Limits%20-NPRM.aspx>.
