Roadside Responder is Struck by a Box Truck and Dies

Incident Number: 11KY006

Kentucky Fatality Assessment and Control Evaluation (FACE) Program
Incident Number: 11KY006
Release Date: June 27, 2012
Subject: Roadside Responder is Struck by a Box Truck and Dies

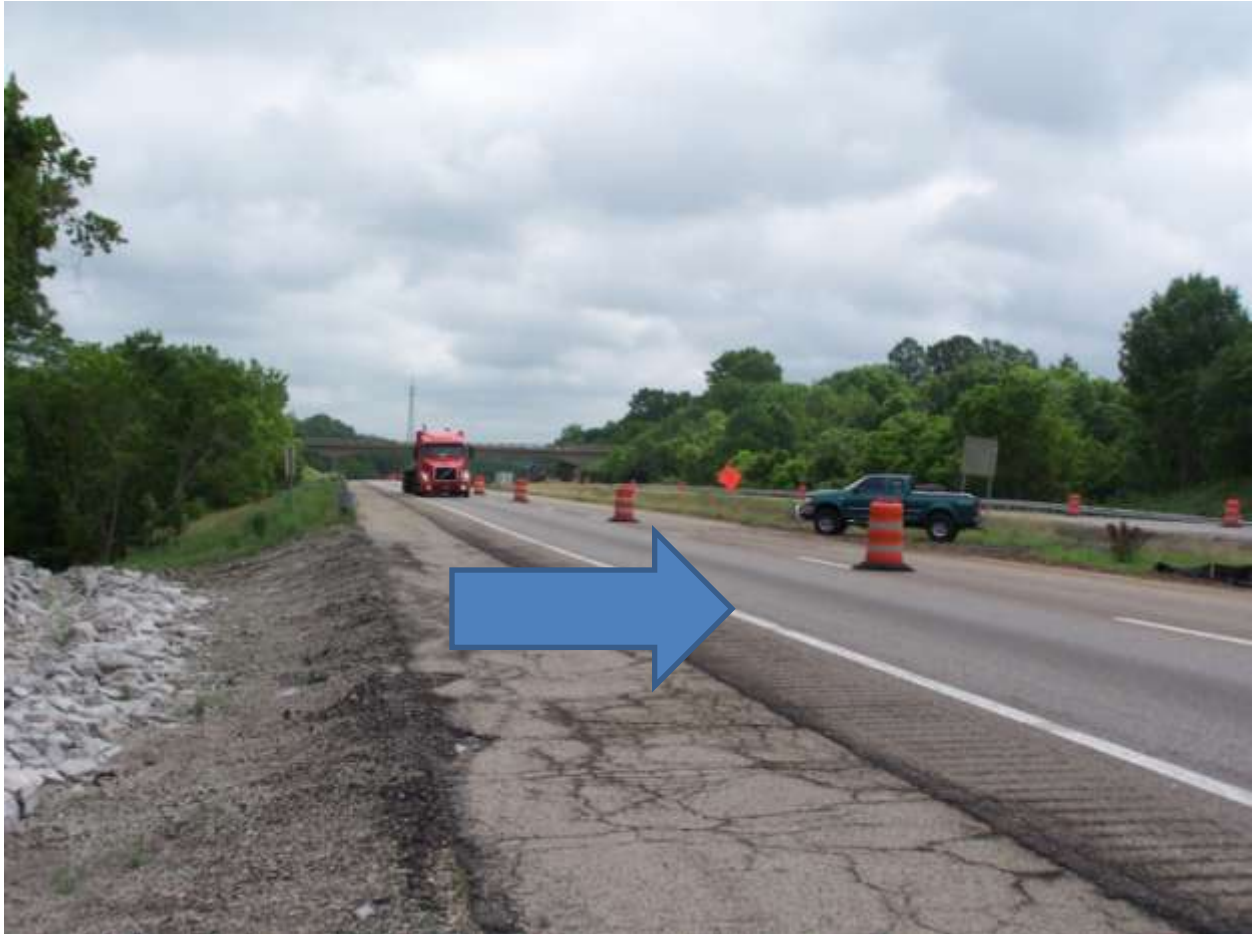
Photograph of location where roadside responder was struck by box truck.

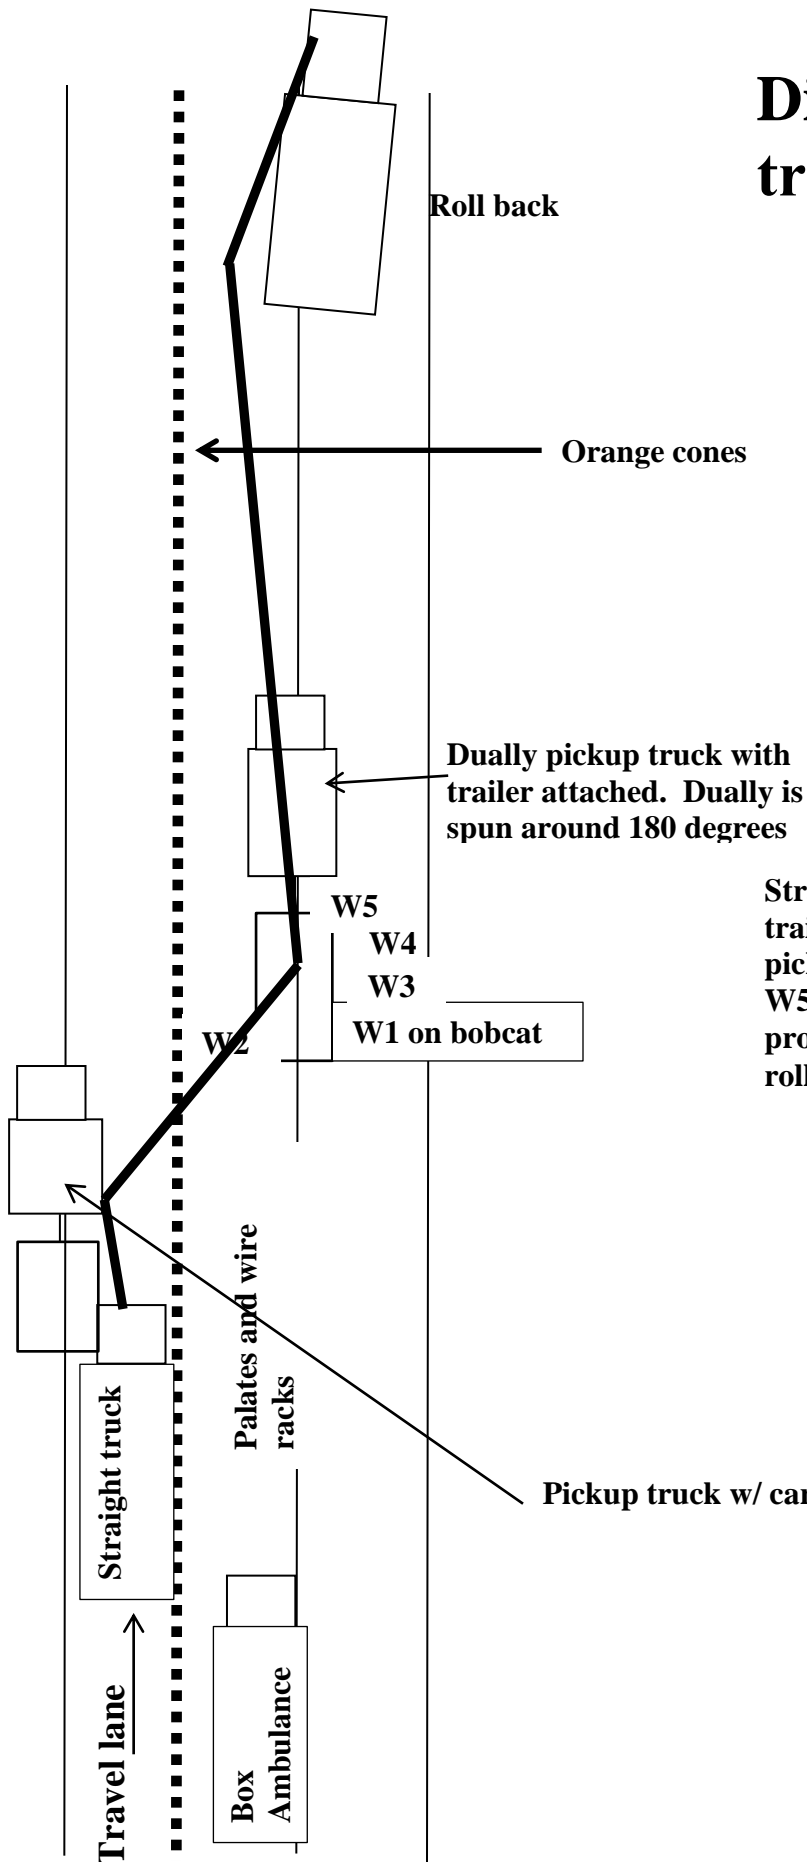
Diagram of straight truck's trajectory

W5 yelled for workers to get out of the way and jumps onto front of trailer. W1 backs bobcat away from trailer, W2 jumps away, W3 pushes W4 away, W3 is struck, falls and hits his head on the pavement

Straight truck rides up onto trailer, disengages it from the pickup truck; then trailer, W5, and straight truck proceed southward, strike rollback and comes to rest.
