Owner/ Operator Hauling Asphalt Flux Dies After Driving into a Ravine and Striking Trees

Incident Number: 11KY072

Kentucky Fatality Assessment and Control Evaluation (FACE) Program

Release Date: August 13, 2012

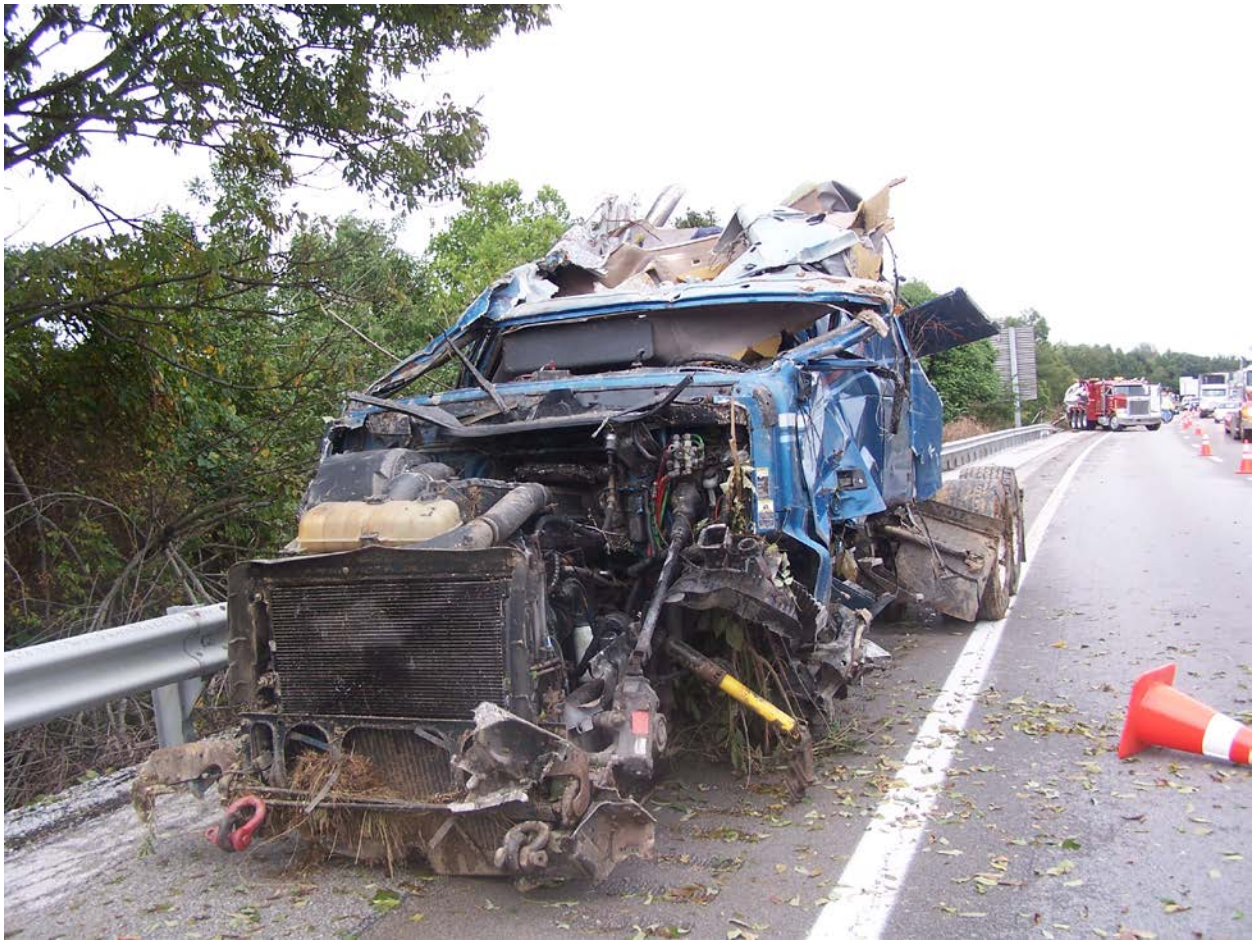
Photograph of semi involved in this incident. Property of KY FACE.

As the driver approached the exit, he crossed the fog line and sideswiped the driver's side of an SUV parked in the emergency lane with the semi's right steer tire. After striking the SUV with the steer tire, the semi became uncontrollable and went through the guardrail on the north side of the west bound lane emergency lane. Upon going through the guardrail, the unit proceeded downward into a ravine where tanker dislocated from the semi. Both the semi and tanker struck numerous trees and received considerable damage. According to the police report, the driver had utilized the restraint system, but was still ejected from the semi.

Recommendation No. 2: Vehicle stabilizer and sensory systems should be mandatory equipment on all commercial vehicles.

To reduce roll-overs, jackknives, fishtails, and other dangerous vehicle maneuvers, fleet owners and owner-operators should consider equipping all semi tractor-trailers with vehicle stabilizer and sensory systems. The Federal Motor Carrier Safety Administration's Code of Federal Regulations, 393.55 requires commercial vehicles manufactured after 1999 to be equipped with automatic braking systems (ABS). The semi-tractor trailer involved in this incident had been manufactured in 2003 and was equipped with an ABS, but not a stabilizer system. When ABS is applied by the driver prior to striking or making an avoidance maneuver, the electronic stability program when coupled with ABS helps prevent the semi-tractor trailer from jackknifing. If the ABS is not activated quickly enough, the electronic stability program can sense incorrect vehicle movement. Independent of driver input or action, the electronic stability program will override the driver, engage, and prevent the semi-tractor trailer from jackknifing or rolling-over. Another system available for trucks is a sensory system which uses forward and side-sensing radar to inform the driver that he/she is too close to the vehicle in front of them or to their immediate side. Two indicators, a light on the dash board and an audio signal, will alert the driver of close proximity to the vehicle in front or side and will automatically slow the truck down thus expanding the driver's reaction time.

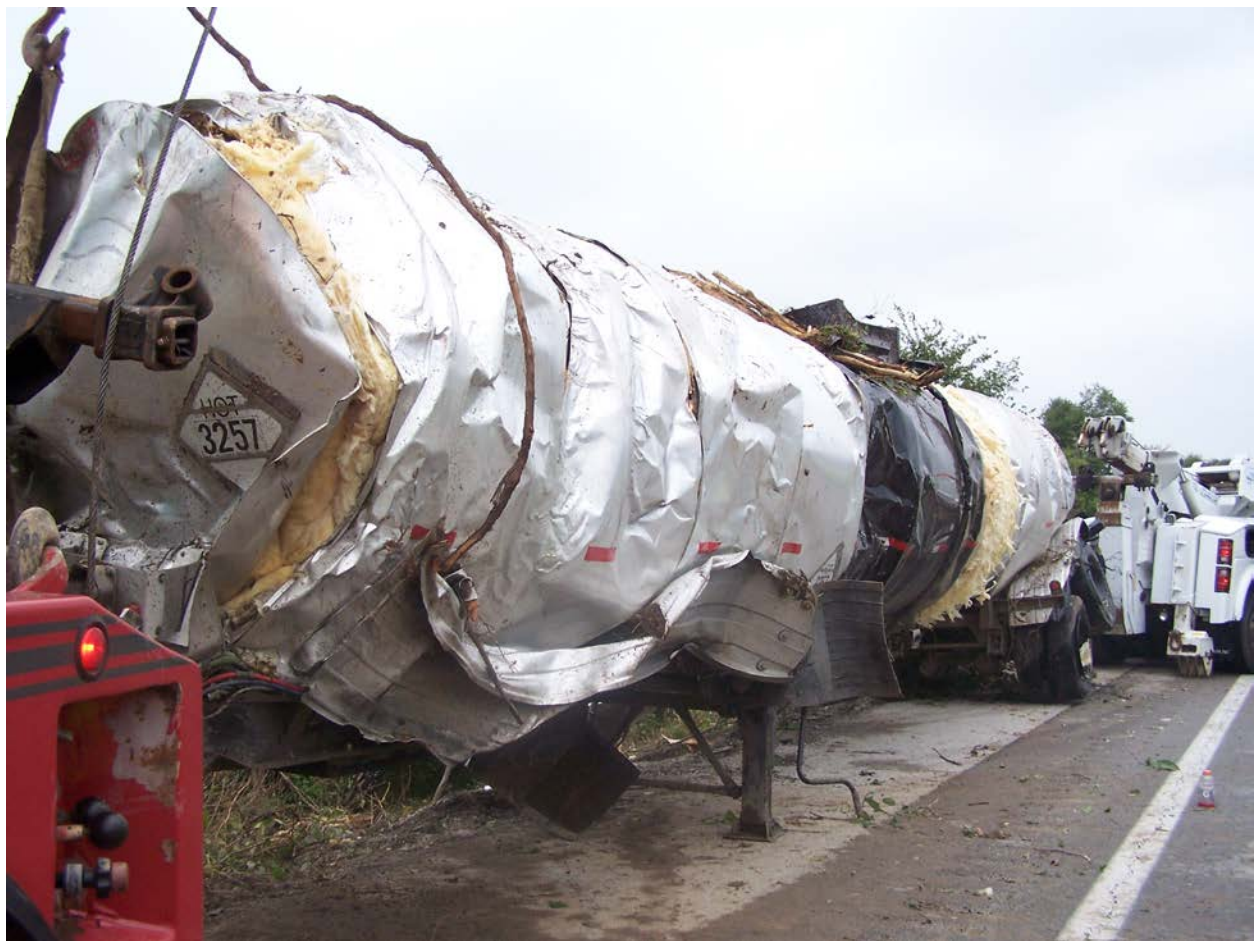
Photograph of tanker hauling asphalt flux involved in this incident. Property of KY FACE.
