Truck Driver Dies When Tractor-Trailer Overtakes After Leaving Road

Incident Number: 12KY011

Kentucky Fatality Assessment and Control Evaluation (FACE) Program
Incident Number: 12KY011
Release Date: May 14, 2013
Subject: Truck Driver Dies When Tractor-Trailer Overturns After Leaving Road

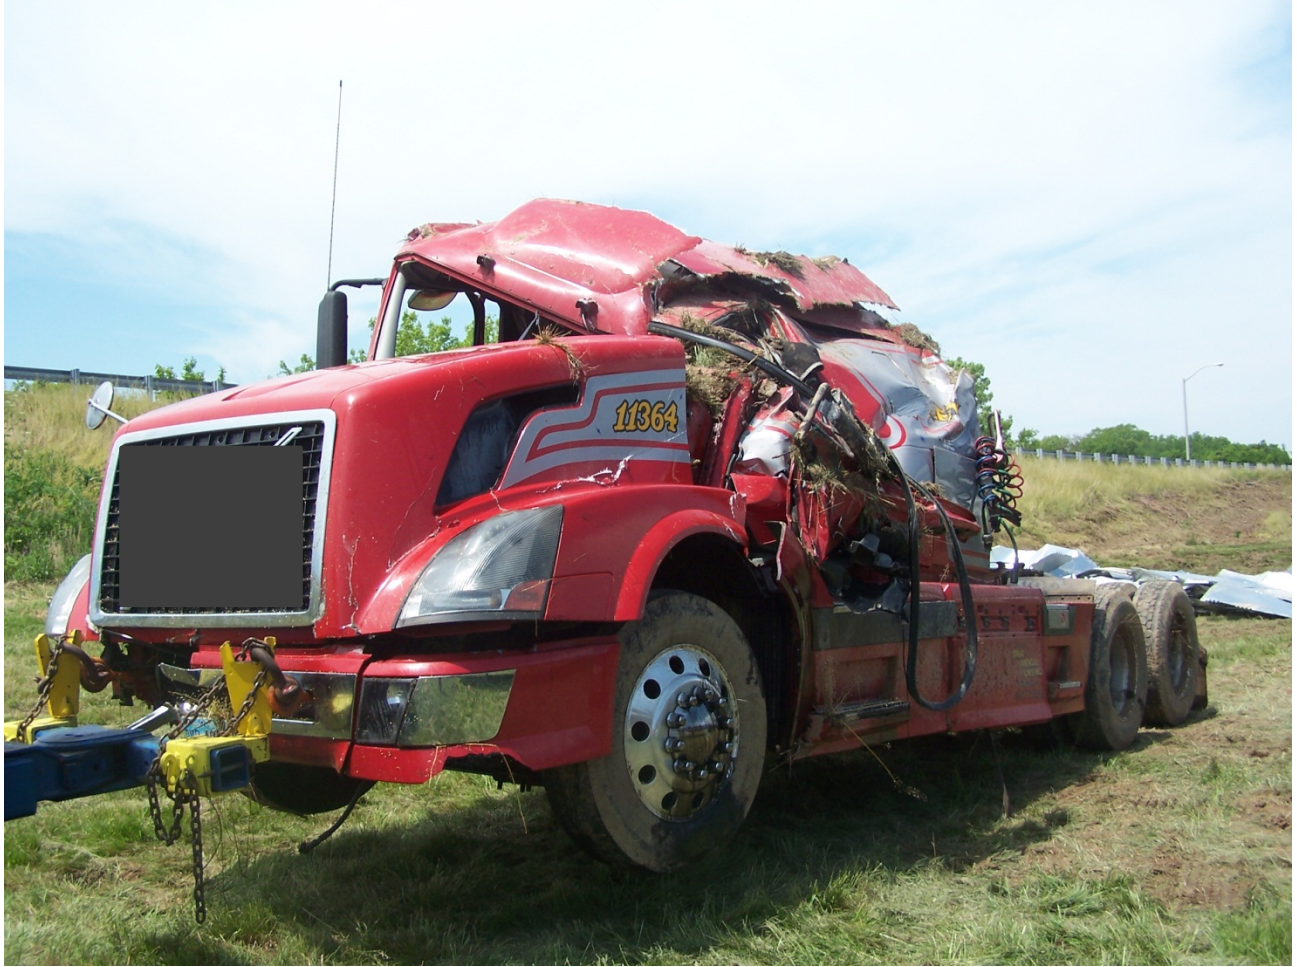
The tractor involved in the crash. Photograph property of KY FACE program

Sheriff's deputies could not determine if the driver was trying to negotiate the ramp and was unsuccessful or if he lost control for some other reason. Test results on the driver indicated he had not been drinking or using any controlled substances. A heart attack was also ruled out as a causal factor in the crash. Speed was not listed as a factor. The damage to the tractor and trailer was noted to be very severe.

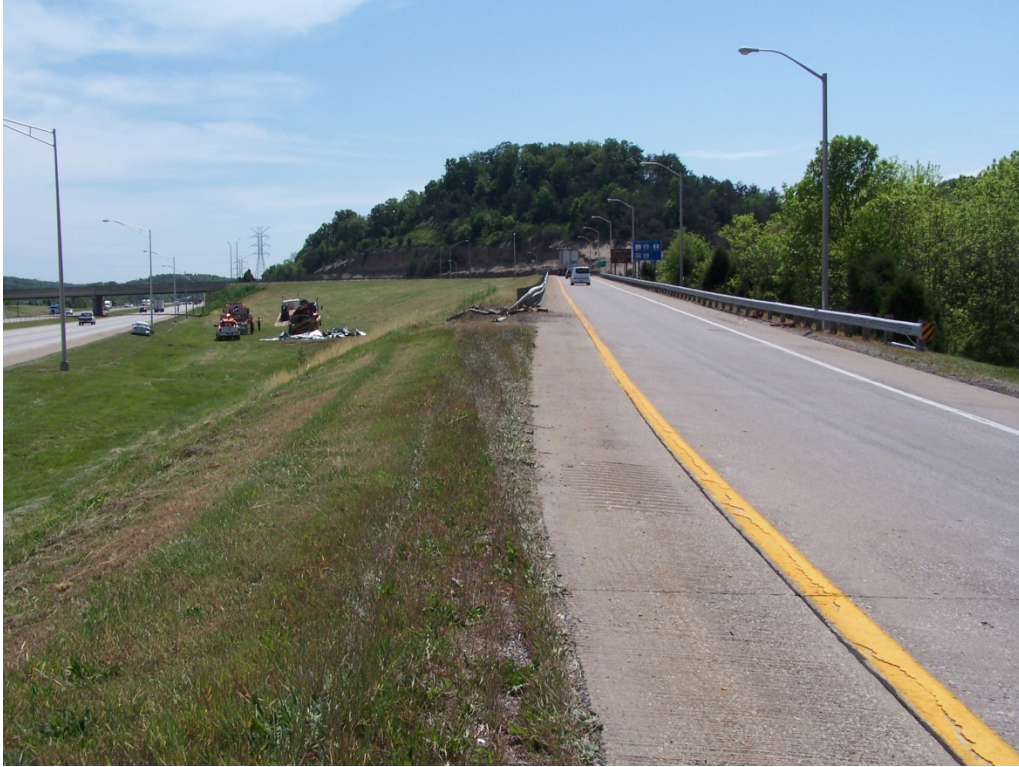
The driver exited the interstate and began to travel up the exit ramp. While traveling on the ramp, the truck struck the left side guard rail and continued off the road. The truck traveled down an embankment and overturned onto its roof at approximately 5:50 a.m. According to the police report, the driver was restrained and there was no evidence of braking at any point. Two sections of the guardrail and five support posts were damaged in the collision.

The exit ramp where the tractor-trailer left the road. Property of KY FACE

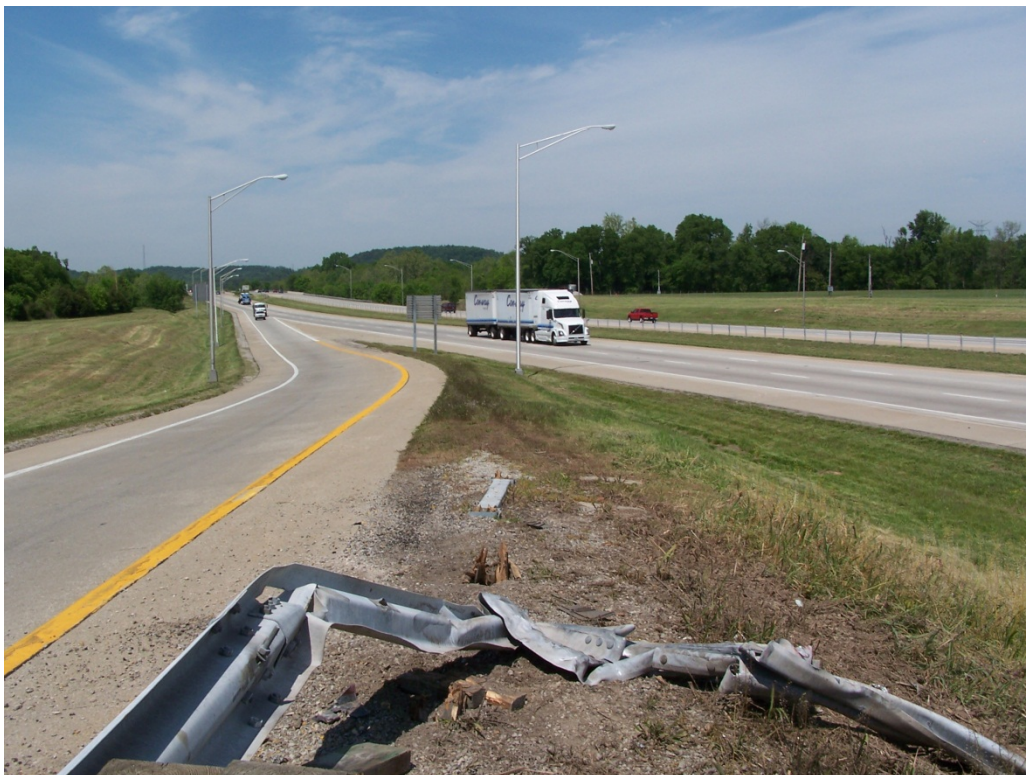
View back to the interstate from the crash site. Property of KY FACE
