# **Factory Laborer Dies When a Car Driven by Coworker Crashes into Him in Parking Lot**

**Incident Number: 12KY037**

**Kentucky Fatality Assessment and Control Evaluation (FACE) Program**  
**Incident Number: 12KY037**  
**Release Date: June 30, 2013**  
**Subject: Factory Laborer Dies When a Car Driven by Coworker Crashes into Him in the Parking Lot**

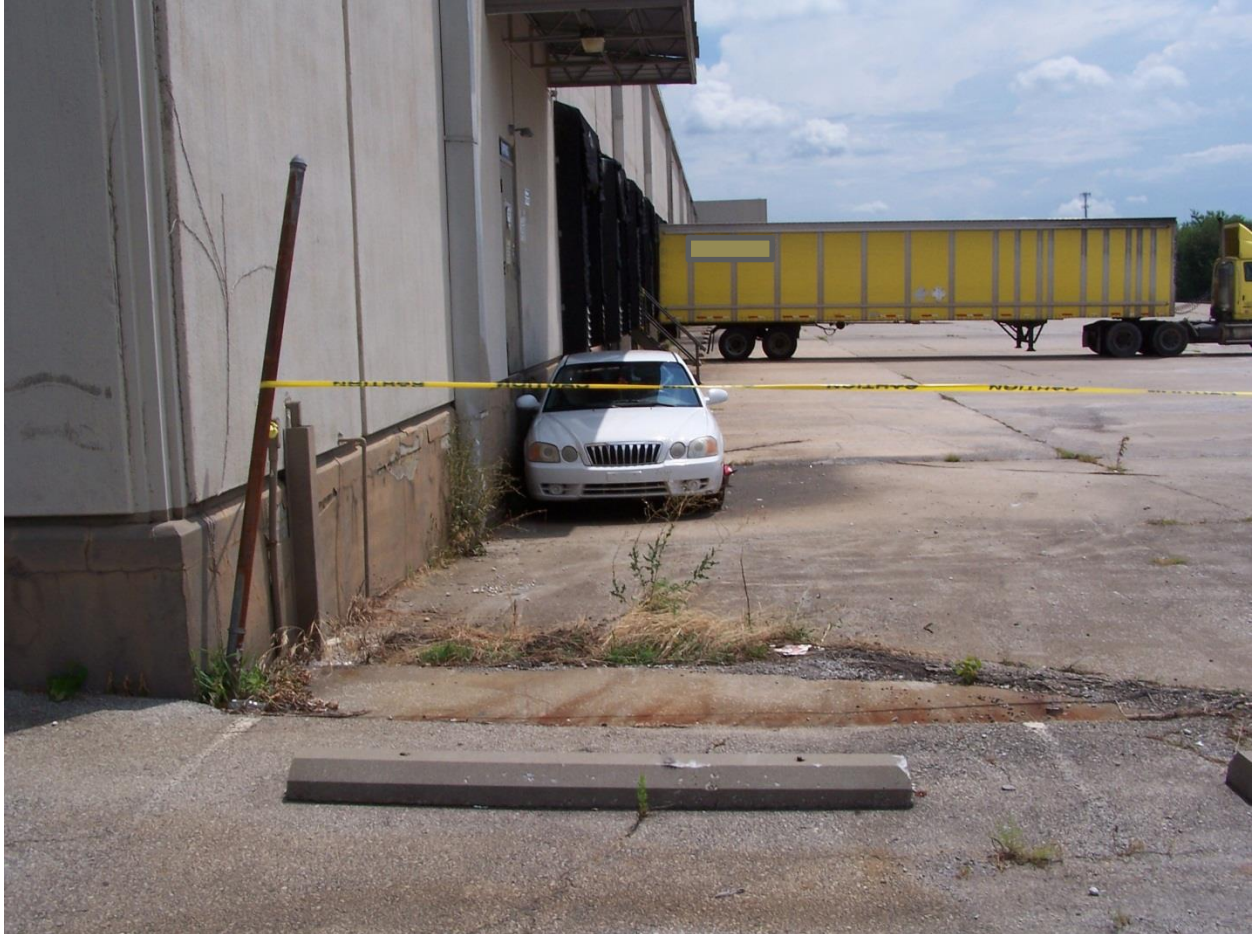
The car in the area where the crash occurred. Photograph property of KY FACE program.

Laborer 2 reported that a vehicle malfunction occurred as she backed up, causing the accelerator to become stuck. The car suddenly sped backward, over a concrete wheel stop, through a chain-link fence, scraping the passenger side of the car against the side of the building, and crashed into the metal stairway under which Laborer 1 was sitting. The car continued traveling backward alongside the building and the force of the car moved the metal stairway approximately 15 feet. Laborer 1 had just arrived underneath the metal stairway, according to coworkers, and was crushed between the building and the passenger side of the car.

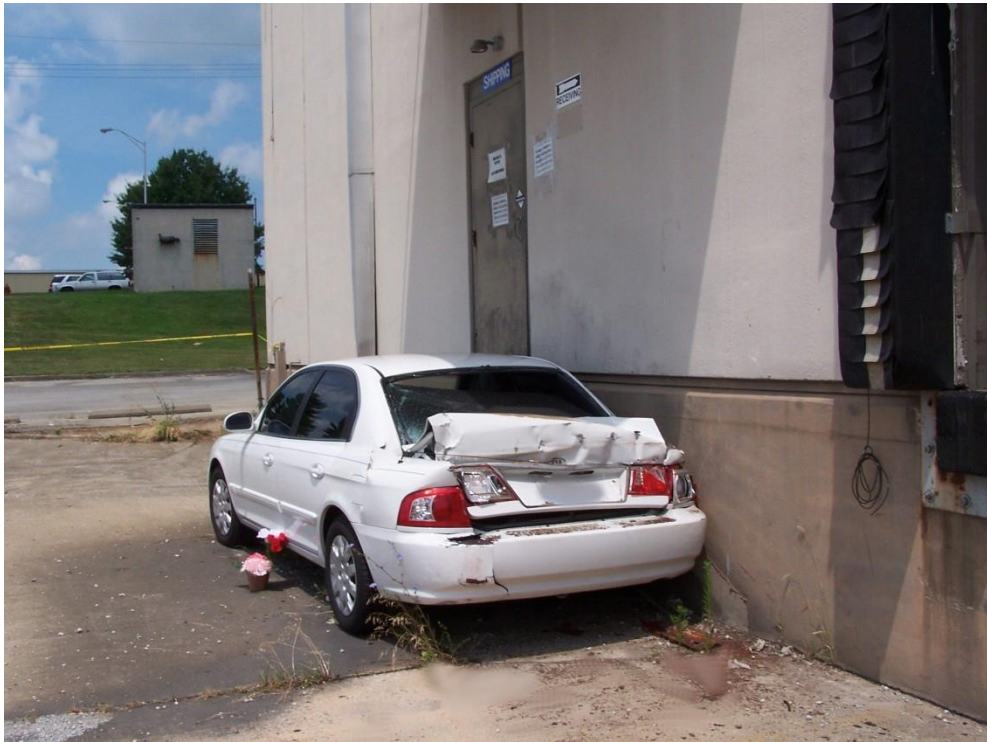
Attachment 1

The car crashed into the metal stairway, pushing it backward from underneath the door in the picture. Laborer 1 had been under the stairway. The stairway had been removed when this photo was taken. Photograph property of KY FACE

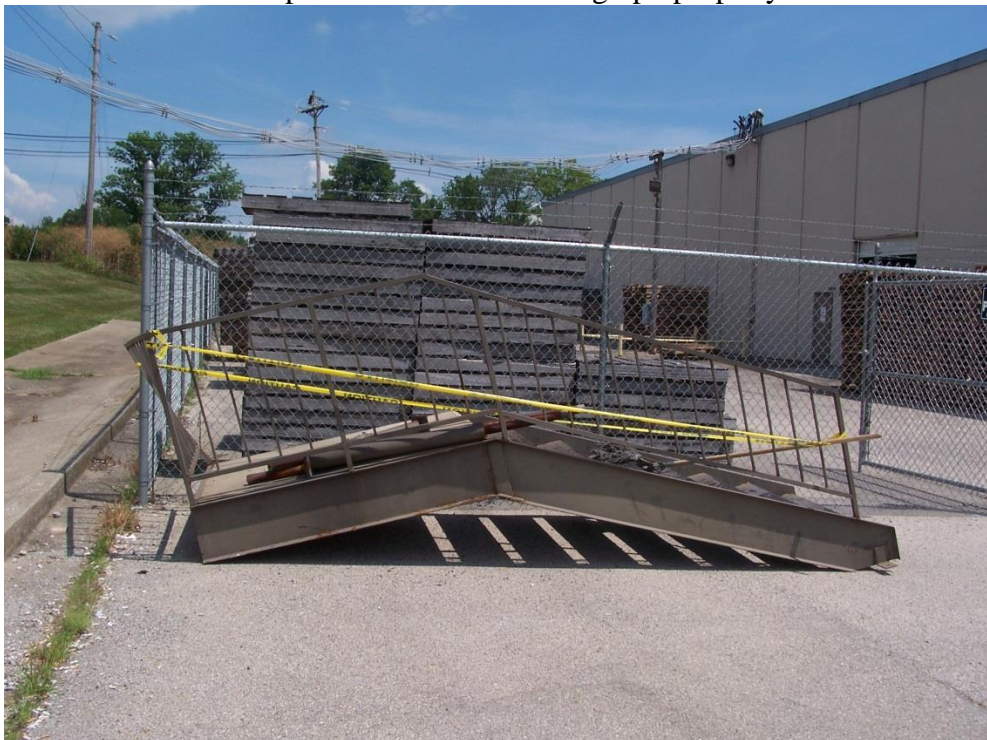
Co-workers of Laborer 1 revealed that it was his habit to take a break outside underneath a small metal stairway in the loading dock area during his lunch break each day. This location gave him privacy and was relatively quiet, but this area was near the loading docks and was surrounded by concrete, metal and vehicles in motion. Employers should provide safe and protected areas for employees to take breaks and require that employees use the designated break areas when on the property for breaks. Employees should refrain from taking breaks in areas that are inherently unsafe. At the factory where the incident occurred, there were two designated break areas, one indoor and one outdoor under a tree next to the employee parking lot.

The metal stairway which had been attached to the building under the door. Laborer 1 was reported to take breaks under this structure. Photograph property of KY FACE

Recommendation No. 1: Employers should establish policies requiring employees to use the safe break areas that are provided.

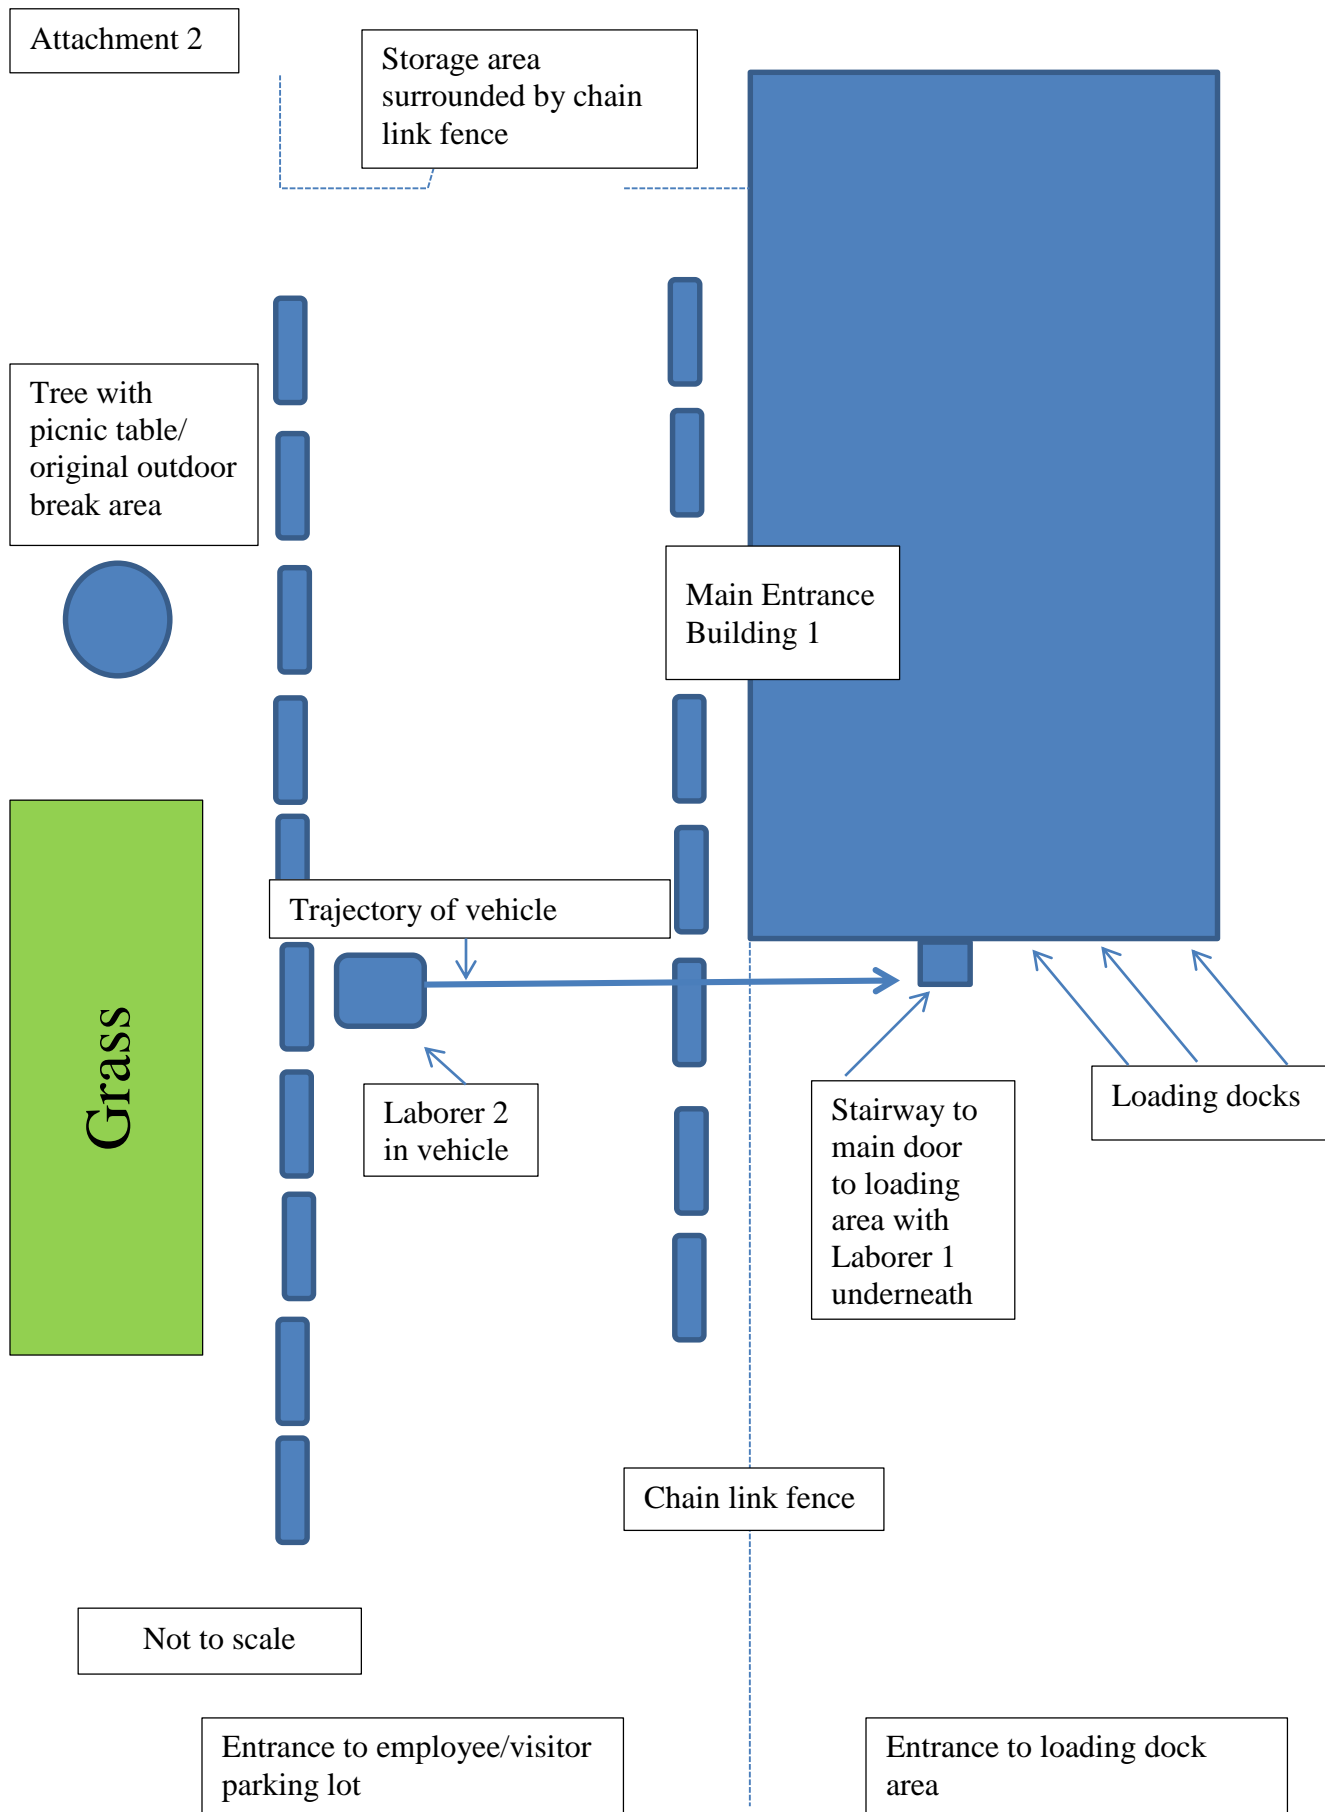
On a sunny summer day shortly before noon, a 29-year-old male factory laborer (Laborer 1) left his workstation to take a lunch break underneath a small metal stairway in the loading dock area. Coworkers revealed that it was the habit of Laborer 1 to take a nap or make cell phone calls outside under this metal stairway during his lunch break each day. The part of the loading dock area where the laborer was taking his break was separated from the employee parking lot by a chain link fence. The distance from the fence to the metal stairway was approximately 30 – 35 feet. On the day of the incident, another laborer (Laborer 2) entered her car with a friend to go out for lunch. She started her car, engaged it in reverse, and proceeded to back out of her parking space which was directly in line with Laborer 1 sitting underneath the stairway (See Diagram - Attachment 2).
