# **Heavy Equipment Mechanic Dies when an Elevated Dump Truck Tag Axle Pins Him to the Concrete Floor**

**Incident Number: 13KY041**

## **Kentucky Fatality Assessment and Control Evaluation (FACE) Program**

**Subject: Mechanic Dies when an Elevated 1800 lb. Tag Axle Pins Him to the Concrete Floor.**

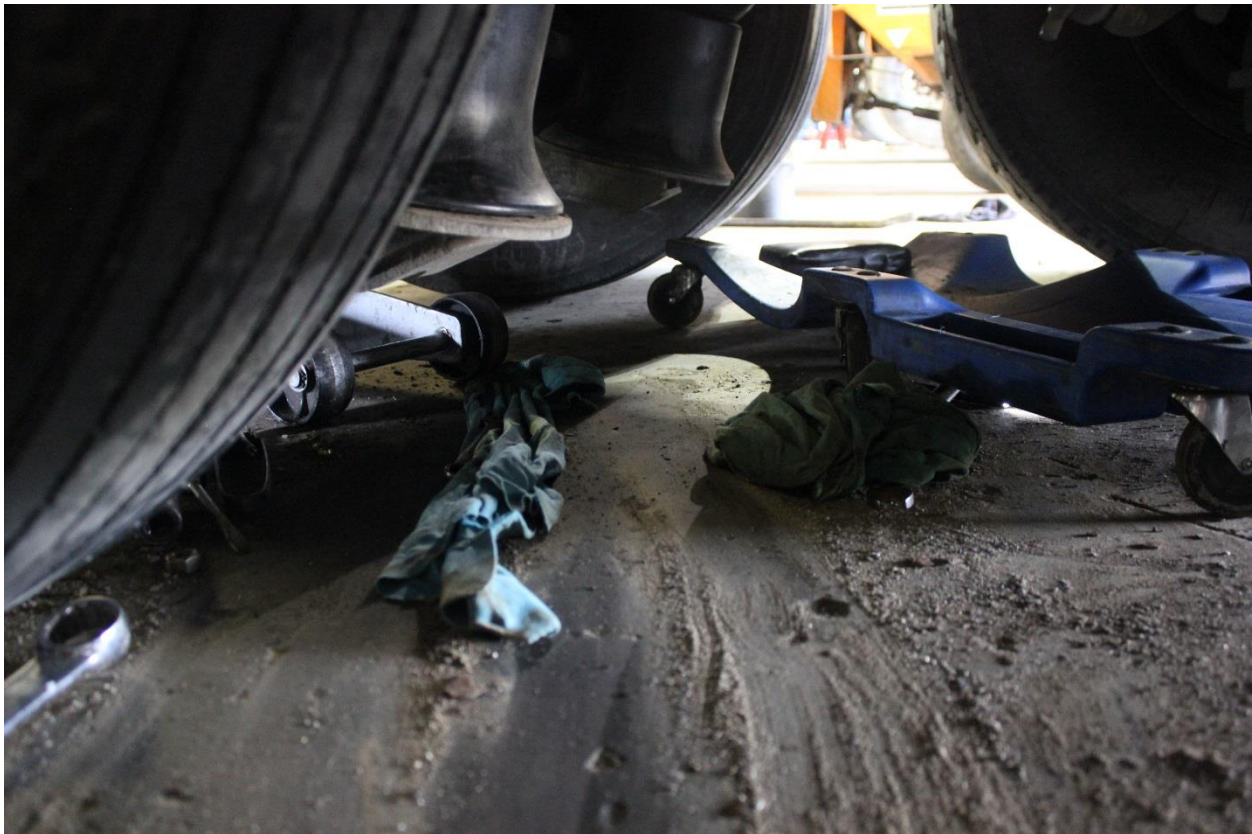
On September 19, 2013, at approximately 4:28 p.m. a 58-year-old heavy equipment mechanic was replacing an air bag on a tri-axle dump truck. The victim was under the truck and axle, which was resting on a hydraulic floor jack. While the victim was under the axle, he inadvertently placed his hand on the jack causing the floor jack to lower and pin him between the axle and the concrete floor. At 4:48 p.m. the shop security camera shows the victim's fellow mechanic return to the shop after he finished repairing a truck he was working on. He returned to the shop where the victim was working, to get ready to leave for the day. He yelled for the victim but received no answer. The mechanic observed the victim's legs and called out his name again, with no response. The mechanic walked around the truck to the passenger side and observed the victim's left hand on the handle of the jack. The mechanic removed the victim's hand from the jack and shook him without getting a response. He yelled for other employees to dial 911 for assistance. The victim's head was pointed toward the jack which was on the front side of the tag axle. The victim was lying on his right side with 1/3 of his body on the creeper. The mechanic started jacking the jack but it would not move. He then turned the handle and the jack started elevating. Once the axle was lifted off the victim, another employee pulled the victim out from under the truck on the creeper. Employees trained in first aid and CPR started CPR and put an AED device on the victim and placed a call to EMS at 4:51pm. EMS and the Sheriff arrived six minutes after the call was placed, and the victim was transported via ambulance to the hospital. After being crushed by the dump truck, the victim succumbed to his injuries due to compression asphyxia on September 21, 2013 at 1:50 am.

**Recommendation No. 1: Employers shall ensure that employees using jacks must crib, block, or otherwise secure the loads immediately after they have been raised.<sup>1</sup>**
