Pedestrian Tow Truck Operator Struck and Killed by Drunk Driver While Rendering Assistance on Highway Roadside

CASE SUMMARY

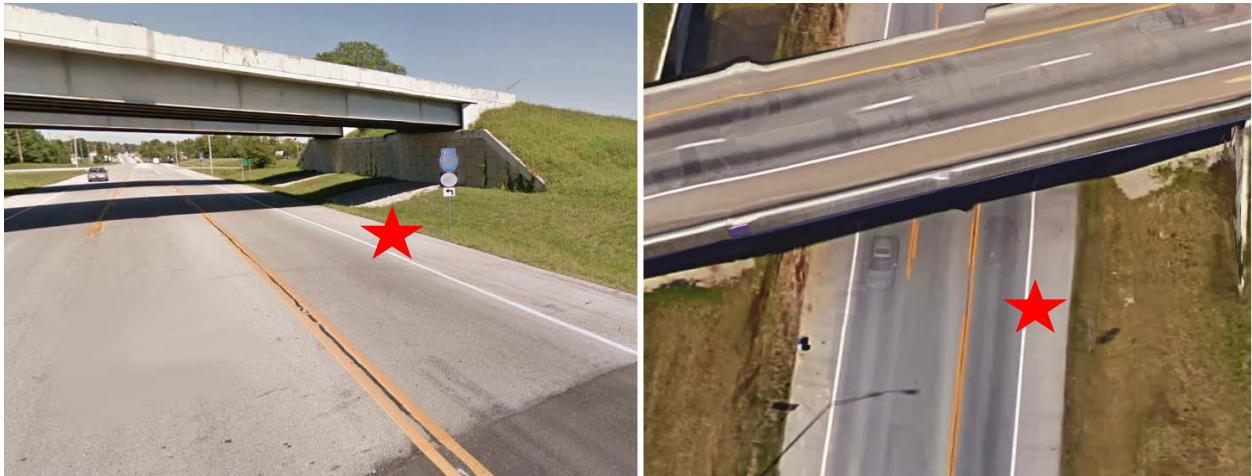
Figure 2. Ground and aerial view of the incident scene. The red star denotes approximately where the driver was standing upon being struck.

The incident scene was the eastbound lane of a two-lane state highway with a central turning lane dividing the two sides. Located just under a 4-lane highway overpass, the road was partially illuminated with streetlights. The roadway was straight, level and dry. The tow truck was parked 2-3 feet from the driving lane. The victim was on the right shoulder of the highway near the lift controls on the left-hand side of his truck. Directly behind the tow truck on the shoulder was a stalled Volkswagen Beetle in need of roadside assistance.

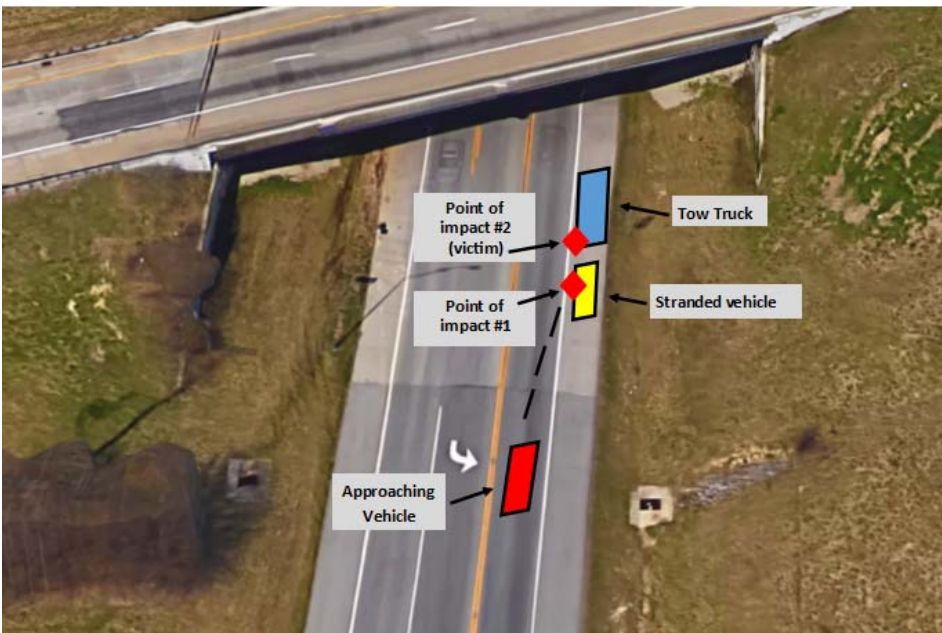
The driver trainee stood by the passenger side of the tow truck in a grassy area observing the tow truck driver. The tow truck driver operated the traffic-side winch controls of his tow truck, while the Volkswagen driver remained in his seat. As the tow truck driver adjusted the winch controls, a 2002 Toyota Corolla veered onto the right shoulder and struck the open driver's side door of the Volkswagen, then struck the victim and the driver's side mirror of the tow truck (see figure 4). The Toyota came to a brief rest on the eastbound shoulder in front of the tow truck, then fled the scene without rendering assistance to the victim.

Figure 4. Trajectory of the crash and locations of vehicles and victim.

Recommendation No. 1: When tow vehicles are equipped with dual winch controls, drivers should operate controls from the non-traffic facing side of the truck.

This particular tow truck was equipped with dual winch controls on both the right and left sides of the truck. By utilizing the passenger side of the tow truck, the tow truck driver would have been better protected from oncoming traffic. Some tow truck companies secure the disabled vehicle on the non-traffic side until they can get to a safe location to secure the other side.

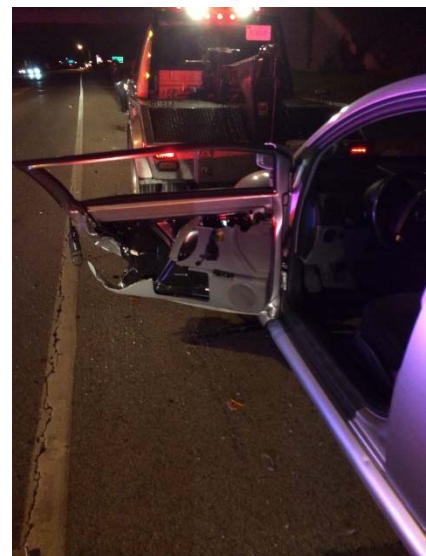
Figure 5. Volkswagen door following initial impact.
