Production Supervisor Falls 19.5 feet through a Metal Roof and Dies

Incident Number: 14KY048

Kentucky Fatality Assessment and Control Evaluation (FACE) Program

Release Date: August 24, 2015

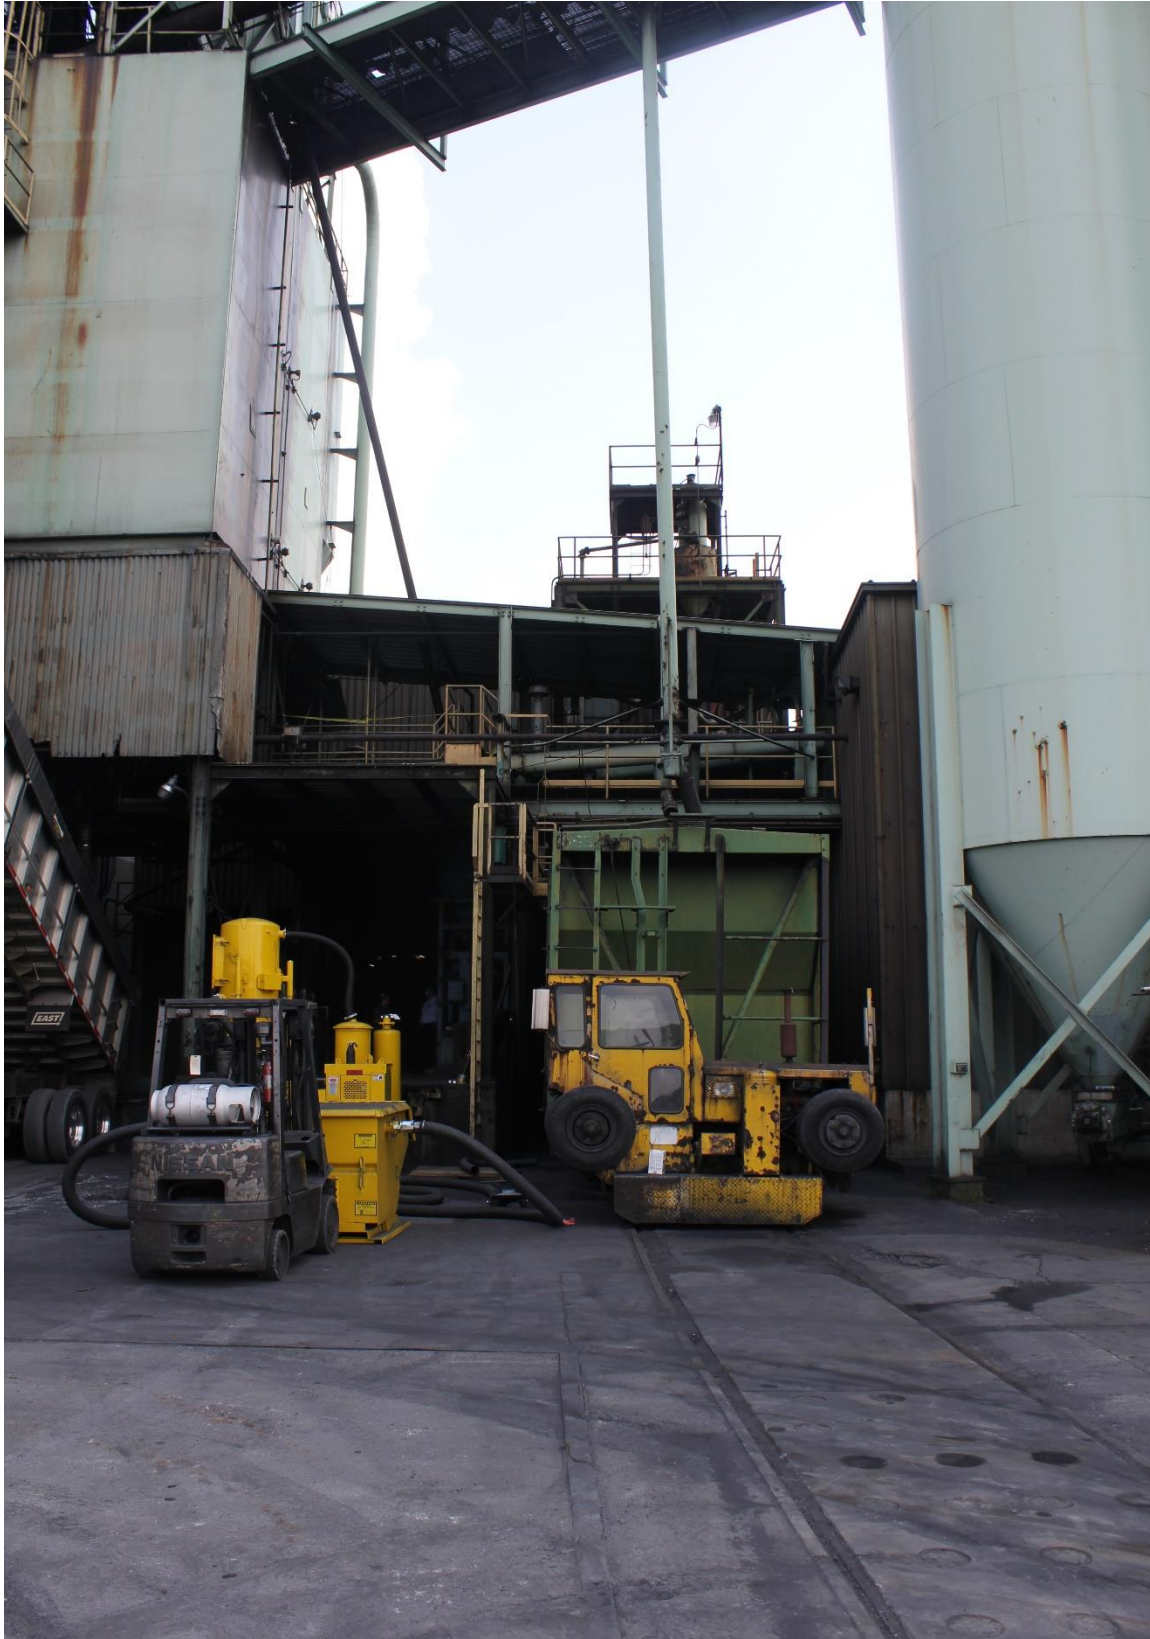
Photo 2: Incident scene

for him and found him lying on the ground. The supervisor had stepped onto a rotten area of the metal roof and had fallen through the roof 19 feet 6 inches to the hard dirt surface below.

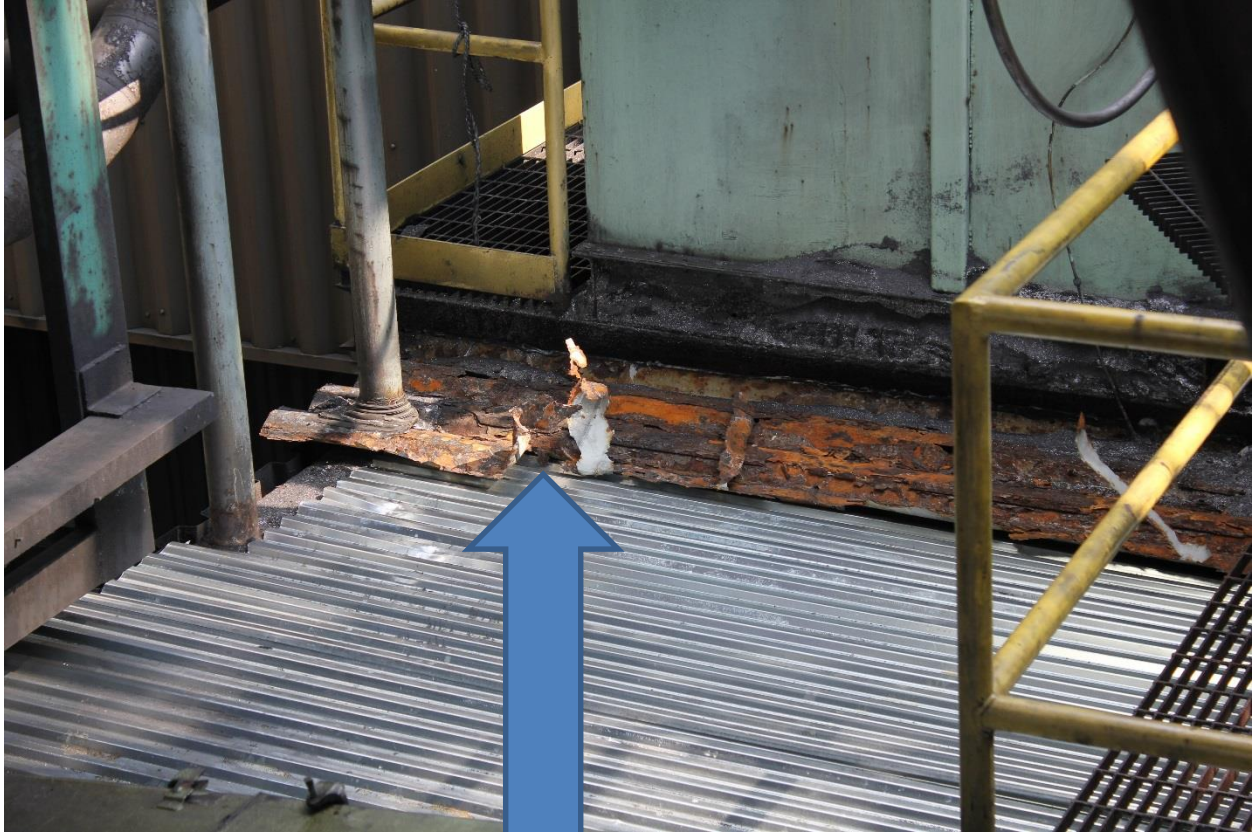
The scene was a metal roof covering a loading dock with a hardened earth surface. The roof area was flat and had a catwalk that ran over for access to the top of the roof. The edge of the roof area did not have any railings present and was 19 feet 6 inches above the ground. The area was slightly more than 13 feet wide. The metal roof had visible signs of rust and deterioration (see photo 3). Plywood was used to cover holes in the metal.

The metal roof was in poor condition as evidenced by the plywood sections covering holes and that there had been at least two other employees who stepped through the roof but had not fallen. The roof was not in suitable condition to support human body weight. Routine assessment of the structural integrity of the roof and regular maintenance of the roof would have prevented this fatality.

Photo 3: rusting roof

Recommendation No. 1 Employer worksites should be regularly assessed for structural integrity.

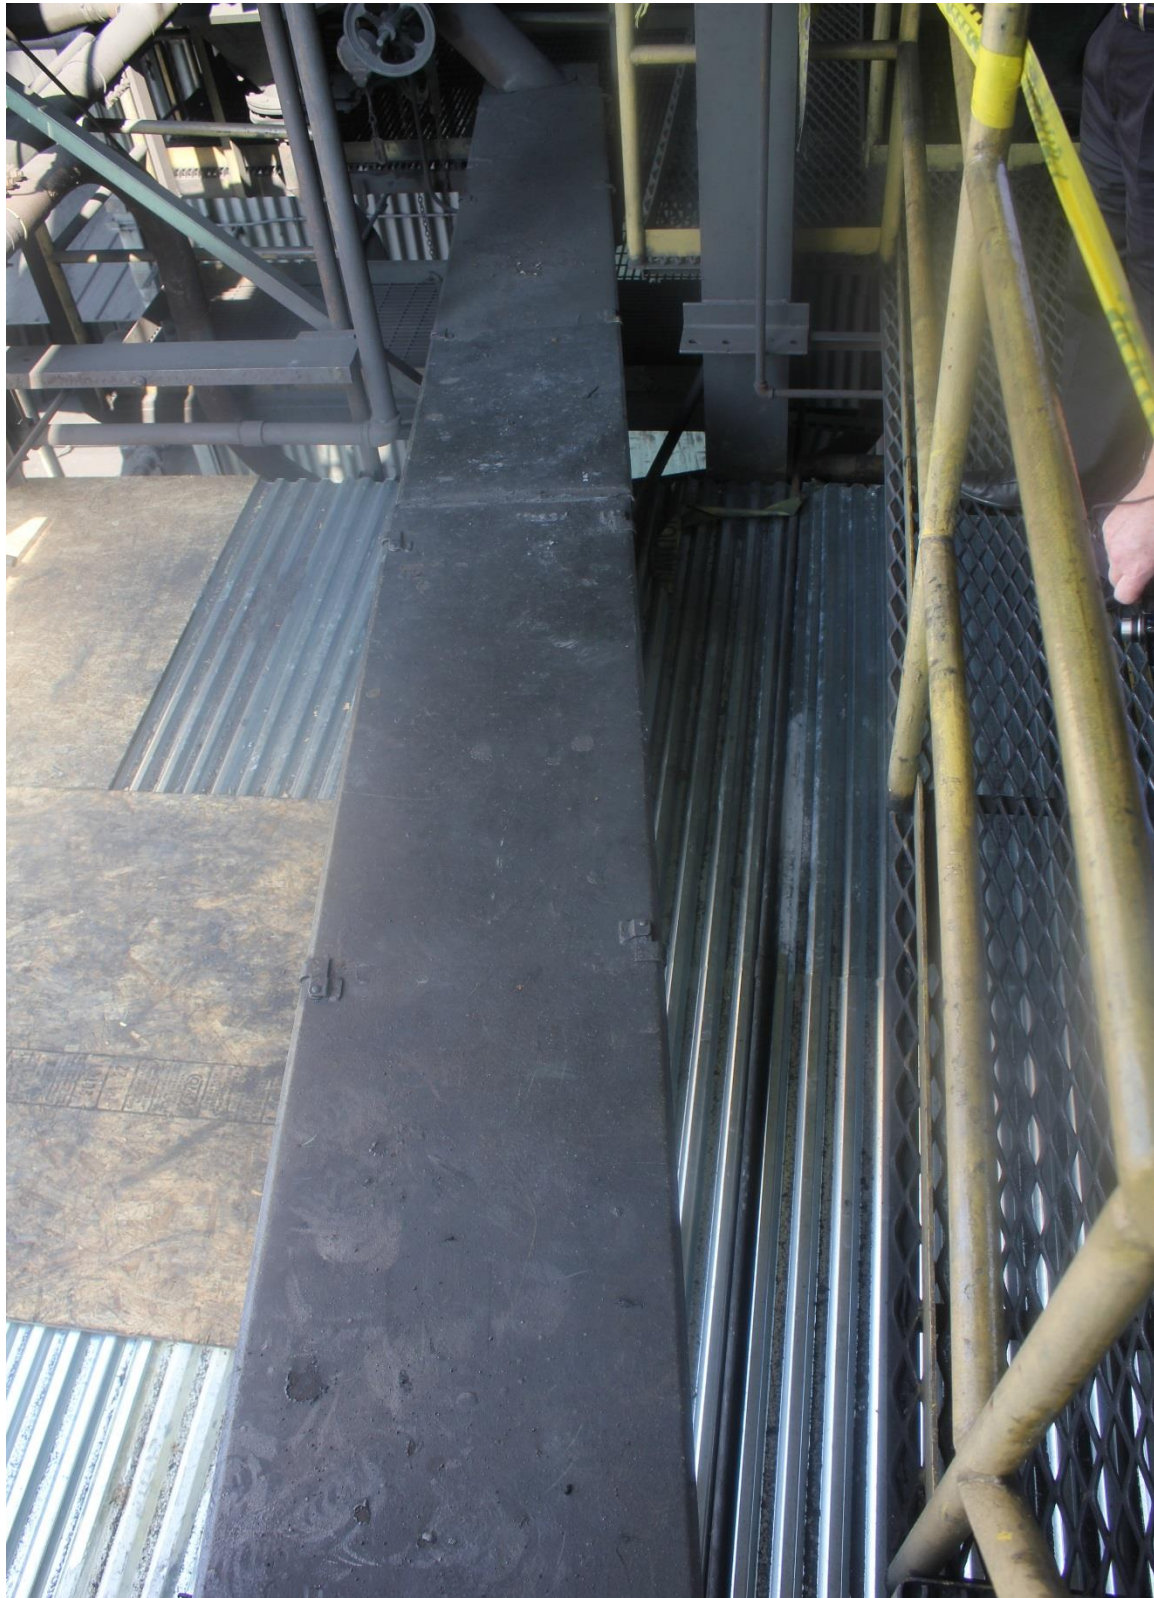
Approximately 8:00 pm on August 7, 2014, a 52-year-old production supervisor and another employee set out to inspect a blending process issue within a pneumatic feed system. To do this, they entered the outside second floor area between a warehouse and the main plant. The work area was a flat metal roof above a loading dock, with a catwalk that ran over the top of the roof (see photo 4). The roof area where employees were working was 19 feet 6 inches above the ground, with no standard railing or other fall protection in place. Like they had done regularly, they climbed through the guard rails onto a catwalk on the roof to access the pneumatic feed system.

Photo 4: catwalk used
