Apprentice Distiller Fatally Burned by Overpressurized Pot Still

Incident Number: 15KY019

Kentucky Fatality Assessment and Control Evaluation (FACE) Program
Incident Number: 15KY019
Release Date: December 15, 2015
Subject: Apprentice Distiller Fatally Burned by Overpressurized Pot Still

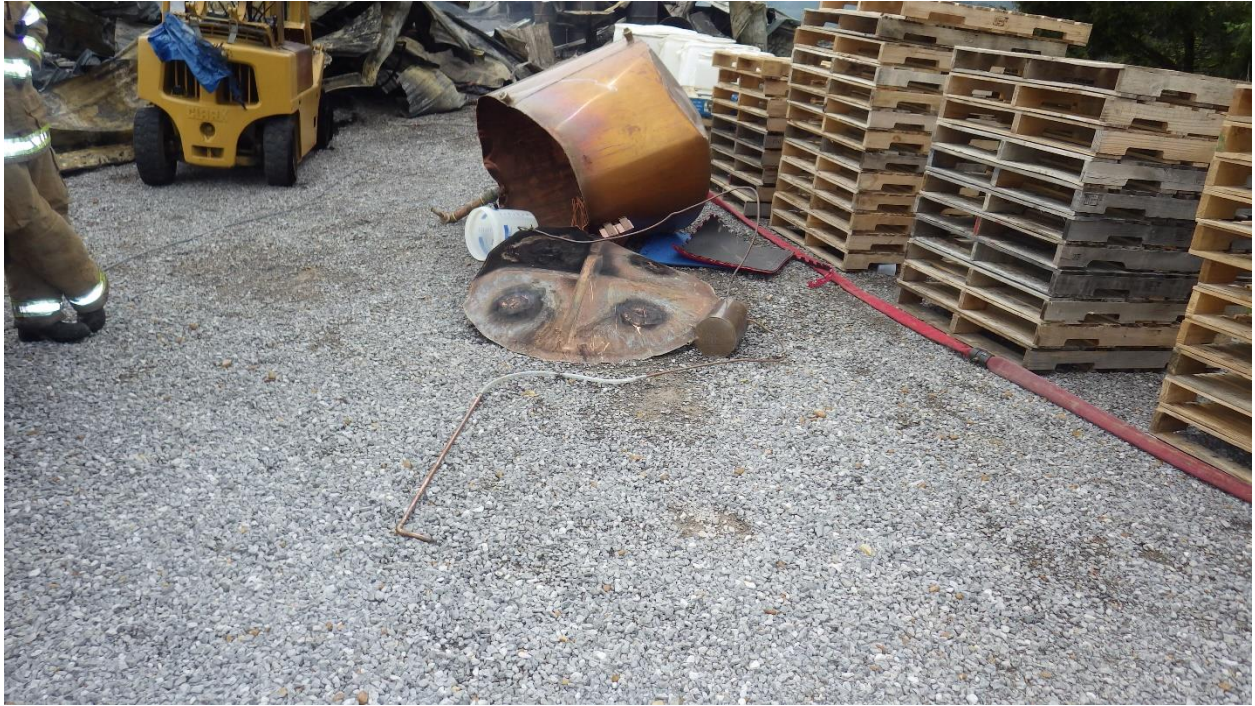
As they exited the building covered in hot mash, the second master distiller found the 300 gallon still and some of its components outside the building in the driveway, next to the distillery, and 90 feet from where the still had been mounted in the building.

Photo #2: The still in the driveway. (Photo courtesy of the State Fire Marshall)

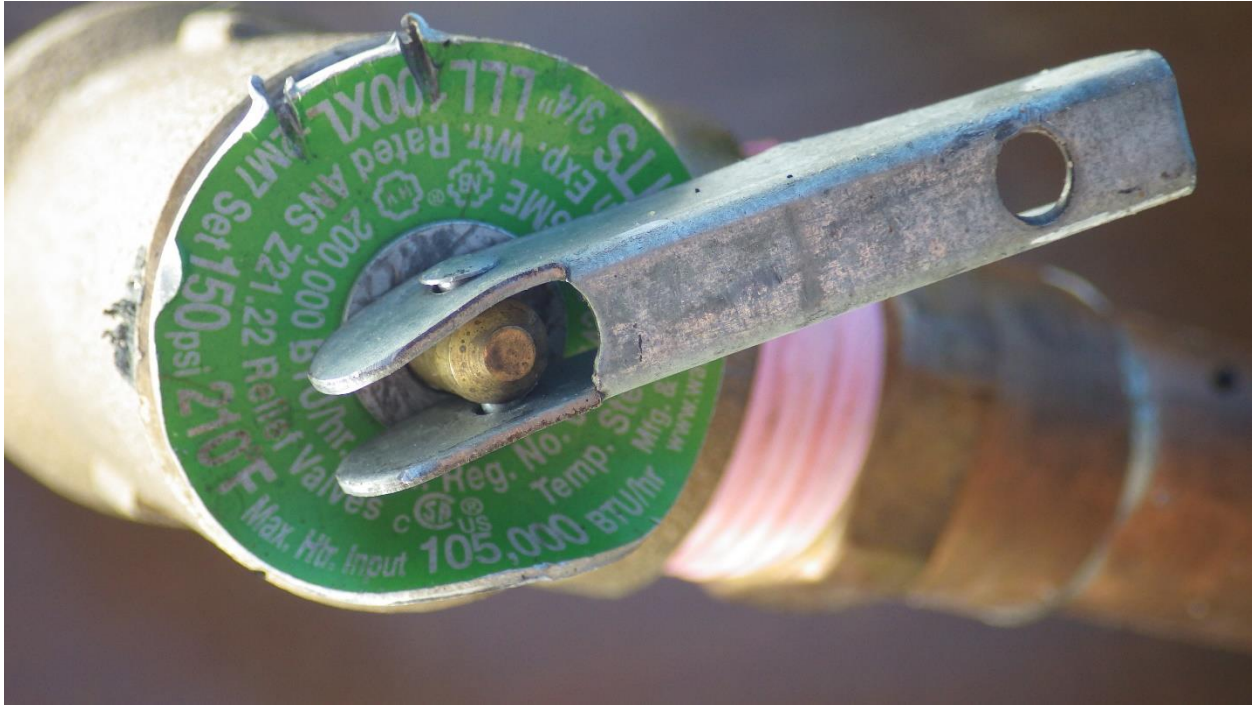
valve that operated on less than 1 psi of pressure.” However, the valve installed on the still was a Watts Model LLL100X1 with a 150 psi and 210 degrees Fahrenheit rating. The valve needed to have a lower psi rating as well as a lower degree rating to ensure the integrity of the still during over pressurization. Pressure could have built up in the still without the employees’ knowledge since they relied on the temperature and pressure relief valve to release pressure if necessary. An appropriate rated temperature and pressure relief valve may have prevented the event. It should also be noted the Watts Model LLL100X1 valve is listed for use only in water heaters.

The State Fire Marshal’s report stated that the setting on the pressure relief valve was different from the setting in the manufacturer specifications. The valve (see photo #3) should have been set to ~15 psi but was equipped with a 150 psi pressure relief valve. With a 150 psi valve, the still could become overpressurized, causing the still to rupture and mash to erupt (see photo #5). The manufacturer told the Fire Marshall that the pressure relief valve was a backup in case the output on the still became blocked.

Photo #3: The PSI of the temperature and pressure relief valve. (Photo courtesy of State Fire Marshall)

Recommendation No. 1: Batch distillation system manufacturers should ensure that an appropriate rated temperature and relief pressure valve be installed on manufactured pot stills.

The State Fire Marshall’s report ultimately recommended that “1) listed pressure relief valves should be installed in the vapor space of the pot and column with the discharge remotely piped to the exterior of the building; and 2) pressure gauges should be installed in the vapor space of the of the pot and the column.”

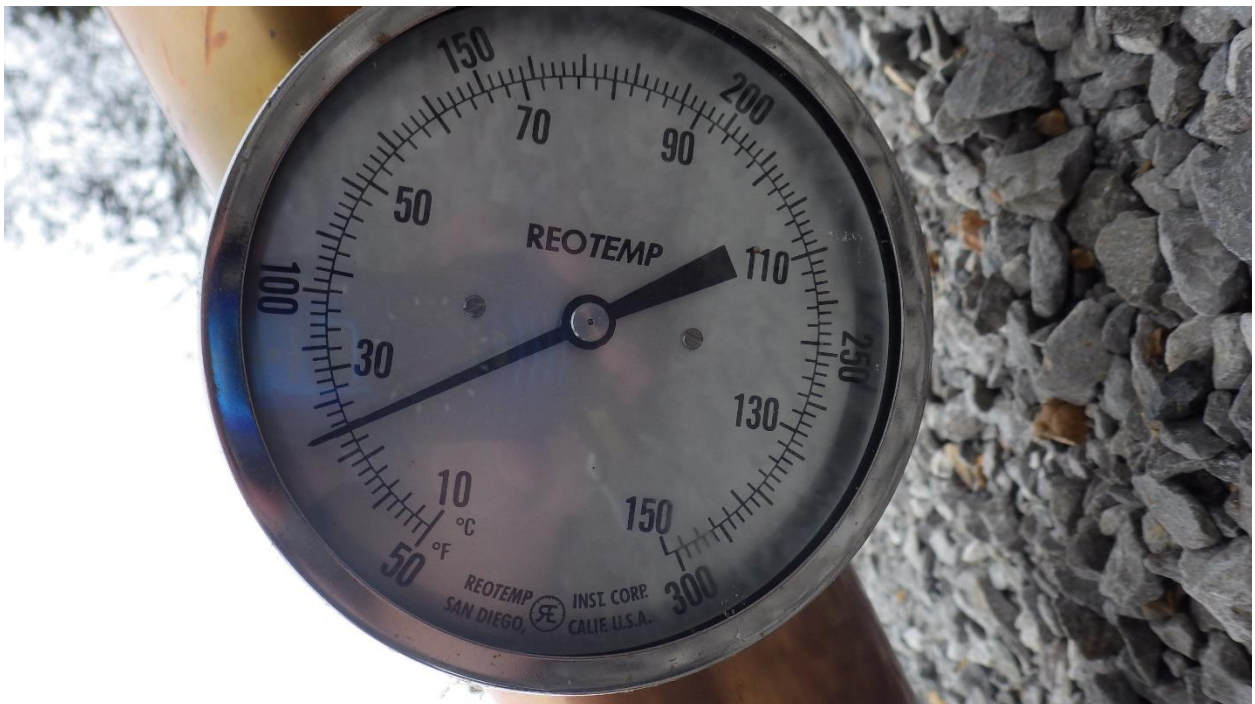
Photo #4: The temperature gauge on the column. (Photo courtesy of the State Fire Marshall)

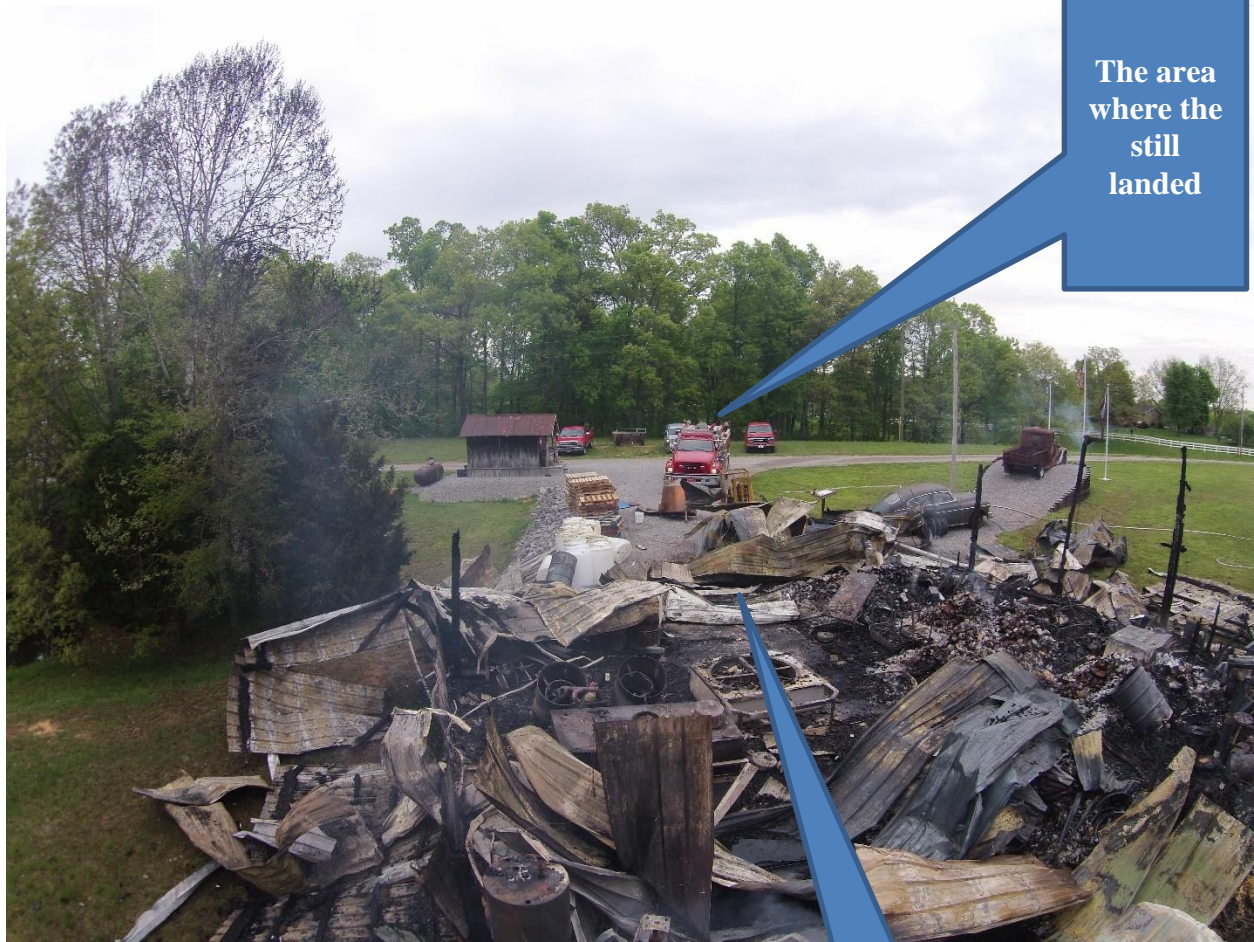
The area
where the
still
landed

Photo #5: Trajectory of the still. (Photo courtesy of the State Fire Marshall)

Area where the
still was sitting
prior to
incident
