## 19-Year-Old Construction Laborer Crushed in Trench Collapse While Laying Sewage Pipe

### CASE SUMMARY

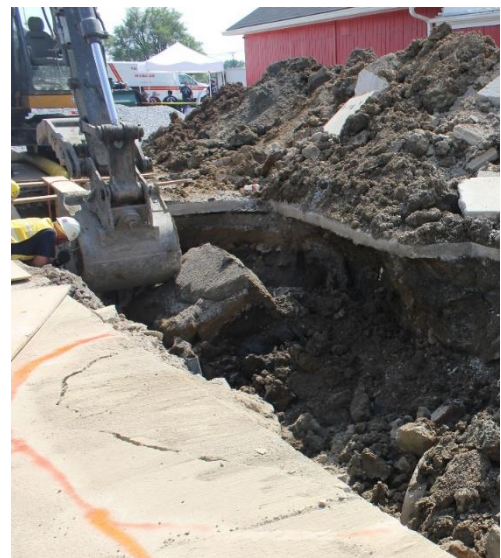
**Figure 1.** Trench following the rescue efforts.

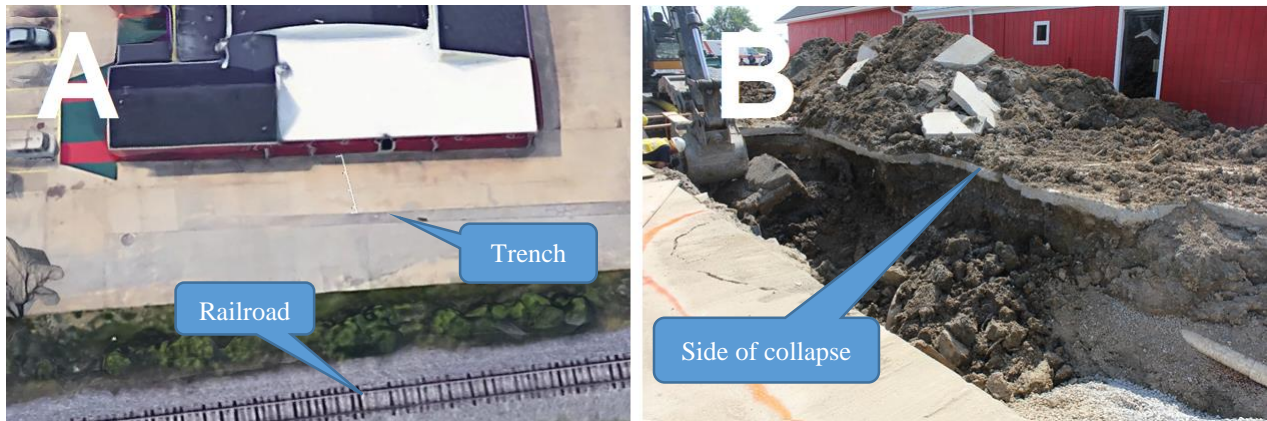
The incident scene was a concrete parking lot with signs of fissures and tension cracks. Signs of previous utility work and excavation in the parking lot were present in the form of previous cut lines and re-set concrete. A trench (measuring 12 feet and 2 inches deep by 5 feet wide by 48 feet long) was located 17 ½ feet from the wall of an adjacent building and 34 feet from an active railroad. Following the collapse, a spoil pile measuring 7 ½ feet tall was found to be directly on the edge of the trench. The crew stated that the spoil pile had been at least 2 feet from the edge of the trench prior to the collapse. Photographs of the collapse show the spoil pile directly at the edge of the trench, suggesting the 2 foot section of dirt and concrete may have given way.

**Figure 2.** A) Aerial view of the parking lot where the trench collapse occurred; B) the trench from ground level.

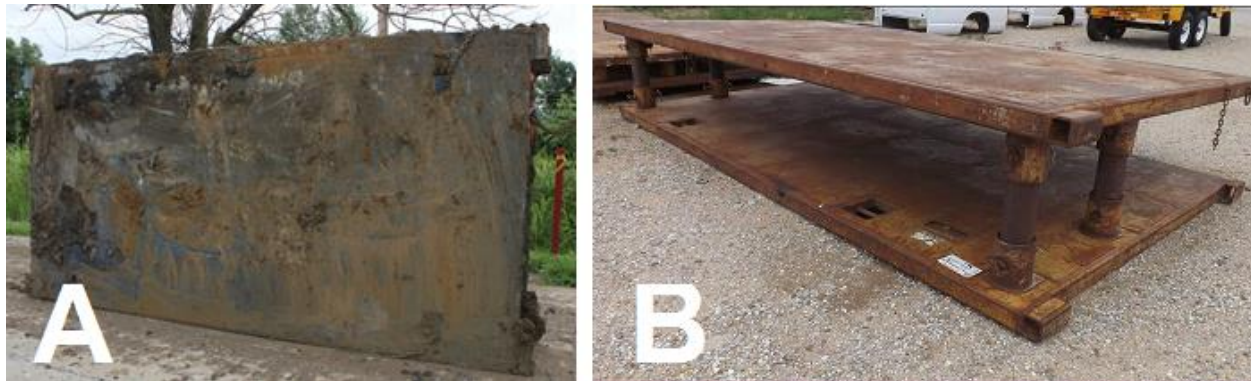
Although the workers used a trench box, it was not tall enough for the trench. The trench was 12 feet and 2 inches deep, while the trench box measured only 8 feet tall. This left the construction laborers inside the trench vulnerable to 4 feet and 2 inches of exposed wall.

**Figure 3.** A) Trench box used to protect the workers, the walls of which were 4 feet and 2 inches too short for the job; B) stock photo of the type of trench box used, side angle view.

***Recommendation No. 1:*** Trench boxes used in excavation projects should have a wall height greater than or equal to the wall height of the surrounding trench.<sup>3</sup>

A trench box protects employees from exposure to soil collapsing into the trench where work is being performed. The trench box wall measured only 8 feet high, while the trench itself measured 12 feet and 2 inches high. This left 4 feet and 2 inches of ground and concrete exposed, placing the workers below at danger of a partial trench collapse. A properly sized trench box could have helped protect the workers from the hazard.

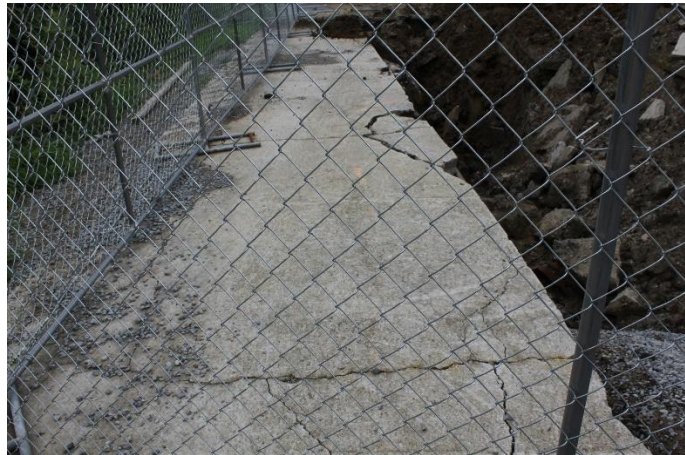
**Figure 4.** The parking lot surrounding the trench, with fissures and cracks.

Soil testing and classification should have been conducted prior to allowing work to take place within the trench, as it may have identified the poor stability of the ground and indicated the necessary protective system. The stability of the soil in this area was likely weakened by previous excavation at the same location, as evidenced by fissures, cracks, and re-set concrete. The ground at the site also was subject to heavy vibrations from equipment use and a nearby active railway.

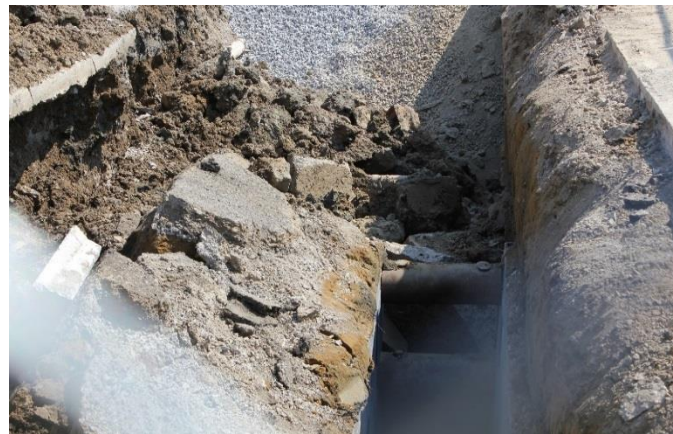
On the day of the incident, two of the construction laborers had been laying pipe in the trench for approximately 6 hours. At 2:20 pm, a large section of the trench edge broke off, dumping a portion of the spoil pile and concrete into the trench on top of both construction laborers. The victim was completely buried, while the other construction laborer was trapped from his waist down. Emergency Medical Services (EMS) was called at 2:22 pm and one of the construction crew members climbed into the trench and attempted to free the trapped construction laborers. A special rescue trench team arrived at 2:30 pm with EMS and began the rescue and recovery process. The construction laborer who was trapped from the waist down remained calm and responsive during the four and a half hour extraction process until he was freed at 6:55 pm and taken to a local hospital for treatment of his injuries. The victim's body was recovered two hours later at 8:55 pm. He was pronounced dead at the scene due to traumatic asphyxia and blunt force injuries of the head, neck, and torso. It is unknown how long the victim was buried beneath the debris before succumbing to his injuries.

**Figure 4.** The trench following the collapse.

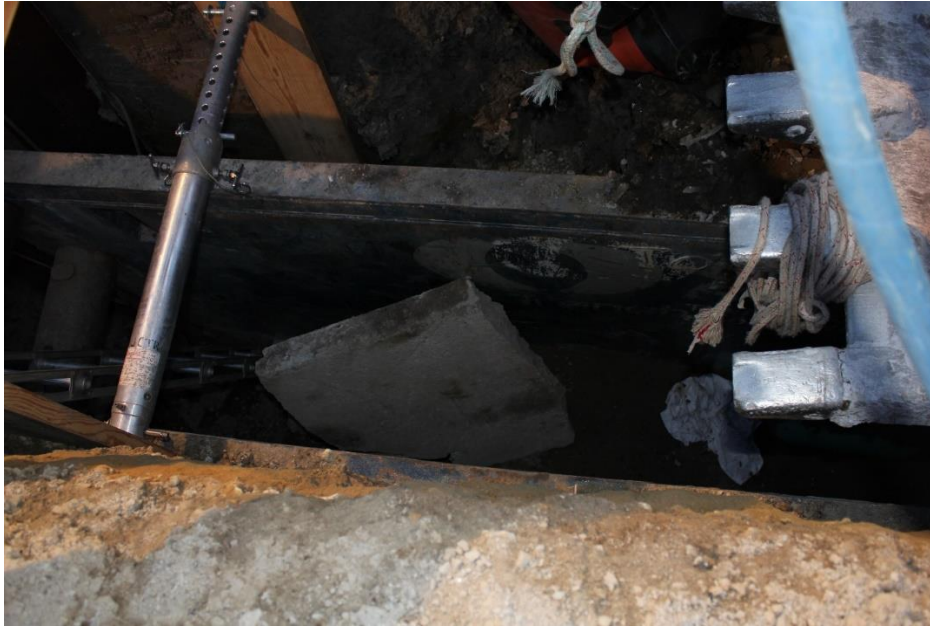
**Figure 5.** The trench during the rescue and recovery process.
