Construction Siding Subcontractor Installer Killed when Oversized Scaffolding Platform Destabilized and Telescopic Forklift Overturned

CASE SUMMARY

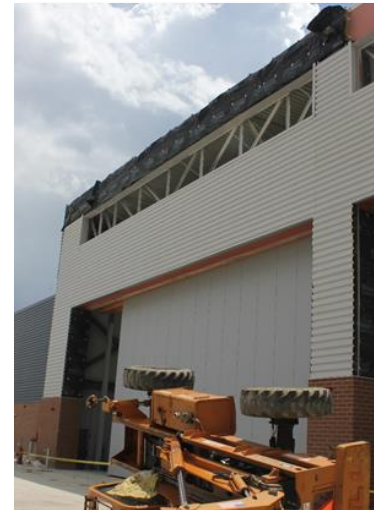
Figure 1. Telescopic forklift overturned at jobsite.

At 11:25 am the employees signaled to the foreman that they were ready to come down. Concerned that the platform may scrape the side of the building during descent, the foreman used the forklift's chassis tilt function to tilt the platform to the left away from the side of the building. The foreman stated that when he tilted the frame of the forklift, he lost control of the tilt and in doing so, the tilt continued to increase. As the tilt increased, the weight of the extended platform caused the forklift to lose its equilibrium and overturn onto its left side, slamming the platform onto the concrete below. Upon impact, the sling used to secure the platform to the fork broke away and the platform's left-side guardrail broke off. While the foreman was able to avoid injury by jumping away, the two siding installers, who were secured to the platform, were thrown onto the concrete lot. A nearby laborer

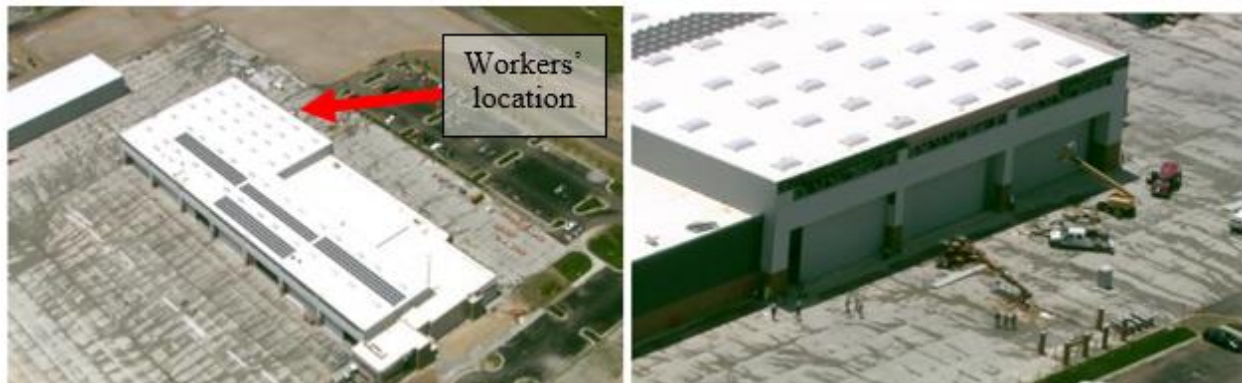
Figure 2. Aircraft hangar where the incident occurred.

The incident scene was a concrete parking lot where an aircraft hangar was under construction. The siding installers were installing insulation on the north wall of the building (figure 2) at the time of the incident, at an elevation of approximately 40 feet.

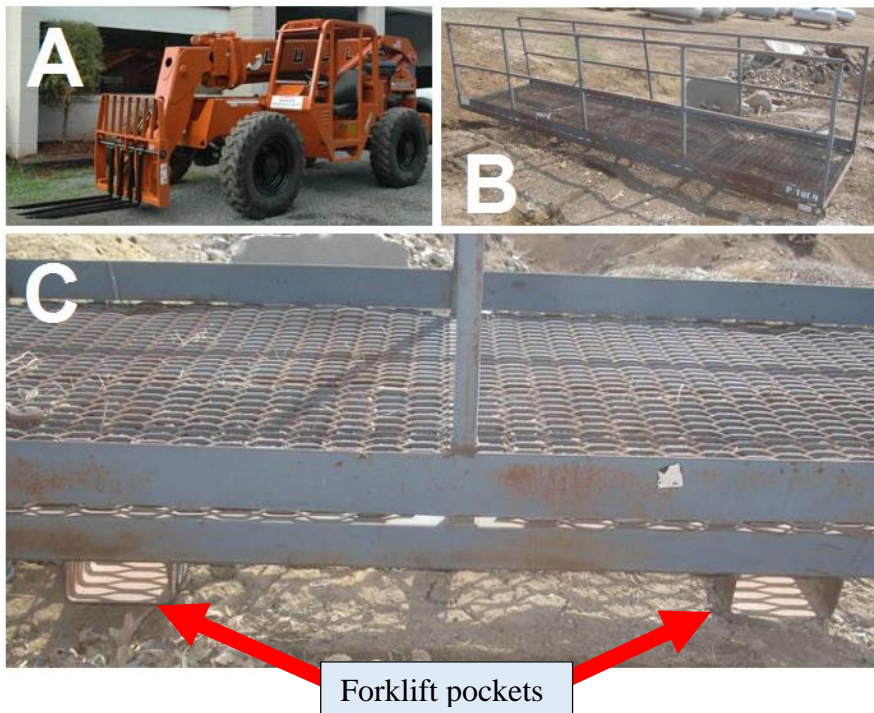
The equipment at the job site was a Lull model 844C rough-terrain telescopic forklift¹ with a wheelbase width of 8 feet and a load capacity of 8000 pounds (Figure 3A). The operator's manual warned that this equipment should only be used for material handling, and should never be used to lift personnel. This forklift model was not factory equipped with stabilizers to prevent it from tipping over.

Figure 3. A) Stock image of a Lull 844C rough-terrain telescopic forklift. B) Stock image of an Arrow brand platform, model 90WP48-192. C) Forklift pockets shown on actual platform.

Arrow brand man platform model 90WP48-192 was used as an attachment to the forks at the end of the forklift boom. This platform was constructed of steel and measured 4 feet by 16 feet, with 43 inch high side walls spanning the length of the platform and no end walls (Figure 3B). Additionally, there were forklift pockets located on both the middle of the long side and on the short ends of the platform to support scaffold platforms (Figure 3C).

The rough terrain forklift truck that was used had a chassis with two axles spanning 8 ft. wide. The platform was 4 ft. by 16 ft. This caused the platform to extend 4 ft. beyond the wheel base on each side of the forklift. According to the operator’s manual and AMSE/ANSI B56.6 1992 safety standards, *“A platform of the lift shall not have a greater width of the forklift.”*⁴

Recommendation No. 4: When using a forklift approved by the manufacturer for personnel lifting, the width of a scaffolding platform should not exceed the width of the forklift wheel base.

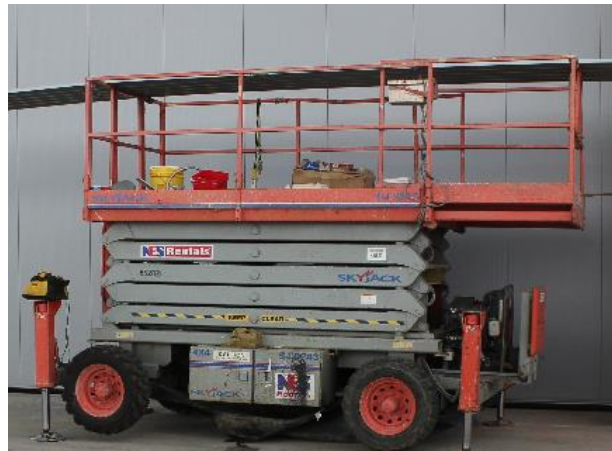
Figure 4. Skyjack SJ8243 Scissor lift which was located on the construction work site that would have been appropriate for lifting the personnel. This lift had a maximum height of 43 feet.

Located on the premises of the construction site was a Skyjack brand SJ8243 Scissor Lift which is specifically designed for the lifting of personnel (Figure 4). The Skyjack model had a maximum platform height of 43 ft., which would have been sufficient to safely access the working area. It is unclear why the Skyjack Scissor Lift was not used.

Recommendation No. 2: When lift equipment is required to elevate siding installers, choose only equipment specifically designated by the manufacturer for that purpose.

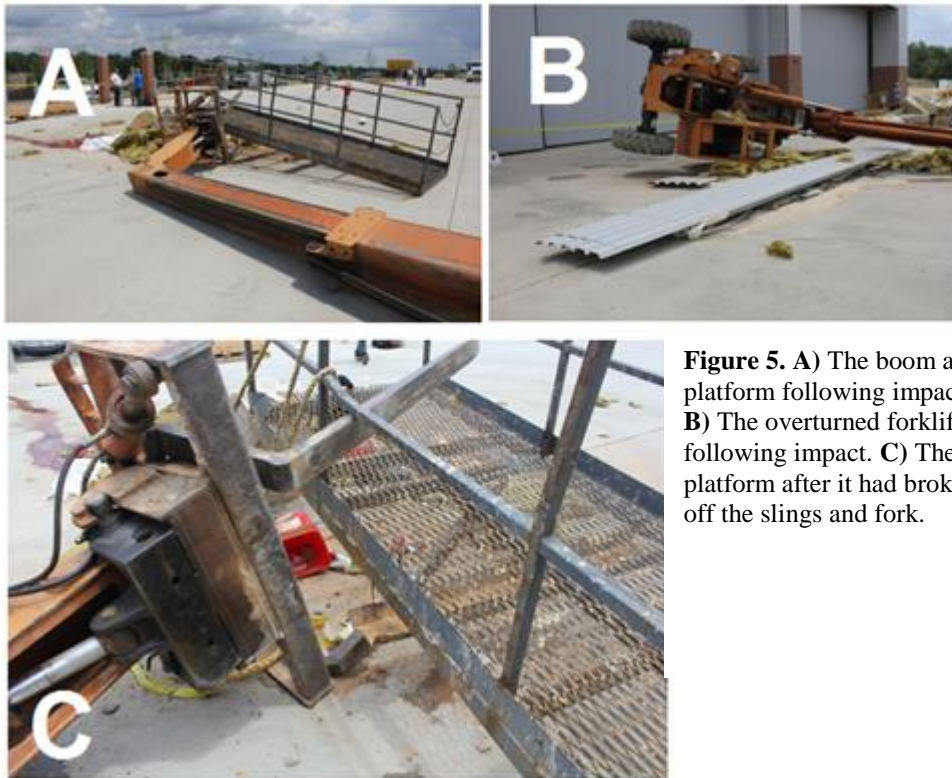
Figure 5. A) The boom and platform following impact. B) The overturned forklift following impact. C) The platform after it had broken off the slings and fork.

The cause of death was multiple blunt force injuries caused by a fall from approximately 40 feet.

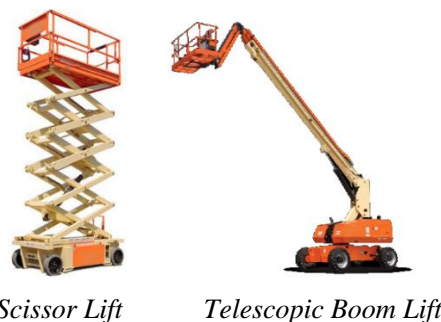
Areal lift examples that would have been safer for this type of job (scissor lift and telescopic boom lift specified for lifting personnel):

Scissor Lift

Telescopic Boom Lift
