Seasonal Lawn Mower Operator Crushed and Dies After Lawn Mower Rolls Over on a 30 Degree Slope

CASE SUMMARY

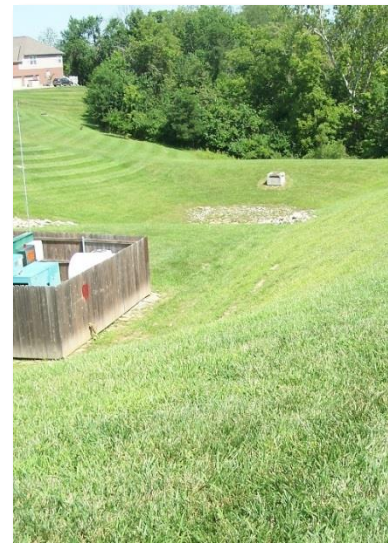
Figure 1. Area where mower overturned at jobsite.

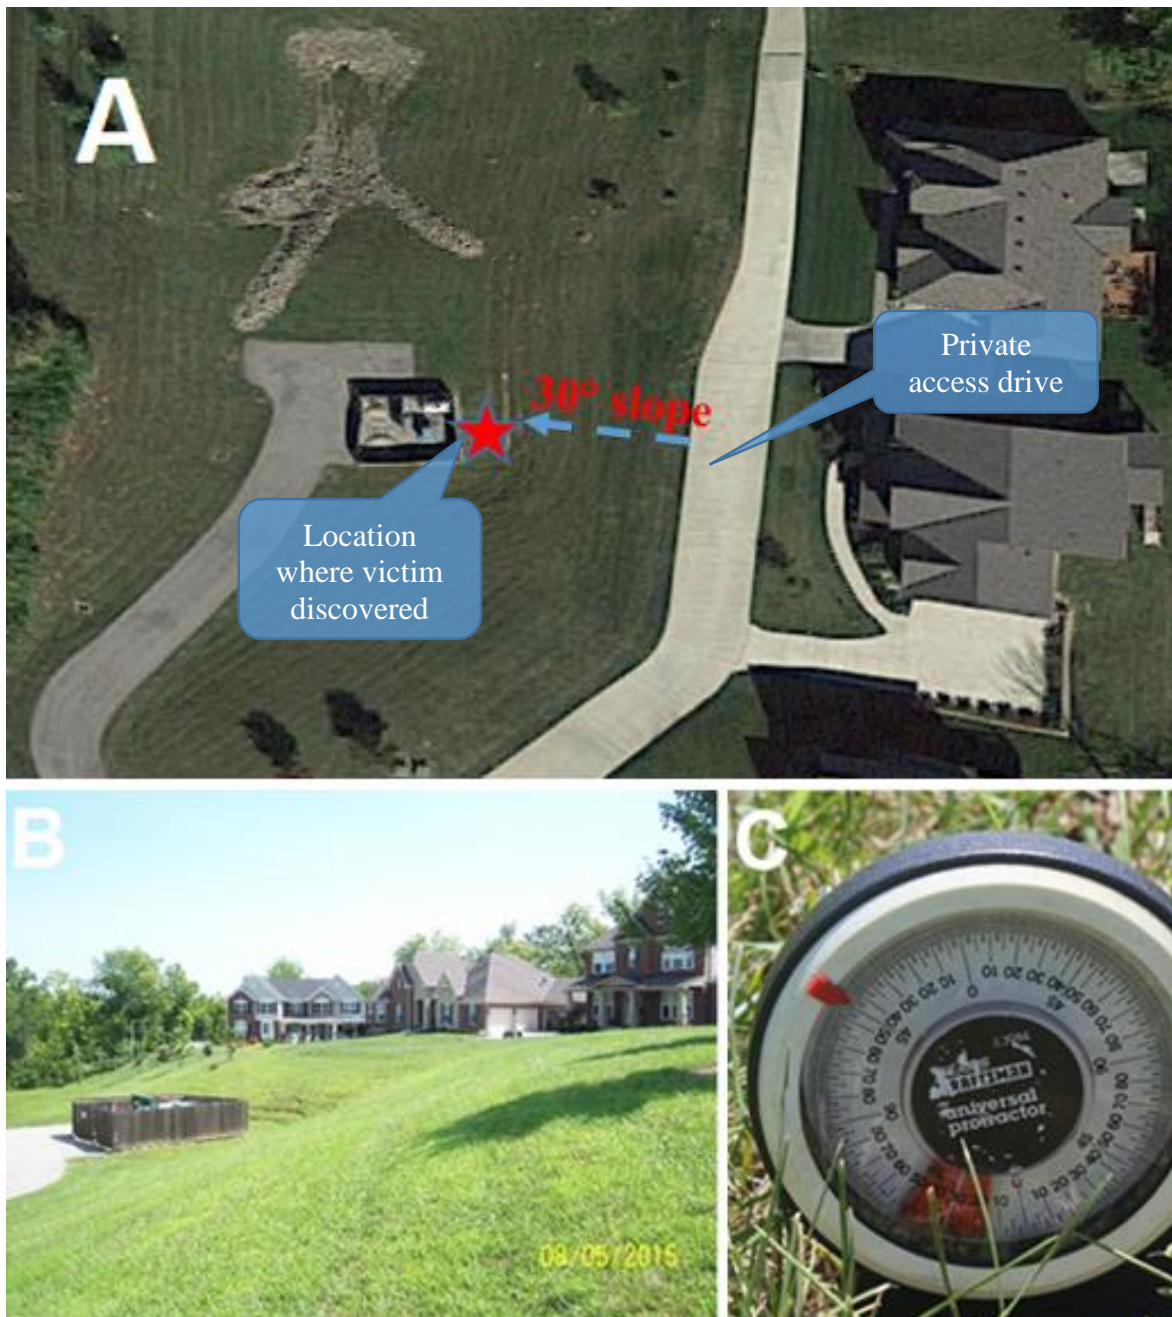
Figure 2. A) Aerial view with star denoting where the victim was discovered, B) side-view of the slope, C) slope reading of 30 degrees.

The incident occurred next to a private access drive in a residential subdivision. Four houses were positioned on the right side of the drive, with a steep embankment on the opposite side. The embankment where the roll-over occurred had a slope of 30 degrees. There was a fenced off area at the bottom of the embankment, where the victim was found. According to the employer, the victim had operated the same lawn mower in this location on several different occasions.

The victim was mowing on a 30 degree incline, and the embankment was cut approximately 16 feet down from the top. The owner's manual states:

“Stay off slopes too steep for safe operation. To check a slope, attempt to back up the slope with the cutter deck down. If the machine cannot back up the slope without the wheels slipping, do not operate the machine on this slope. Under no circumstances should the machine be operated on slopes greater than 15 degrees”¹

Operating on a slope greater than the manufacturer's recommendation increases the likelihood of the mower overturning. If the slope is greater than 15 degrees, a push mower, string trimmer, or

Recommendation No.1: Never operate a lawn mower on a slope that exceeds the angle limits specified by the lawn mower manufacturer; use lawn maintenance equipment designated for steep slopes.

other specialized cutting equipment should be used. ² A push mower should be operated horizontally across the slope. If the slope falls within the manufacturer's recommended maximum slope for riding lawn mowers, a best practice is to mow up and down the slope rather than across the slope. ³ Contact the manufacturer or refer to the user's manual to determine maximum slope safety specifications.

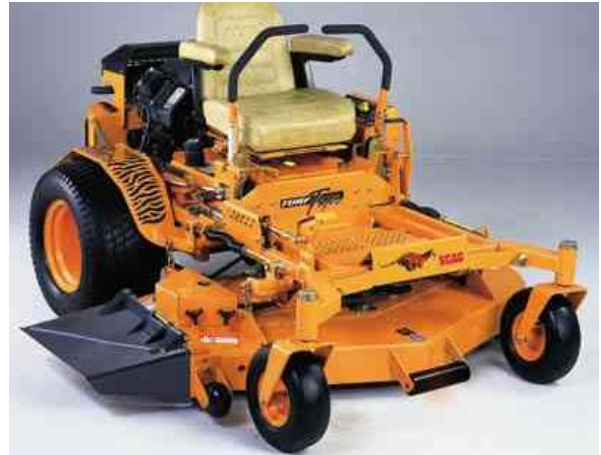
The equipment operated at the job site was a 2004 Scag brand Turf Tiger zero-turn mower, a model that weighs approximately 1,800 pounds (figure 3). The mower had a zero-turn radius and was capable of traveling at 12 mph. It was purchased without a roll over protection system, but it was equipped with a seat belt.

According to a representative for the employer, the user manual stated that the rollover bar was optional. The owner's manual clearly stated that while the rollover bar was optional, it should be used if the mower was to be operated on slopes or inclines to ensure operator safety.¹

Figure 3. Stock photo of a Scag brand Turf Tiger zero-turn riding lawn mower without ROPS installed.

Recommendation No. 2: To prevent rollover injuries, riding lawn mowers should be equipped with roll-over protective structures (ROPS) and seat belts.

Equipping a mower with a ROPS and utilization of seat belts has shown to be effective in preventing serious injury and death due to overturns. This particular riding lawn mower model was available for purchase with a ROPS. It is strongly advised that riding lawn mowers be equipped with factory installed ROPS.

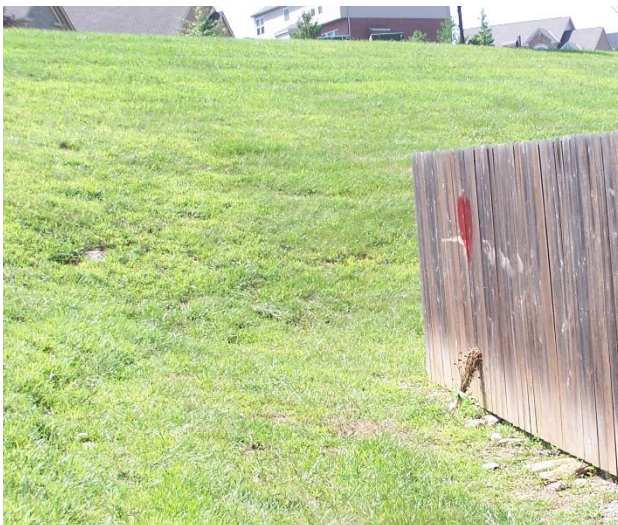
Figure 4. Flowers and a heart representing where the victim and overturned lawn mower were discovered.

The supervisor and two other landscapers left the victim to his mowing while they operated weed trimmers in other areas. Upon returning to the victim's area at 10:28 am, they found the victim under the mower at the bottom of the hill against a wooden fence (figure 4). The supervisor, with the assistance of the other landscaper workers, rolled the mower off the victim, checked for vital signs and found none. The landscapers called 911 at 10:29 am and notified the company. It is unknown how long the victim had been under the mower before the supervisor and the other landscapers found him. The victim was pronounced dead at the scene by the coroner at 11:30 am.
