## Tree Trimmer Electrocuted and Dies While Trimming Tree Away from Power Lines

### CASE SUMMARY

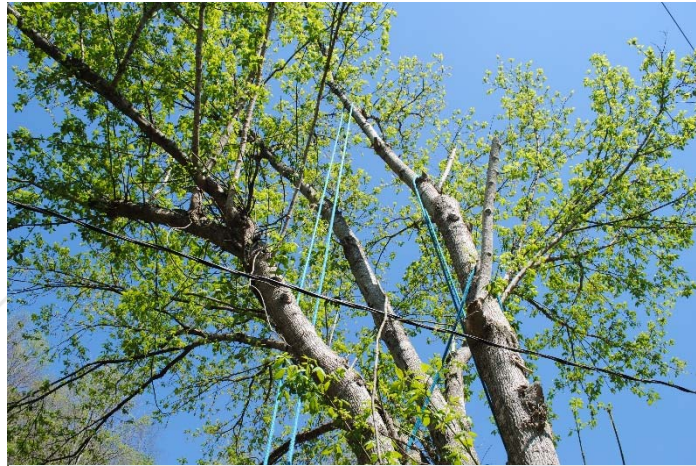
On Monday, April 18, 2016, a 23-year-old male tree trimmer (victim) was strapped into a personal fall arrest harness while trimming trees along a 34.5 kilovolt power line at a height of approximately 25 feet 4 inches from the ground. As he was cutting a limb growing at a 75-degree angle to the ground, it is believed that the limb made contact with the power line as the victim was trimming it, resulting in a fatal electric shock. The victim was found dangling from the tree by his fall arrest system, and was pronounced dead at the scene at 11:00 am.

**Figure 1.** Tree the victim was trimming when he was electrocuted.

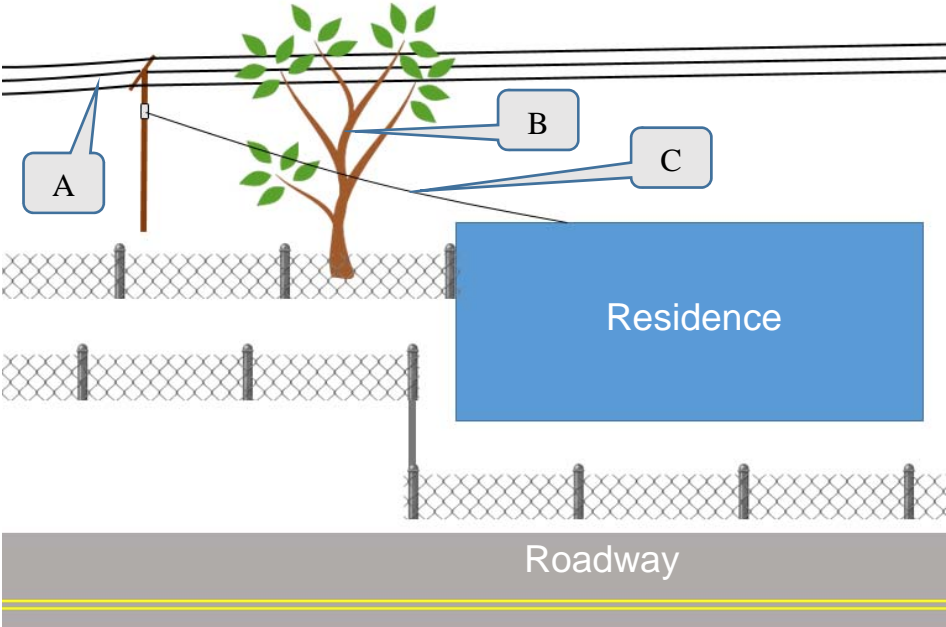
**Figure 2.** Diagram of incident scene (not to scale). Primary power lines (A), tree the victim was trimming (B), and insulated service line (B).

The incident occurred on a rural residential property positioned along a two-lane state highway. Three primary power lines (figure 2A) ran parallel on the back side of the property and provided electricity to local residences along the road. The power line that resulted in the fatal shock registered at 34.5 kilovolts. An insulated service line (figure 2C) originated from a transformer on the utility pole directly to the house. Directly behind the house, the ground sloped down towards a river that was lined with brush to be cleared by the landscaping services company. Near the top of the slope and behind the property’s chain link fence was a 48 ½ ft. tall box elder tree with branches that grew in close proximity to the nearby power lines (Figure 2B).

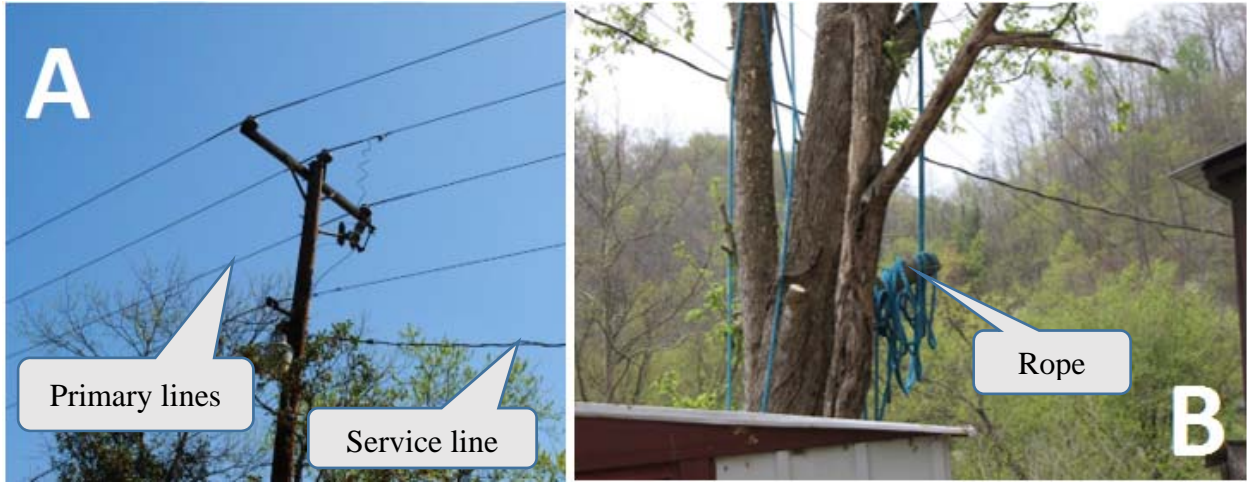
**Figure 3.** Utility pole that ran power lines behind home (A); climbing rope for victim’s fall arrest system (B).

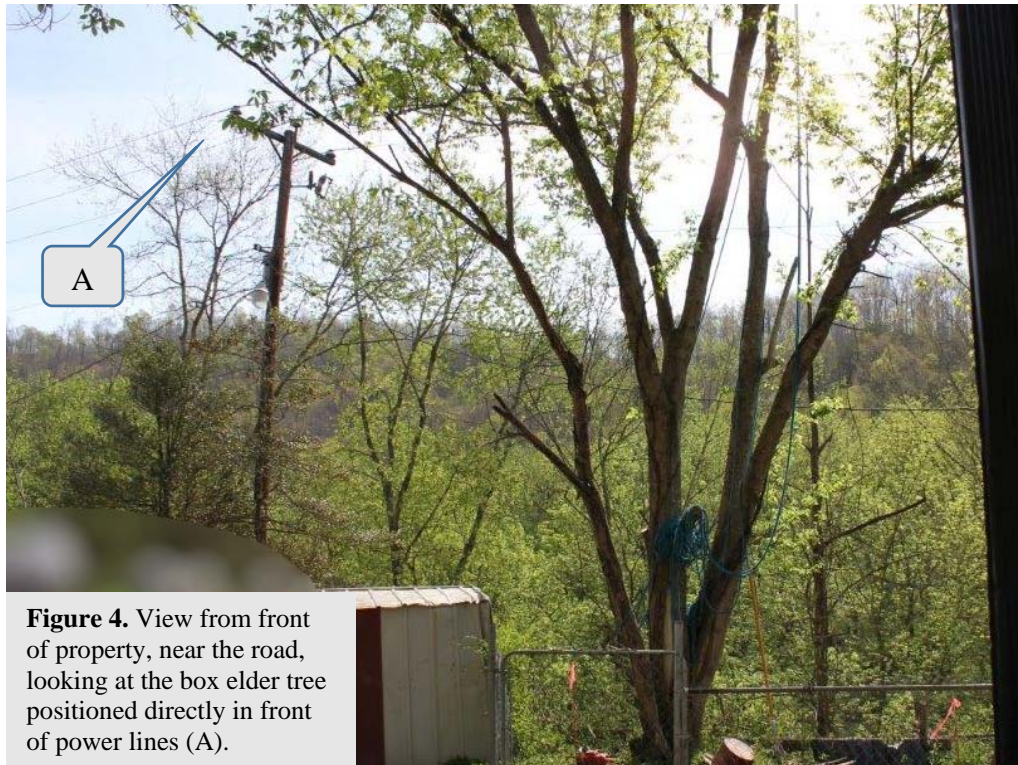
**Figure 4.** View from front of property, near the road, looking at the box elder tree positioned directly in front of power lines (A).

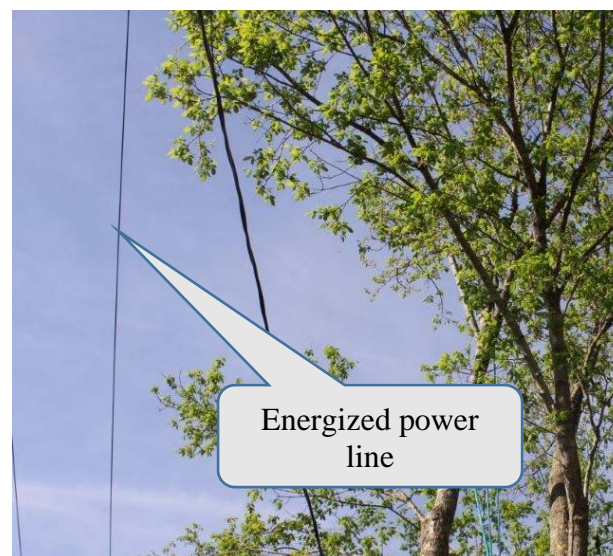
The victim assigned the other tree trimmer to use a chain saw and cut brush on an embankment 15 feet below the base of the tree. Equipped with an insulated pruner pole and a chain saw, the victim rigged his climbing rope, secured his fall arrest harness, and climbed the tree. While he was wearing leather work gloves, they were not insulated rubber gloves that are designed to protect from energized sources. When the victim reached a height of approximately 25 ft. 4 in. from the ground, he began cutting a 2-inch diameter limb growing at an approximately 75-degree angle to the ground with the chain saw. Investigation of the scene indicates that the limb moved toward and made contact with the 34.5 kilovolt power line as the victim was holding it. This resulted in the victim sustaining electrocution.

**Figure 6.** Energized power line in proximity to the tree's branches.

***Recommendation No. 1: Insulating equipment, such as insulating rubber gloves and sleeve combinations, or insulated power line sleeves, should be used when tree trimming work is to be performed within the minimum approach distance (MAD).***

Employers are required to establish minimum approach distances (MAD) that are no less than those mandated by OSHA (refer to tables in reference 3 to compute these distances). Additionally, employers are required to restrict employees from removing branches or handling any items which come within the MAD unless the employee is insulated from the energized source or the energized source itself is insulated prior to beginning work.<sup>2</sup> The use of rubber insulating gloves and sleeves together fulfill this requirement. The victim in this incident was holding a tree limb that came within the MAD of the uninsulated power lines. Wearing rubber insulating gloves and sleeves may have prevented the electrical current from travelling through the victim’s body and causing the fatal shock. Alternatively, the energized power line should be insulated prior to beginning work. Employees who lack line insulating resources should contact the local power utility provider to request that sleeves be installed prior to beginning work.

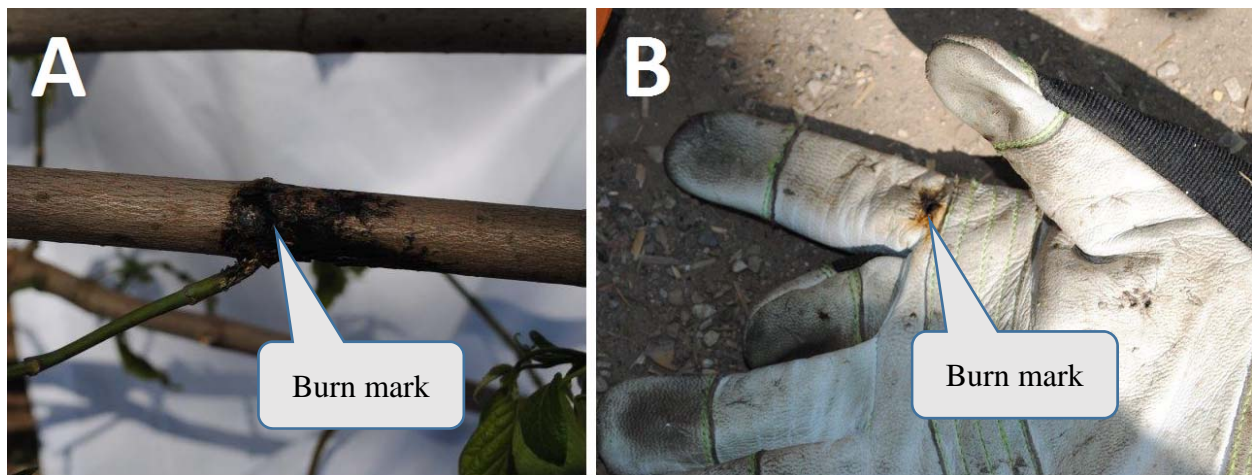
**Figure 7.** One of three burn marks on the branch (A); burn mark on the victim's glove (B).

According to the official preliminary investigation of the scene, a tree limb measuring approximately 15 ft. 4 in. was found lying beneath the tree in the victim's working vicinity. The tree limb had burn marks in three different locations: one at 1 ft. 2 in., one at 1 ft. 7 in., and one at 11 ft. from the branch's end. Additionally, burn marks on the victim's gloves indicated contact with a high electrical voltage source (Figure 7B). The locations of the burn marks on both the branch and the gloves suggest that the victim was holding the branch as he sawed it from the tree, and the branch came into contact with the exposed 34.5 kilovolt power line.

hand work.”<sup>2</sup> The victim was not wearing rubber insulating gloves, the exposed power line was not insulated, and he was in contact with other conductive objects when the branch he was holding came into contact with the power line. While the victim was wearing leather work gloves, they were not sufficiently insulated to prevent electrical shock, as evidenced by the burn marks (Figure 7B).
