School Custodian Struck and Killed by Pick-up Truck on School Grounds While Performing Crossing Guard Duty

CASE SUMMARY

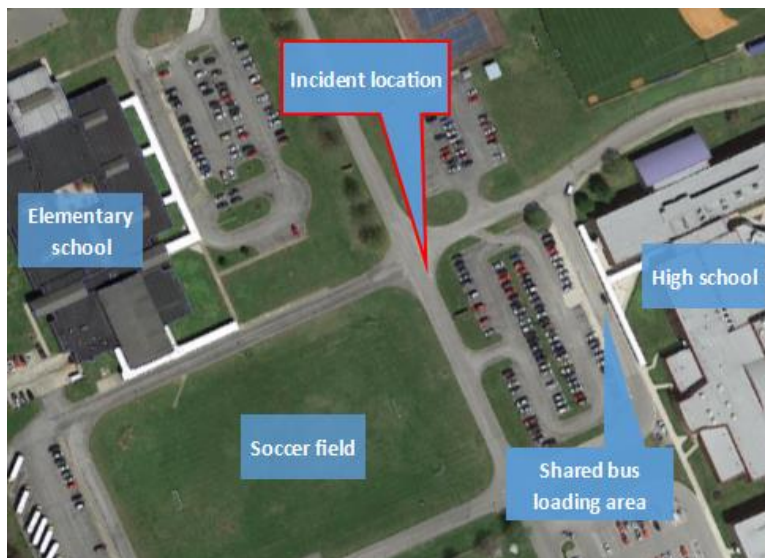
Figure 2. Aerial view of the school grounds; the victim was struck in an intersection connecting drivers to the high school, elementary school, and soccer field. The red line denotes the approximate walking path of the victim, starting at the high school.

The incident occurred in the intersection of two access roads which connected drivers to an elementary school, a high school, and a practice soccer field (see Figure 2). The posted speed limit in this area was 15 miles per hour. On the day of the incident, the victim was to perform crossing guard duties in this intersection, so that children from the elementary school could safely reach the shared school bus access area in front of the high school. The intersection where the victim was struck did not feature crosswalks, sidewalks, or other crossing safety features (see Figure 3, A and B).

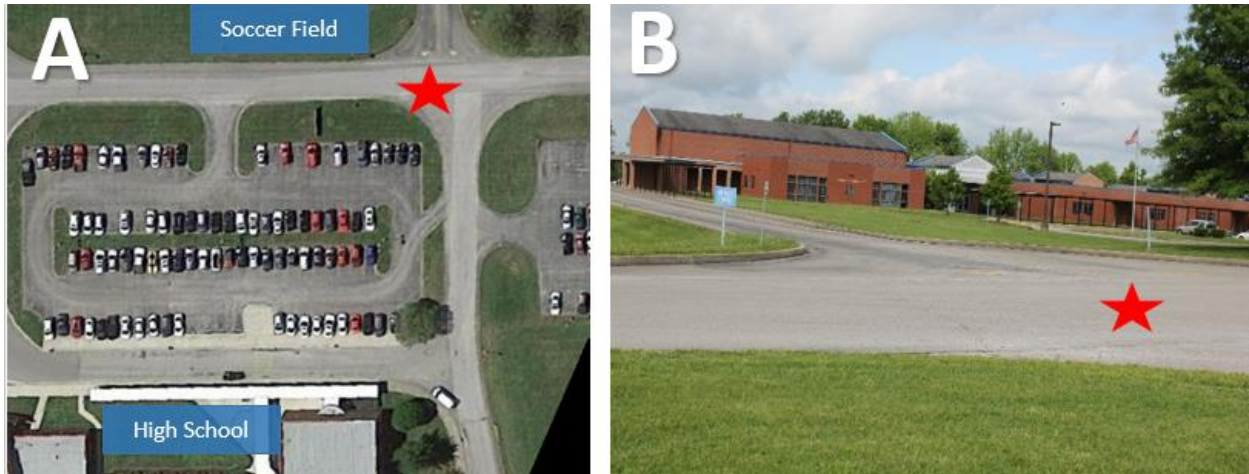
Figure 3. Aerial view of the school grounds (A); view of intersection where victim was struck, looking towards nearby elementary school (B). The red star in each photo denotes the approximate location at which the victim was struck.

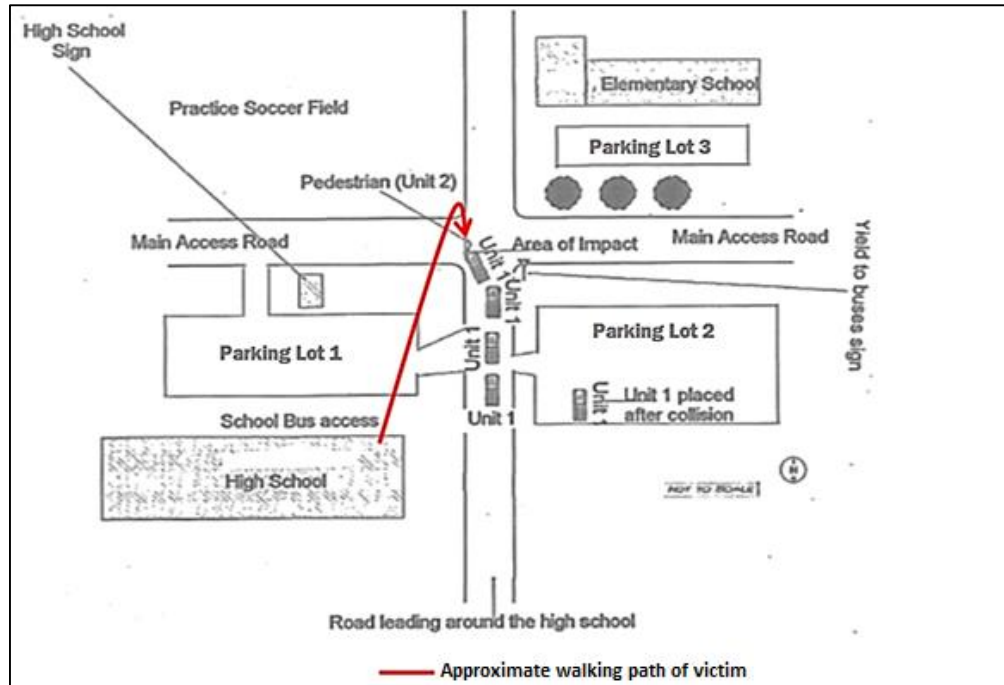
Figure 4. Incident diagram of the scene and the fatal incident. The red line indicates the walking path of the victim. Unit 1 was traveling away from the high school and turning left onto the main access road when the victim was struck. (source: *Kentucky Highway Patrol*).

Equipped with his high visibility safety vest and handheld stop paddle, the victim exited the main high school building and spent a few minutes talking with several employees, who were waiting in front of the high school for buses to line up and students to begin loading. After saying his good byes, he walked toward the intersection separating the elementary school from the high school where he would perform his crossing guard duties. He took his normal route of walking through the faculty parking lot (Figure 4, Parking Lot 1).

During this time, a fellow school employee was in his Chevrolet pickup truck traveling next to the high school and toward the intersection (Figure 4, Unit 1). The fellow school employee had stopped and talked with two co-workers before preceding towards the access road intersection. There was no stop sign but a yield to bus sign in this intersection. The victim had almost crossed the main access road when, according to witness account, he abruptly reversed direction and walked back across the road into the direct path of the Chevrolet pick-up truck that was making a left turn (Figure 4, red line). The fellow school employee said that he had just looked to his right for traffic clearance and was traveling less than 5mph, when he felt a bump and witnessed the victim stagger and fall straight backwards. He immediately exited the truck to help the victim.

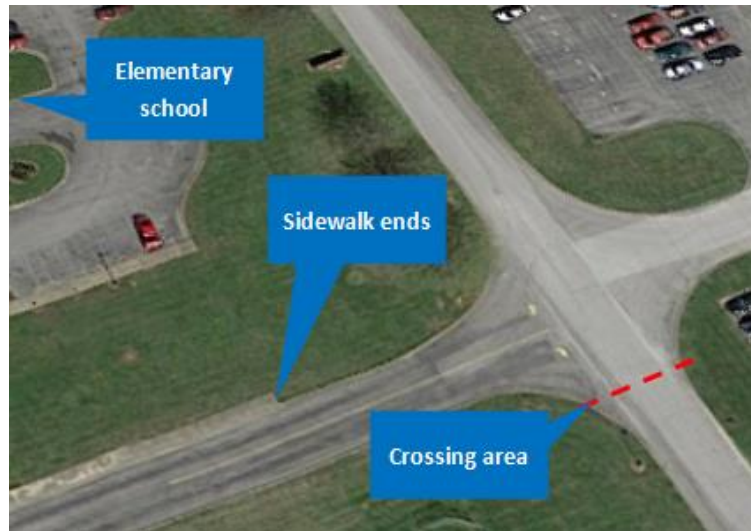
Figure 6. Intersection and crossing area. The elementary school crosswalk did not extend to the intersection.

Both the high school and the elementary school main entrance areas had sidewalks and crosswalks connecting to the nearest parking lots; however, the intersection where the victim was struck did not feature sidewalks, crosswalks, or other pedestrian safety features. A sidewalk extending from the elementary school stopped short of reaching the intersection. Although there was a ‘yield to buses’ sign in the side of the intersection from which the pickup truck driver was traveling, there were no stop signs in the intersection. The four-way intersection should have featured stop signs since children and other pedestrians were expected to cross. School personnel indicated that buses and other vehicles often traveled in this intersection. The speed limit on the school campus was 15mph; the crash report did not state the estimated speed of the driver at the time of the crash.

Recommendation No. 1: Schools should provide a walkable campus by installing sidewalks, crosswalks, stop signs, and other safety features in areas where pedestrians might be exposed to traffic.

A 2008 report by the National Highway Traffic Safety Administration found that roadways lacking crosswalks accounted for 42 percent of all pedestrian fatalities from 1997-2006.¹ Sidewalks and crosswalks should be planned, designed, and installed to facilitate safe walkability and roadway crossing in areas where pedestrians are exposed to passing traffic. Sidewalks should be regularly repaired and crosswalk stripes repainted so that they are readily visible both to pedestrians and motorists. To further protect pedestrians, pedestrian crossing warning signs should be placed in advance of crosswalks to alert approaching motorists, and stop lines should be painted on the road as a stopping point for motorists. This incident may have been prevented if such pedestrian safety features had been in place.
