REPORT#: 17KY007

Dry Wall Supervisor Falls from Unsecured Plank

State **FACE** Program

Fatality Assessment & Control Evaluation

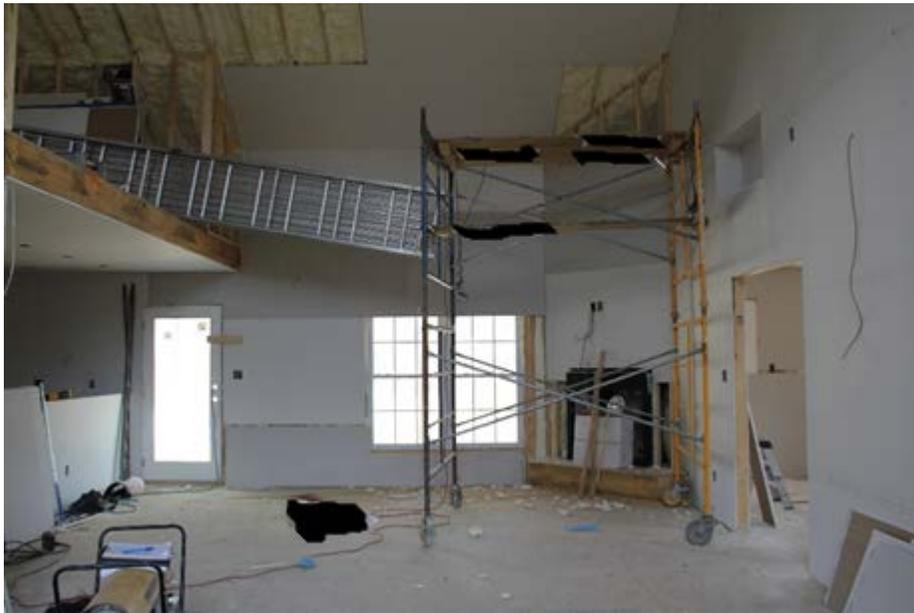
Figure 1. Scaffold and plank from which the victim fell

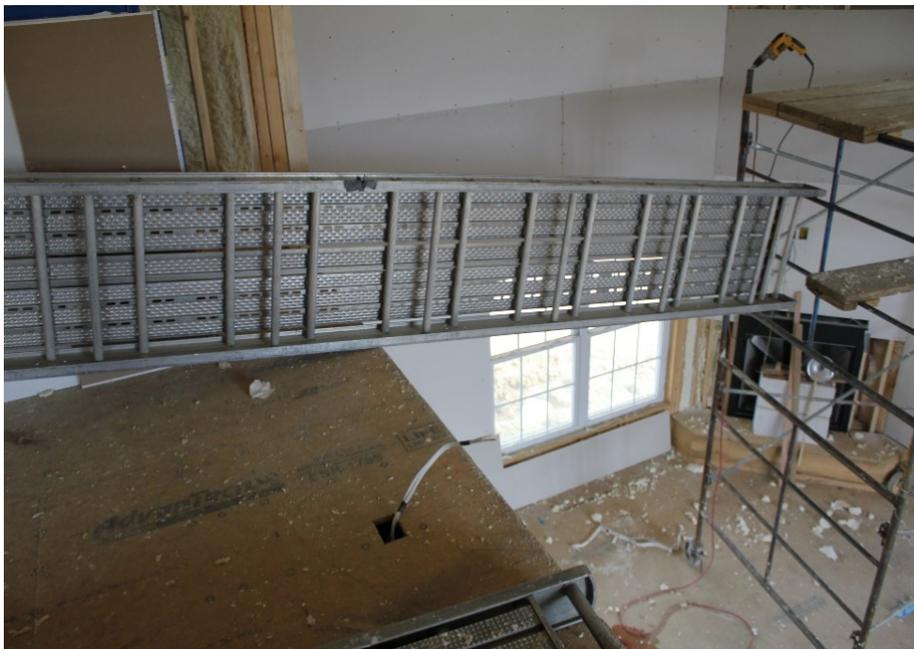
Figure 2. Position of the plank after it had flipped onto its side. Photo taken from loft area

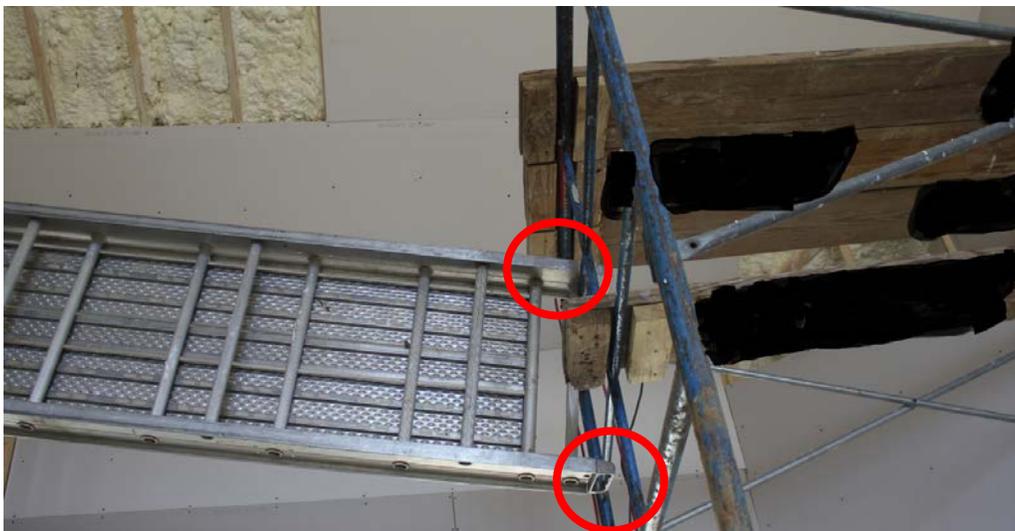
Figure 3. Position of the plank after the accident. Note the lack of attaching hooks (circled)

Discussion: The supervisor was using a metal walk plank for the purpose of accessing the elevated loft area via the scaffold. The intended purpose of this particular metal plank was to be used as a stair ramp for moving materials into the house, and was not meant to be used as part of a scaffold. Even if the employee had been using an approved scaffold extension, according to OSHA regulation 29 CFR 1926.452(w)(6)(v)(7)³, *“no employee is on any part of scaffold which extends outward beyond wheels, casters or other supports.”* In order to use platforms that extend outward beyond support, the scaffold must use outrigger frames or equivalent devices to ensure stability.

Recommendation #3: Employers should ensure scaffolds are fully planked or decked.
