REPORT#: 17KY034

REPORT DATE: 6-29-2018

Dump Truck Driver Loses Control and Flips Truck Resulting in Fire

State **FACE** Program

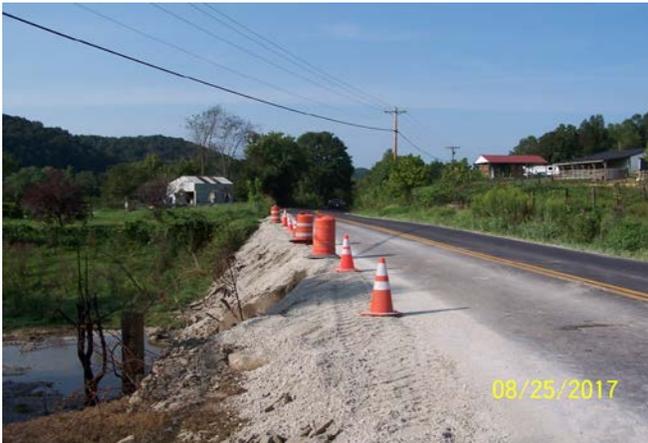
The incident took place on a rural two-lane state highway without guardrails. An eight-foot steep embankment dropped off from the right shoulder of the road. The Sheriff's department referred to this culvert as a cattle crossing, where rock and rebar protruded from concrete retaining walls. The state highway on which the truck travelled posted a 55 mph speed limit; however, prior to entering the curve, an advisory speed limit sign was posted, recommending 35 mph. Advisory speed placards are not regulatory signs; they are warning signs. The curve warning sign indicated that vehicles should slow down to navigate the curve safely.

Photo 1: Embankment at the crash site. Barrels and cones added post-incident.
(photo property of KY FACE)

Recommendation #3: State roadway maintenance branch should consider guardrails for drop-offs steeper than 3:1.

According to the Kentucky Transportation Cabinet Division of Highway Design, a trained engineer uses American Association of State Highway and Transportation Officials (AASHTO) roadside design guide to determine if a guardrail is needed. A slope steeper than a 3:1 warrants the consideration of guardrail.

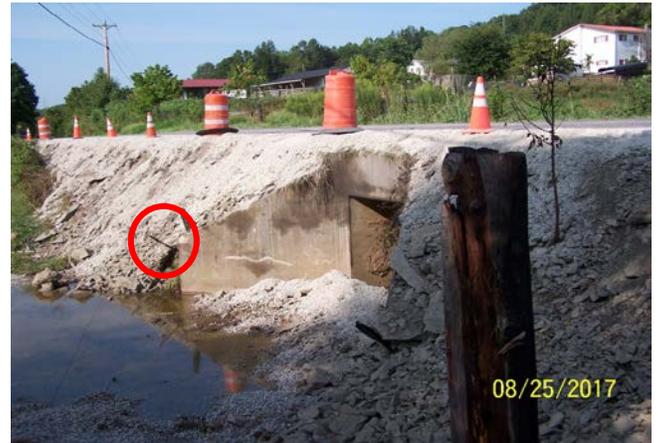
Photo 2: Rebar that the fuel tank struck. (photo property of KY FACE)

The truck left the roadway on the passenger side and flipped onto its right side into the culvert eight feet below the highway. As the truck flipped, the fuel tank struck a piece of rebar that was protruding from the concrete retaining wall leading to a water drainage tunnel under the highway. The fuel tank ruptured, causing a small fire in the engine that rapidly began to spread as fuel leaked from the tank.

Recommendation #5: The Kentucky Transportation Cabinet should consider a campaign to educate landowners on how to file a roadway maintenance repair request.

Discussion: According to the Kentucky Transportation Cabinet’s (KYTC) website page concerning roadway maintenance, the roadway maintenance branch is responsible for several programs, including “Contract maintenance activities such as upgrading existing roadside guardrail, drainage structure maintenance and replacement, concrete pavement repair, slide repair, asphalt patching and other miscellaneous maintenance contracts as required”⁸. Generally speaking, culverts are hydraulic conduits used to convey water from one side of a highway entrance to the other for the purpose of drainage, making their repairs the responsibility of the KYTC. In this incident, a single piece of rebar measuring approximately 16 inches was protruding from what is referred to as a ‘box culvert’ - a rectangular four-sided concrete structure used in managing and storing storm water. According to the Kentucky Division of the Federal Highway Administration, in instances when small culverts run on a private landowner’s property, it is the responsibility of the landowner to inform the KYTC of structural deficiencies. The KYTC would then travel to the site and make repairs. An open records request filed by the KY FACE team revealed that no repair request for this particular culvert was submitted. In order to prevent similar incidents from occurring in the future, the KYTC should consider a campaign to educate landowners on how to file maintenance requests via the KYTC website when a road, bridge, or culvert that runs on the owner’s property is in obvious disrepair. Had the landowner informed the KYTC of the protruding rebar, it is possible the repair would have been made prior to the incident and subsequent fire.

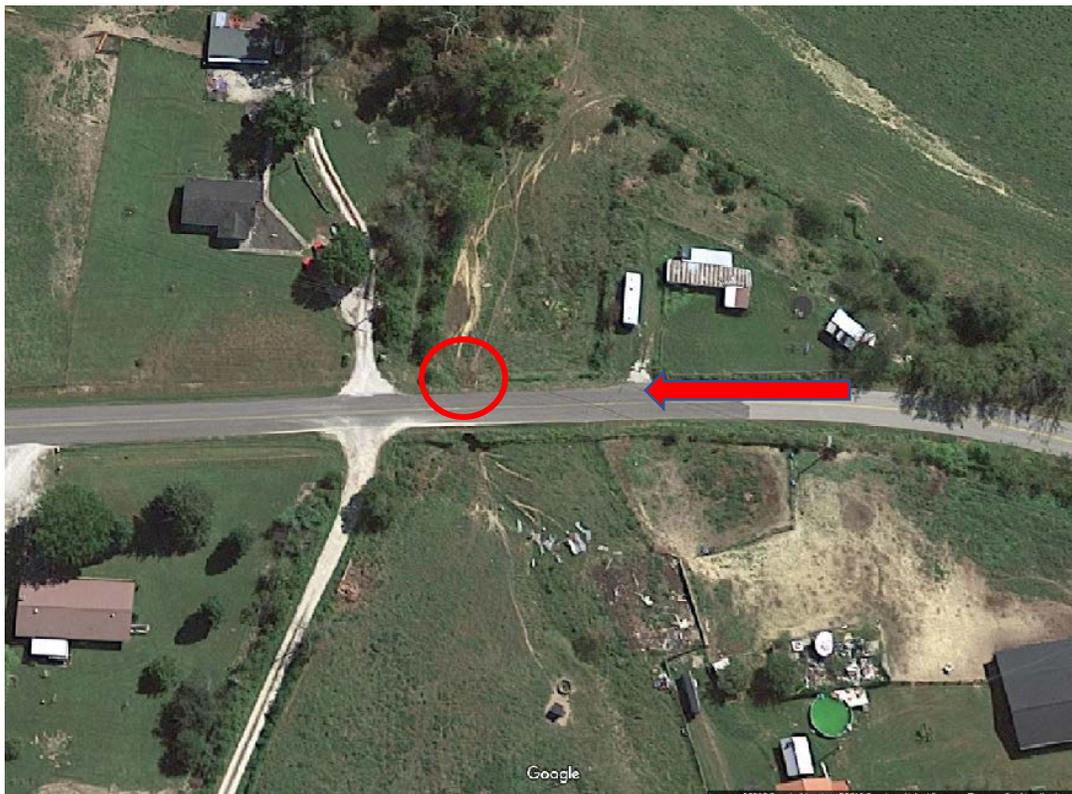
Photo 3: Aerial view of crash site. Circled area shows final resting spot of the overturned truck. (photo courtesy of Google Maps)
Arrow shows direction of travel

Tire marks suggested the truck gradually drifted to the right, went off the road and into a small ditch area. The driver attempted to drive out of the ditch 224.10 feet from the final resting spot of the truck. The deputy sheriff stated the truck driver was traveling over the recommended speed limit of 35 mph. While the speed limit along the state road was posted at 55 mph, the curve was posted at 35 mph with an advisory speed sign prior to the curve. As the victim entered the curve, neighbors who lived in the vicinity stated they heard the driver trying to apply the truck's compression release engine brake – commonly referred to as a Jake brake - in an attempt to slow the truck. The deputy stated the Jake brake failed to slow the truck to a safe speed, causing the loaded truck's center of gravity to shift toward the passenger side, and the driver to lose control of the vehicle.

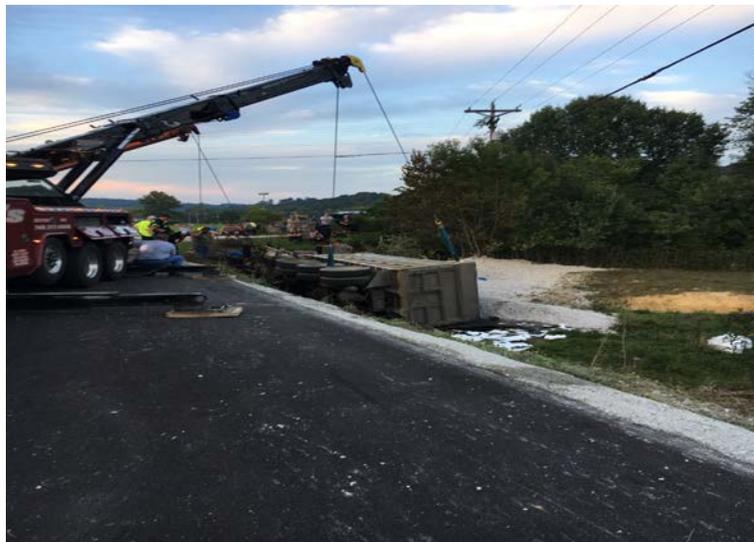
Two neighbors, a husband and wife who heard the crash and saw the smoke from their residence, ran to assist the driver. When they arrived and noticed the fire, the husband desperately tried to pull the unconscious driver out of the burning truck through the front windshield that had become dislodged, while his wife called for emergency assistance and the fire department. The couple stated the driver was thrown and trapped along the passenger side of the truck where the flames were hottest, making it impossible to pull his unconscious body from the burning truck.

Photo 5: Crashed dump truck. (Photo courtesy of witness)

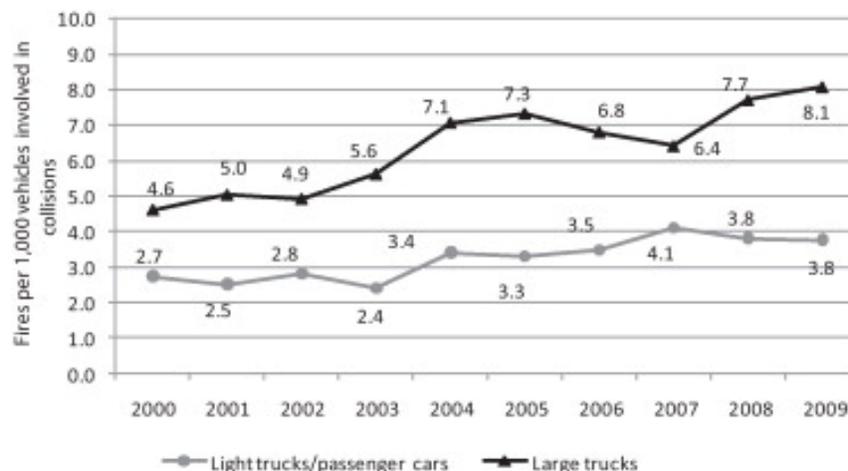
Fig. 1. Vehicle fire rates due to motor vehicle collisions, 2000–2009.

Discussion: Large truck manufacturers should consider an engineering redesign and new placement of fuel tanks within all trucks. With the high number of truck crashes that result in fire, this redesign could save lives as well as equipment. According to the Bunn et al. (2012), large truck vehicle fire rates in Kentucky were significantly increased when compared to light trucks and passenger cars.⁶ The study recommended the fuel tanks would be better protected within the truck body and not exposed.

The article states, *“There could be many reasons for large trucks being more likely to catch fire in a motor vehicle collision. The average large truck weight (typically up to 80,000 pounds) can result in a greater impact force in collisions with a fixed object. There are fuel tank placement differences between large trucks, and light trucks, and passenger cars, which could account for fire likelihood differences between vehicle types in head-on and single vehicle collisions. Increased exposure occurs in large trucks because the two fuel tanks on the semi-tractor are exposed under the cab and are located directly behind the front axle.”*

Recommendation #4: Large truck manufacturers should consider re-design and placement of fuel tanks.
