REPORT#: 18KY024

REPORT DATE: 11-12-18

Dump Truck Operator Electrocuted After Truck Bed Contacts High Voltage Line

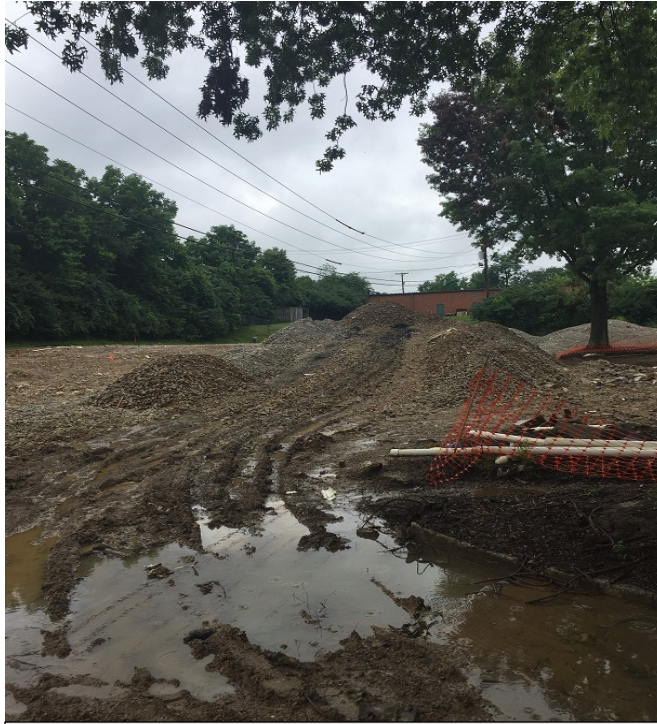
The incident took place on a construction site on which a set of townhouses had recently been demolished. Because of the amount of debris and displaced soil, a pile of rubble measuring three feet in height was present. Due to the saturated ground and the weight of the vehicle, the victim would often drive his dump truck onto the pile of rubble while performing his responsibilities. With the buildup of debris and the truck bed extended the full 24 feet, the top of the truck bed measured 27 feet from the ground. The overhead power lines that the dump truck contacted measured 24'9" from the ground because of the buildup of debris.

Photo 1: Incident site. Photo property of KY FACE.

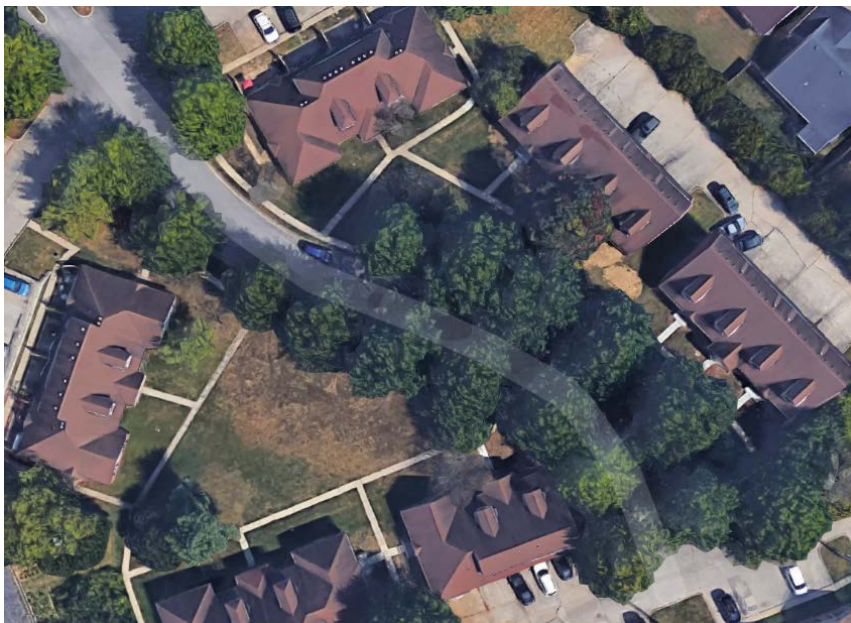
Photo 2: Overhead view of the worksite. All townhouses featured in photo were demolished at the time of the incident.
Photo courtesy of Google Maps.

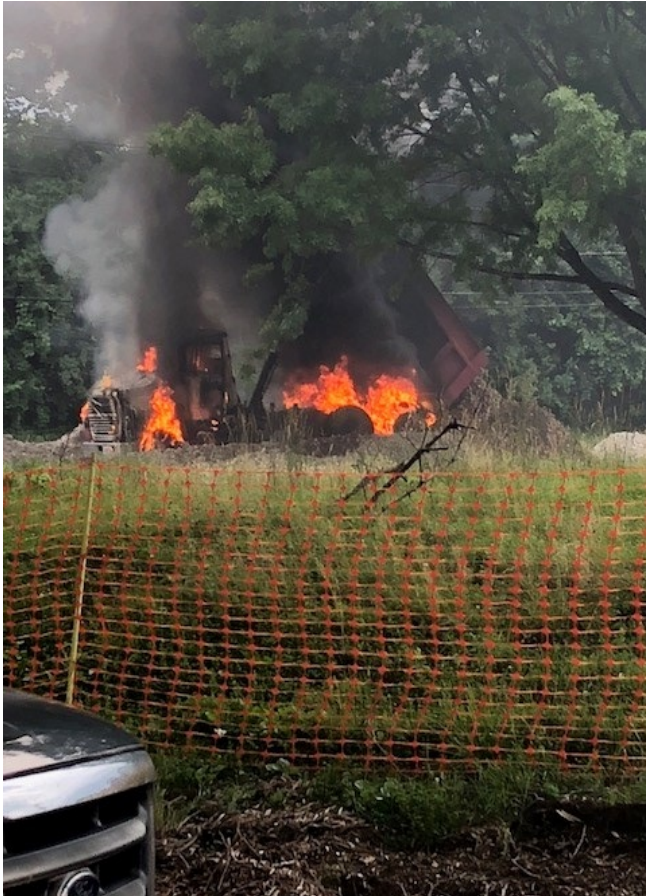
At approximately 4:35 pm, as the victim was raising the truck's bed, he slowly backed up to dump a load of large concrete debris into the rock crusher. As the bed of the truck extended to its full raised height of 24 feet above the ground, it made contact with overhead electrical lines carrying 7,200 volts. This caused electricity to travel through the vehicle and catch the back tires of the truck on fire. Realizing the truck was on fire, the victim honked the horn to attract the attention of his brother-in-law who was getting a drink of water. The brother-in-law saw that the truck's tire had begun burning, and ran towards the truck. The driver, after getting his co-worker's attention, attempted to exit the vehicle in order to escape the flames. The victim opened the door, stepped onto the metal running board with his hand on the exterior of the truck, stepped off with one foot, and contacted the ground. Due to being in contact with both the ground and the electrified dump truck, the victim became grounded, completed the circuit, and was immediately electrocuted. The victim's co-worker and employees from the primary construction company were able to pull him away and doused him with a fire extinguisher to put out the flames on his body. The victim sustained charred electrical burns as well as thermal burns caused by his blue jeans catching on fire. The electrical current entered and exited his feet and hands.

Photo 3: Dump truck while burning.
Photo property of KY FACE.

Recommendation #4: Stay in the vehicle and call 911.

Discussion: When a vehicle contacts electrical power lines, best practice is for all passengers to remain in the vehicle and call 911. Due to the high voltage carried within power lines, electrical current can easily travel through the vehicle and into the ground below, electrifying a radius of up to 30 feet from the vehicle. In this instance, one of the dump truck’s tires caught fire, requiring the victim to exit the vehicle before the power could be disconnected. In situations where employees must exit a charged vehicle, it is recommended to jump away from the truck as far as possible with both feet launching and then landing simultaneously. As you move away from the vehicle, do not lift your feet to walk. Instead, keep your feet on the ground and scoot away, not allowing the heel of one foot to move past the toe of the other. Continue this method until you are 30 feet from the vehicle. If a tingle is still felt in the body after 30 feet, continue shuffling away from the vehicle until you no longer feel this effect⁵.

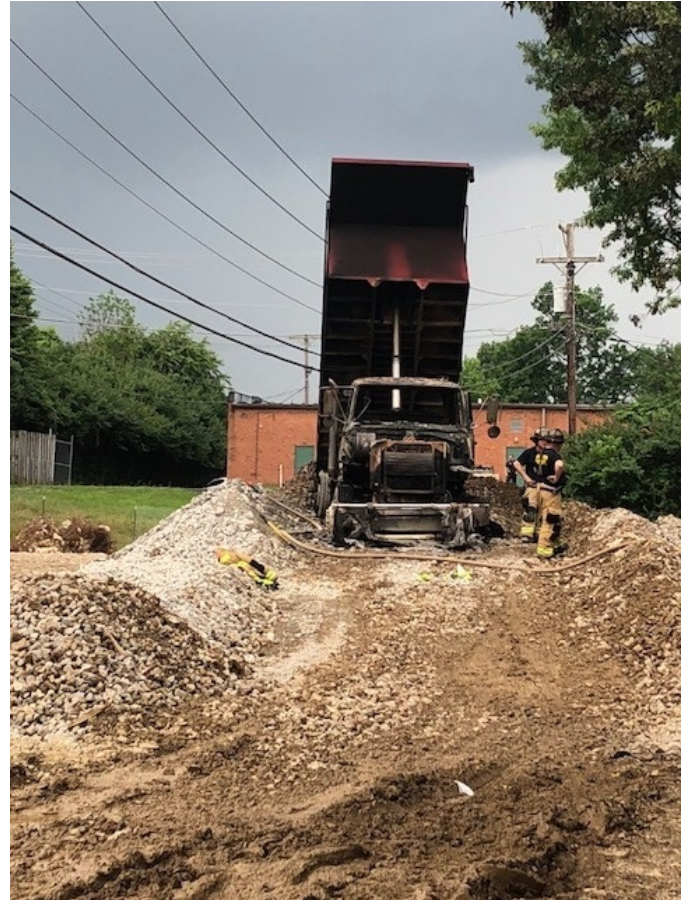
Photo 4: Dump truck post-fire.
Photo property of KY FACE
