REPORT#: 19KY047

Commercial Driver Dies after Overturning on Two-Lane State Highway

Fatality Assessment and Control Evaluation (FACE) Program

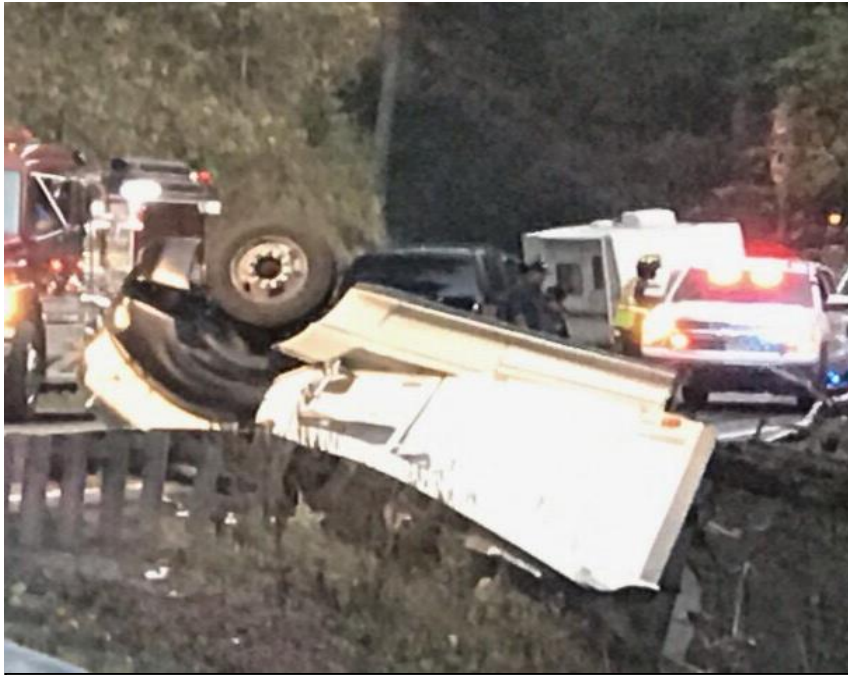
Photo 1. Photo of the semi-truck and trailer involved at the scene of the crash.
Photo retrieved from WTVQ.com (Photo was taken from the west)

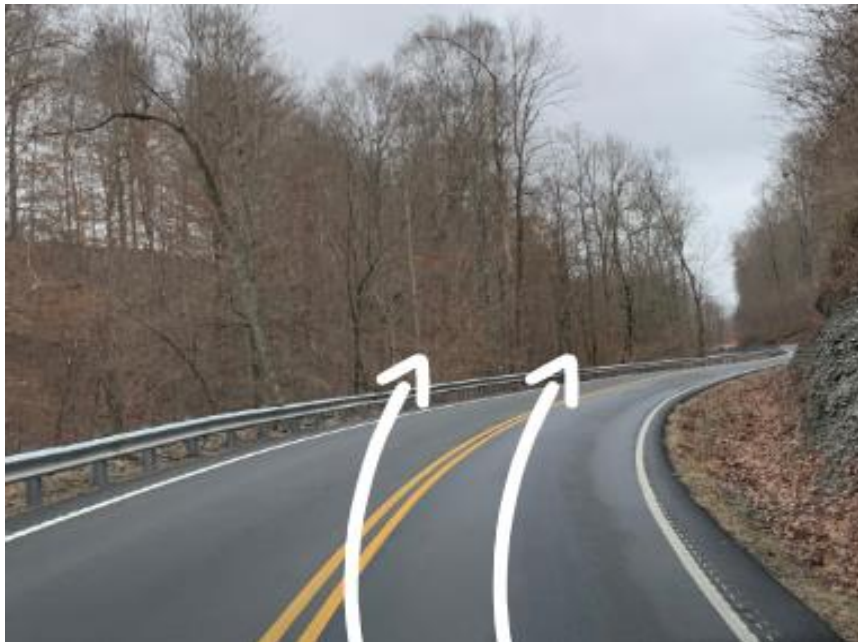
Photo 2. Photo with animation depicting the path the semi-truck and trailer traveled as it entered the west-bound lanes. Photo created by and property of KY FACE.

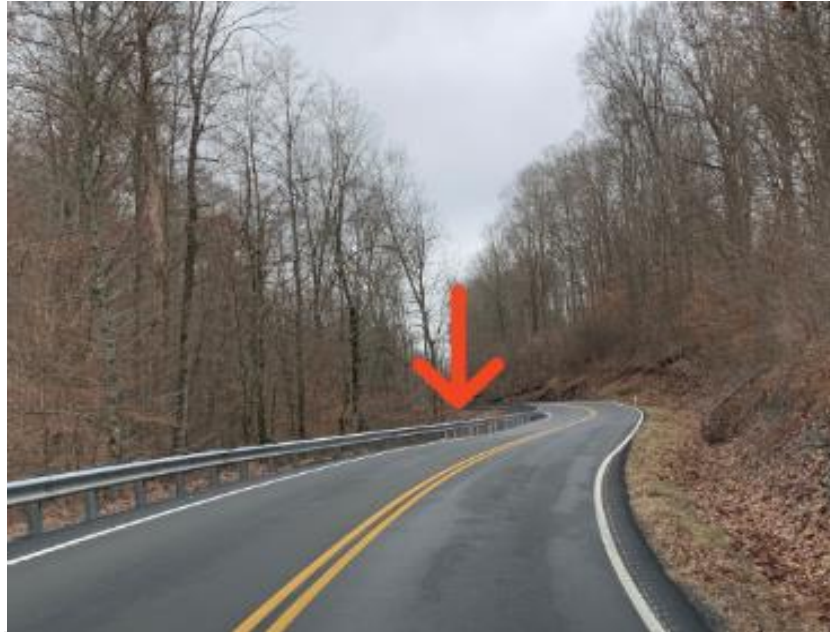
Photo 3. Photo representing the point in which the rear driver's side trailer struck and punctured the W-beam guardrail. Photo by and property of KY FACE.

The force of the impact punctured and compromised the guardrail, and the shifting weight of the cargo pitched the trailer off of the roadway. The trailer overturned as it descended down the embankment, subsequently pulling the tractor down and overturning it as it exited the highway down the embankment. The semi-truck came to final rest partially on the west-bound travel lane with the rear of the truck and trailer completely off of the roadway. First responders arrived on the scene of the crash at 6:37 AM. Upon approaching the vehicle, it was determined that the driver had succumbed to injuries sustained in the crash, and he was pronounced dead at the scene. Accident investigators determined the victim was wearing a seat belt.

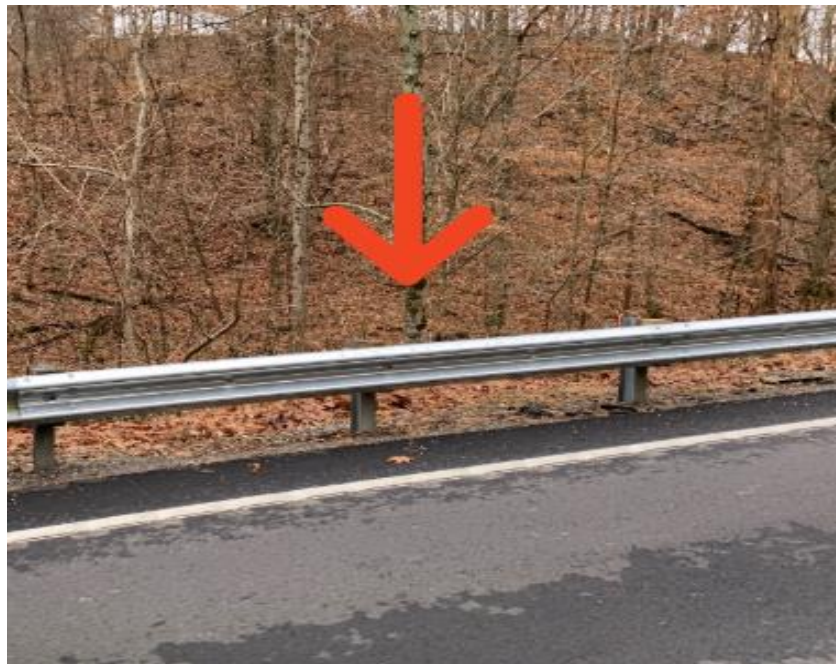
Photo 4. Photo of depicting the area the semi-truck and trailer overturned down the embankment. Photo by and property of KY FACE. (guardrail had been replaced when photos were taken)

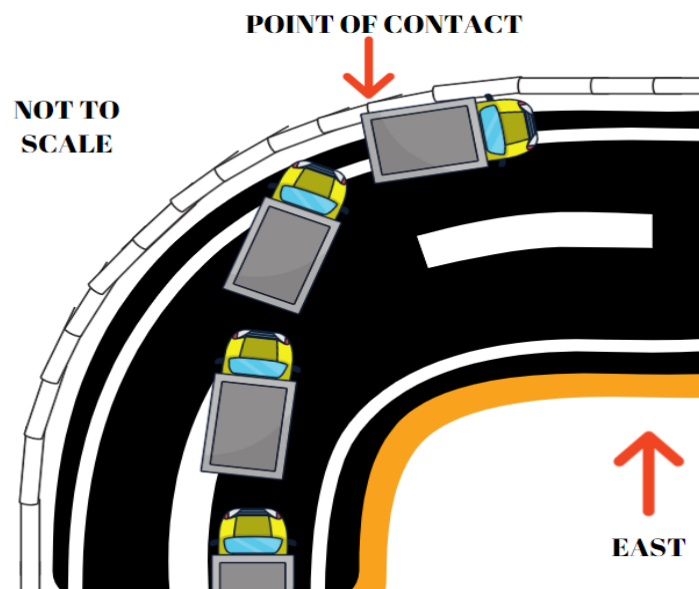
Diagram 1. Diagram showing the path the semi-truck and trailer traveled as it crossed the centerline and struck the W-beam guardrail before descending down the embankment. Photo created by KY FACE.

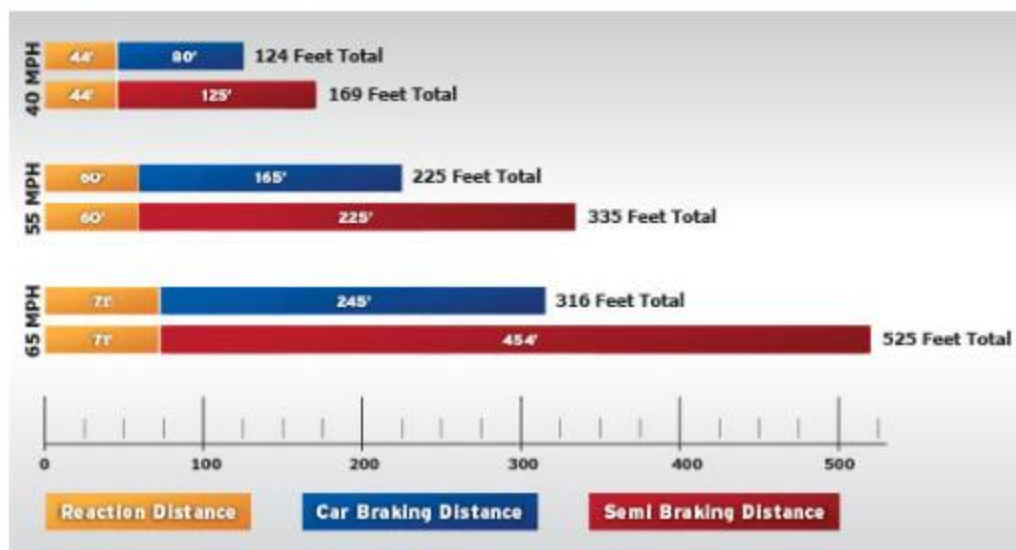
Taking these three factors into account, the below graph compares car braking distance to semi braking difference. At 55 MPH, the speed limit the victim was traveling, a semi-truck would need approximately 335 feet to come to a complete stop v/s a passenger vehicle needing only 225 feet.

Chart 2. Chart depicting car braking distances v/s semi braking distance⁸.

Considering commercial vehicle size, weight and increase stopping distance, the Kentucky Transportation Cabinet should consider assigning commercial vehicle specific speed limits to state highways.
