# Temporary Electrician Helper Steps into Unguarded Elevator Shaft and Dies

**Incident Number: 14KY039**

**Kentucky Fatality Assessment and Control Evaluation (FACE) Program**  
**Incident Number: 14KY039**  
**Release Date: September 28, 2015**  
**Subject: Electrician Helper Steps into Unguarded Elevator Shaft and Dies**

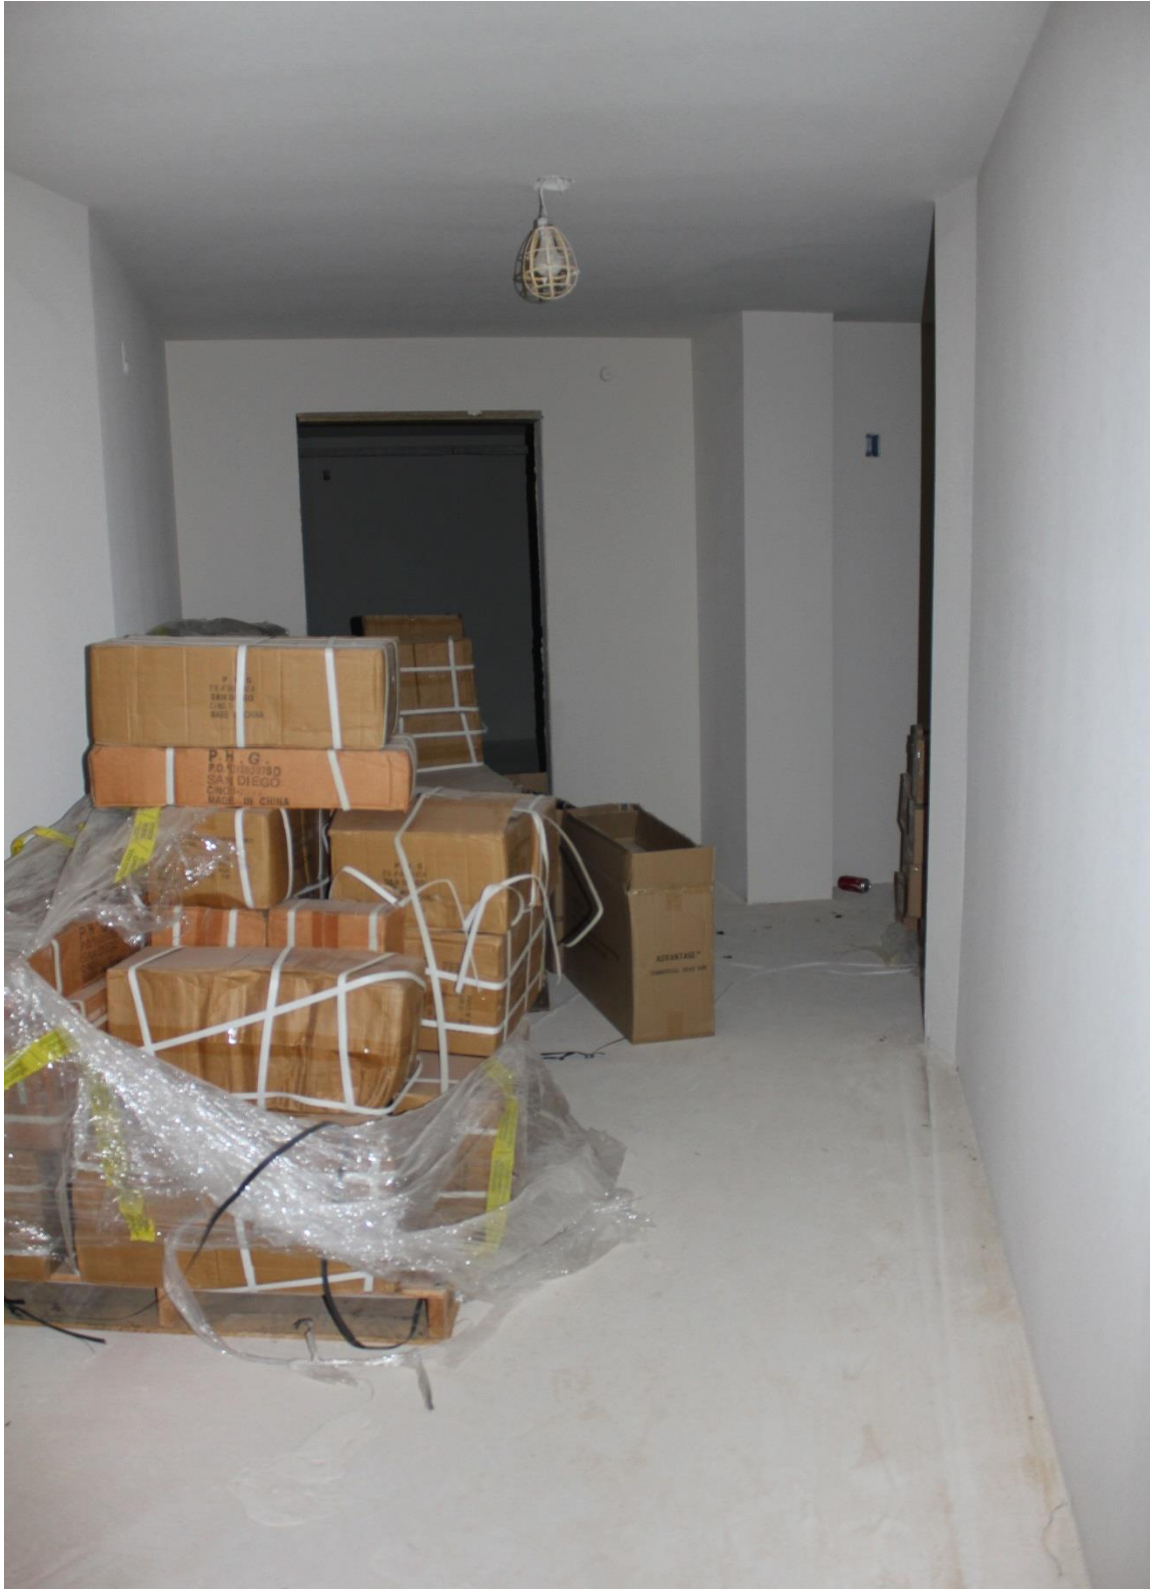
The scene was a commercial construction (four-story building) site. The elevator had yet to be installed, and the shaft opening was left open with no safety guards in place. The victim was laying out light fixtures to be installed in the second floor hallway by the elevator shaft. There was no lighting in or around the elevator shaft locations on the first and second floors. Footprints were observed on a small dusty pallet located in the passageway outside the 2<sup>nd</sup> floor elevator shaft, indicating that employees had to walk over the pallet to navigate through this crowded area.

Pallets and boxes cluttering the hallway work area.

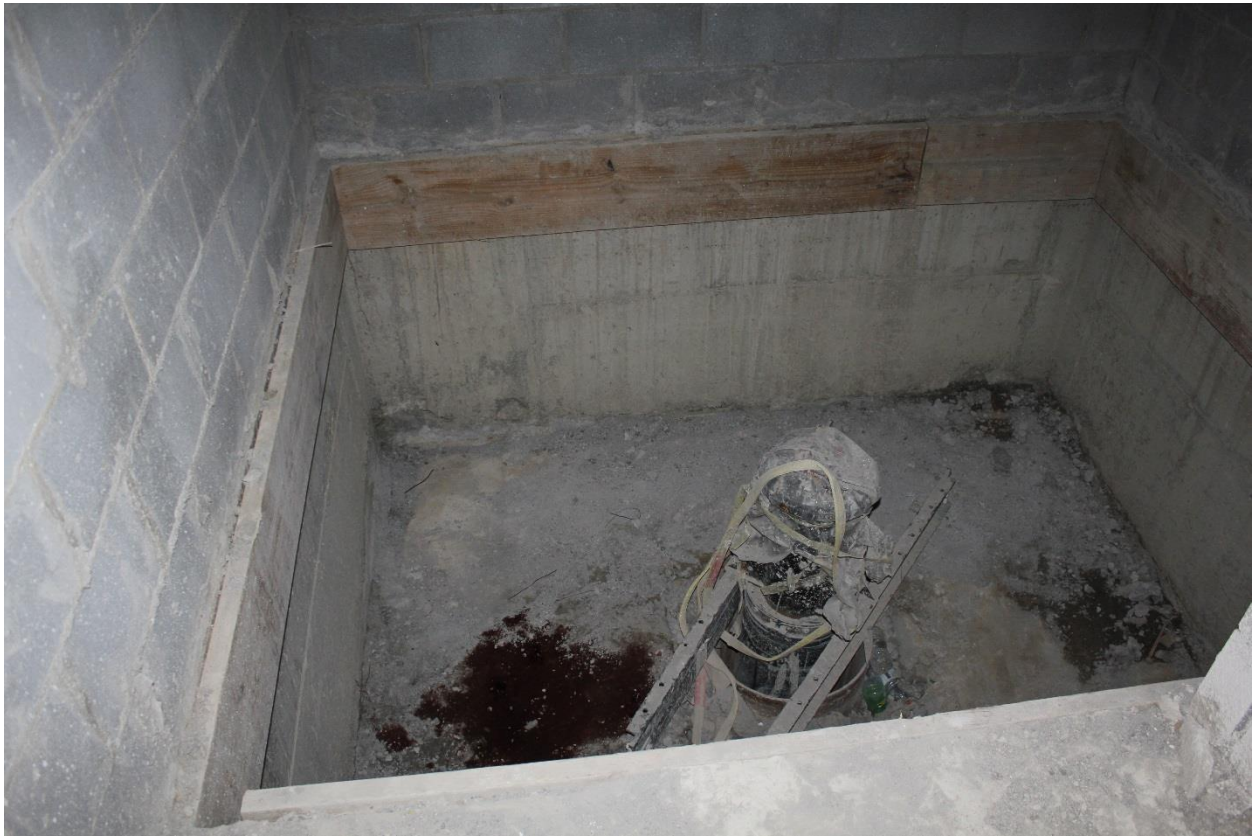
In this incident, the elevator shaft was not guarded. In compliance with OSHA 1910 standard for walking and working surfaces, employers must place guards around all openings where falls could occur. All exposed sides must be guarded following the standards.

First floor landing inside elevator shaft where the victim landed. Photo courtesy of KY OSH

#### **Recommendation No. 1: Employers should guard all open areas where falls could occur.<sup>1</sup>**
