Driver Exits Burning Semi-Truck and Falls to His Death

CASE SUMMARY

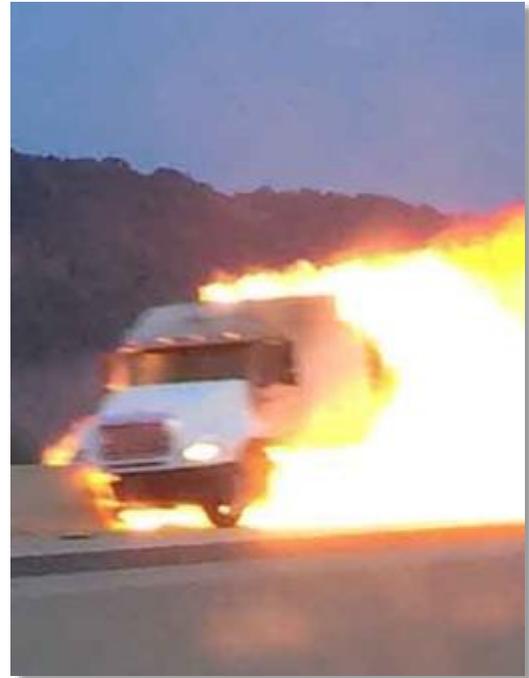
On Friday, June 8, 2015 a 52-year-old semi-truck driver was traveling southbound on a six-lane interstate. He suddenly braked hard and swerved to the right striking the right shoulder of a bridge concrete barrier wall spanning a river. The passenger side diesel fuel tank on the truck ruptured and caught fire as a result of the friction.

Figure 1. The semi-truck engulfed in flames following the incident.

On June 8, 2015, at approximately 6:15 am, a semi-truck driver drove southbound on a major interstate, lost control on a bridge, and struck the right shoulder concrete barrier bridge wall (see

figure 1). The vehicle rode the top of the barrier, which caused the passenger side fuel tank to rupture and catch fire. The vehicle came to rest several hundred feet down the roadway with the passenger side leaning over the bridge, continued to burn and then exploded (see figure 5).

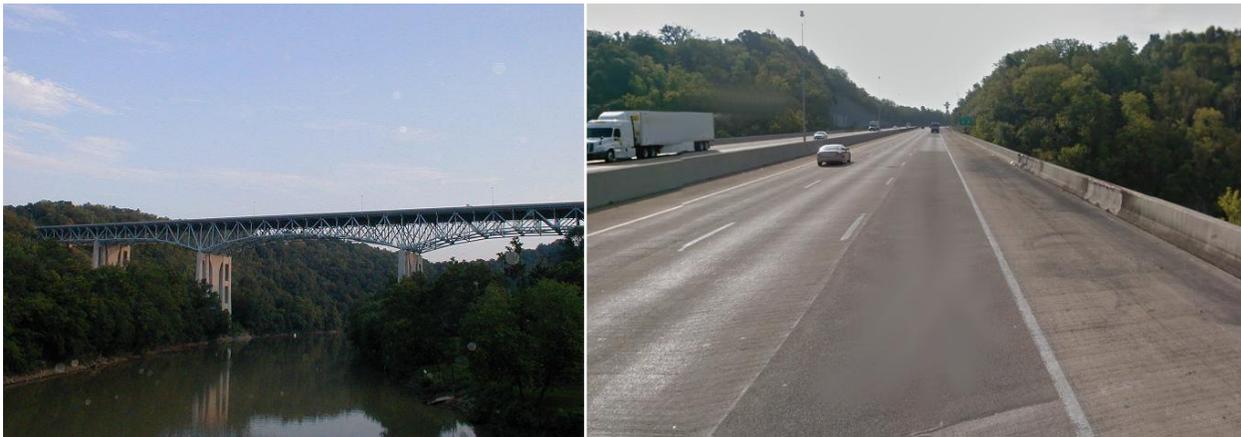
Figure 2. Interstate bridge where the incident occurred.

The incident scene was a southbound six-lane interstate bridge span, 250 feet above a major river. The stretch of roadway was clear and straight with barrier walls on each side and in the middle to divide the interstate. The bridge was lighted for nighttime travel. The tractor trailer was a 2006 Columbia 120 Freightliner.

Although the bridge span was well lit at night, the incident occurred at 6:15 am (dawn) which may have contributed to the driver being unaware of the large drop to the river.

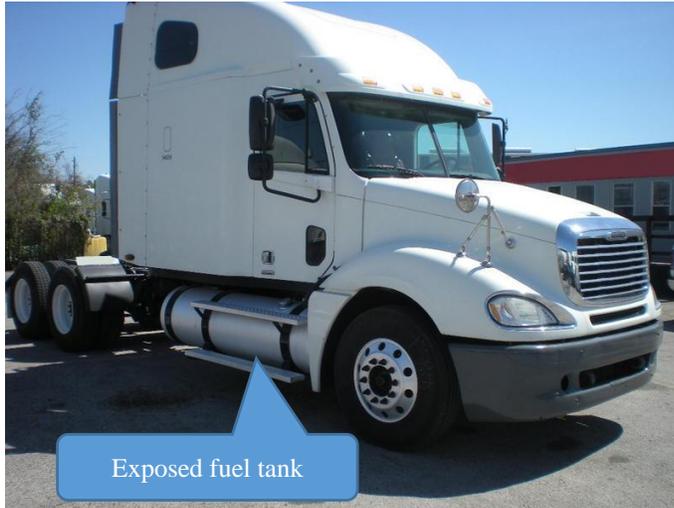
The equipment was a 2006 Freightliner Columbia 120 with dual side-mounted fuel tanks, one on each side. This type of design has been shown to make the fuel tank more susceptible to explosion during a collision. The truck was not equipped with a standard fire extinguisher.

Figure 3. Stock photo of a 2006 Freightliner Columbia 120, similar to the unit involved in this incident.

Recommendation No. 1: Manufacturers should consider the redesign and relocation of fuel tanks to reduce risk of penetration and fire.

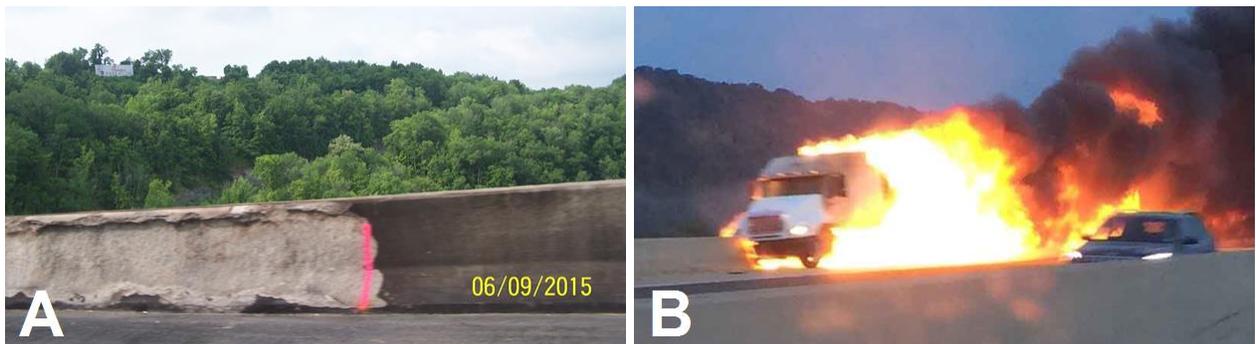
Figure 4. A) Damage to the concrete railing from the semi-truck. B) The semi-truck in flames.

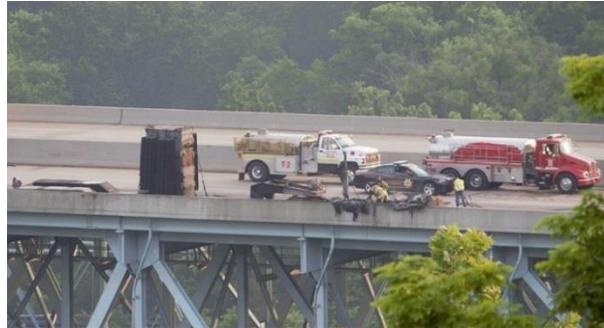
Figure 5. Emergency crews working the scene.

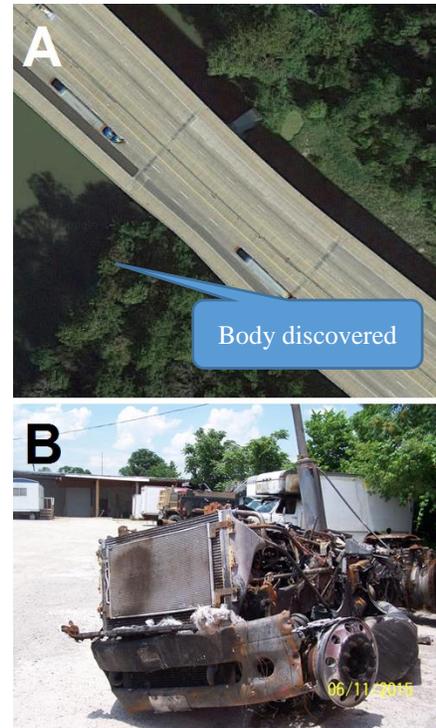
After an extensive search, fire fighters discovered the victim's body 170 feet below the bridge in a steep, wooded area next to the bank of the river (see figure 6A). The victim was pronounced dead at the scene.

Figure 6. A) Area of woods where the victim was found. B) The charred remains of the semi-truck.

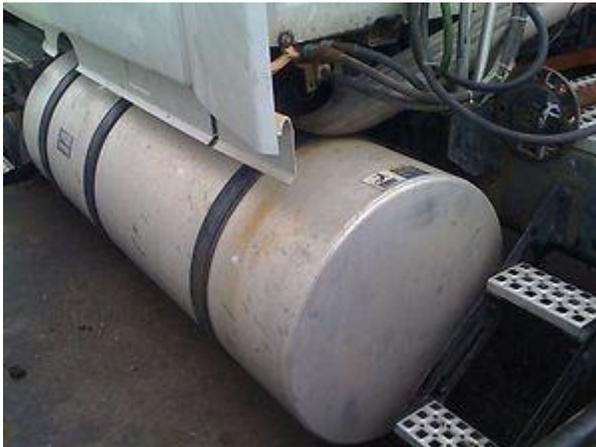
Semi-trucks have two 140 gallon, or greater, diesel fuel tanks, one on each side of the semi. These exposed tanks are at risk for penetration and a resulting fire. A 2012 study of Kentucky motor vehicle collisions found that large trucks are at higher risk for collisions involving fires than passenger cars and pickup trucks.¹ Manufacturers should consider redesigning and relocating fuel tanks on large commercial vehicles to reduce the risk of penetration and fire. Special attention should be paid to increasing the distance that displaced truck components must traverse before coming into contact with the fuel tanks, and to providing protective barriers between the fuel tanks and the frame of the truck.

Figure 7. Stock photo of a side mounted fuel tank commonly found in semi-truck designs.
