Mechanic Struck and Killed by Over-Pressurized Suspension Air Spring on Tractor Trailer

CASE SUMMARY

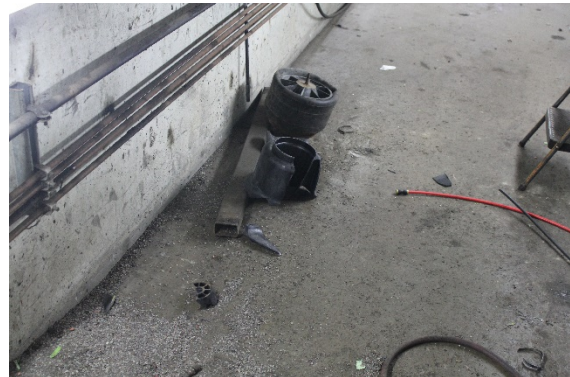
Figure 1. Left side air spring after the explosion.

Instead of using a jack and jack stands to raise the axle, it was common practice for the employees to use the shop air system connected to the vehicle air system to raise the axle. As they were raising the left rear frame with the newly installed suspension air spring, the air spring exploded from the over pressurization, hitting the victim in the forehead. The victim's safety glasses were in his pocket at the time of the explosion.

Recommendation No. 1: Employers should enforce the use of manufacturer's instructions and specifications when replacing suspension air springs.

Manufacturer instruction states that jacks and chocks should always be used to secure a vehicle. The employees used the shop air compressor instead of jacks and jack stands to lift the tractor. The manufacturer also recommends no more than 100 psi for the air spring. The employees used the shop air compressor, which was set to a pressure of 175 psi. The truck's air system was set to 120 psi; however, the truck is equipped with a computerized sensor that detects the volume of air needed, depending on the weight of the load. It fills the air spring and shuts off automatically when it has the correct volume of air.

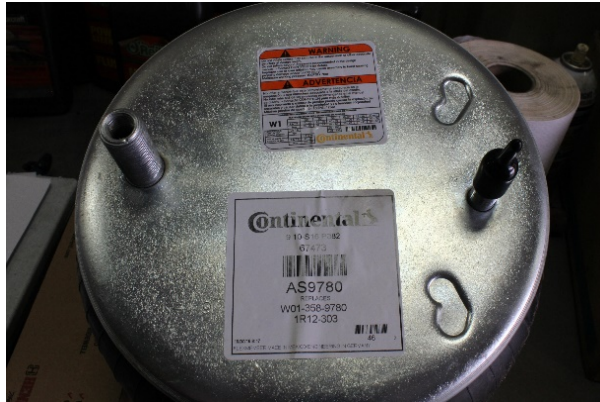
Figure 2. Sample of a new air suspension air bag to be installed.

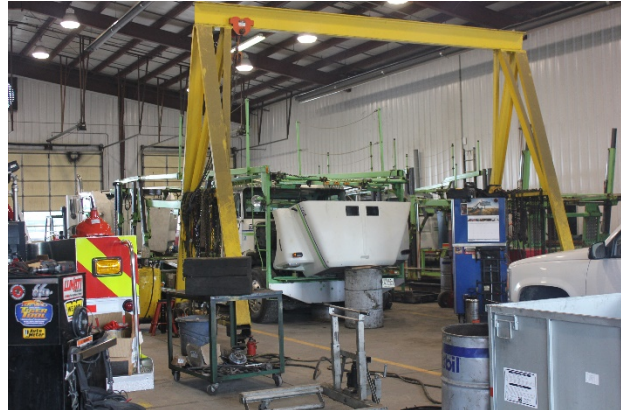
Figure 3. The tractor-trailer the installation was taking place.

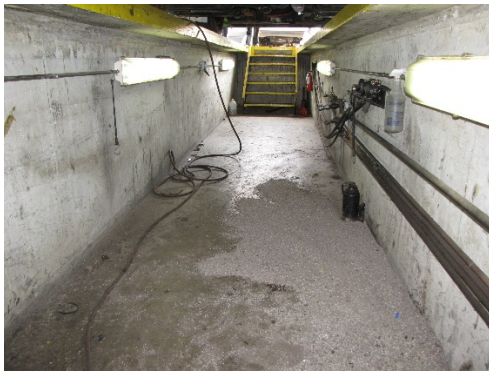
The incident took place in a concrete pit, which was approximately 5 feet deep and 4 feet wide, and located in the floor of the building. This pit allowed access to the undercarriage of the trucks while allowing employees to remain in a standing position. Both mechanics, the victim and his coworker were working in this area when the incident occurred.

Figure 4. View of the pit in which the victim was working at the time of the incident.

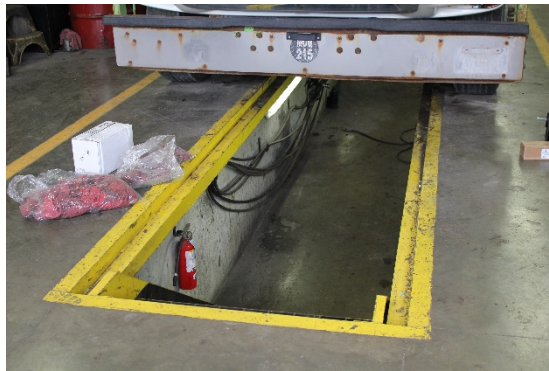
Figure 5. View of the pit from above.

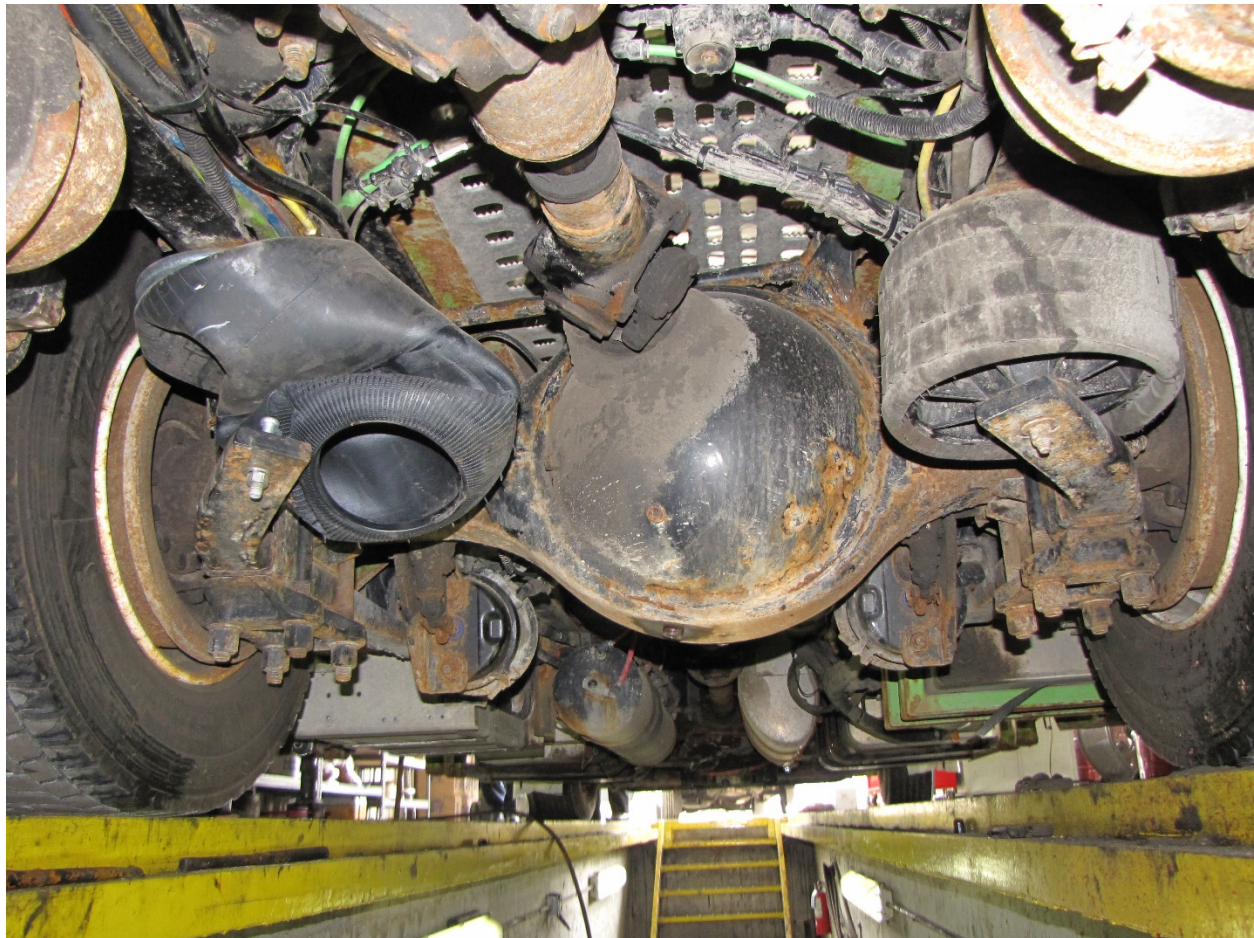
Figure 6. Air spring after the explosion.

At approximately 9:00 am, the mechanics installed a new suspension air spring on the left forward rear axle of the vehicle's tractor. They used the air from the shop air compressor to fill the air bag. The shop air compressor pressure was set to 175 psi. The vehicle air system on the truck that is normally used to fill the air springs is set to 120 psi. Using the vehicle air system is recommended in the manufacturer's instruction on installation of air springs.
