Falls in Construction

Case Studies

Kentucky Fatality Assessment and Control Evaluation
(FACE) Program

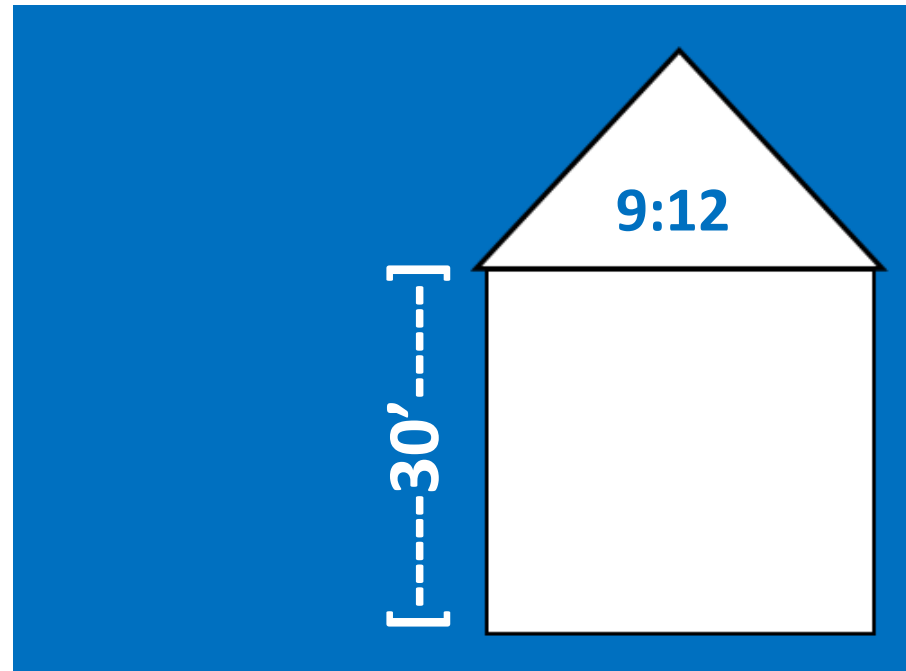
- The incident took place on a church roof which had a 9:12 pitch.
- The distance from the roof eave to the ground was roughly 30 ft.

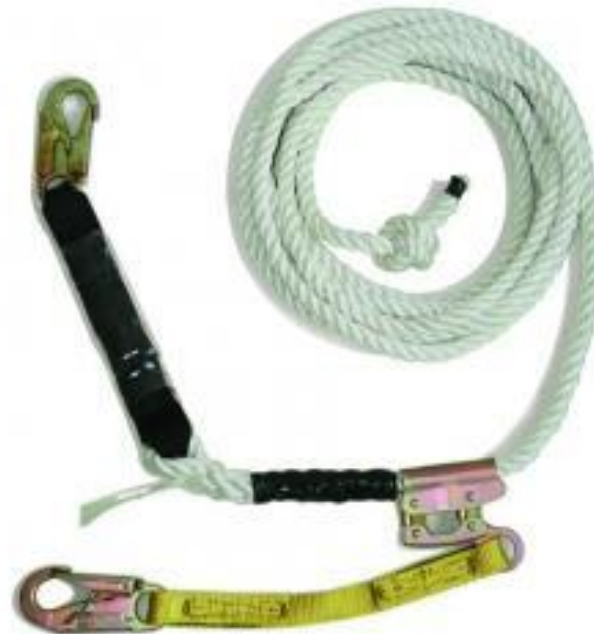
- Vertical Lifeline Rope.
- Had visible signs of aging and deterioration prior to use.

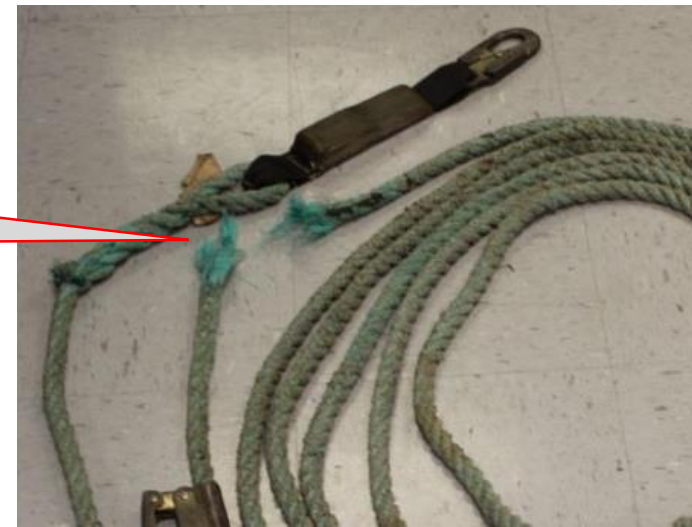
Severed rope

- The manufacturer estimated the rope to be approximately 4 years old.
- The state of deterioration of the rope was readily visible, and would have been identified had a proper PPE inspection taken place.
- The positioning device and snap hook showed rust.

1. Fall protection is **critical** when working from heights.
2. Fall protection **must** be inspected for defects prior to use.
3. You should **never** start a job at heights unless you are using fall protection that you are 100% confident will not fail due to a defect.

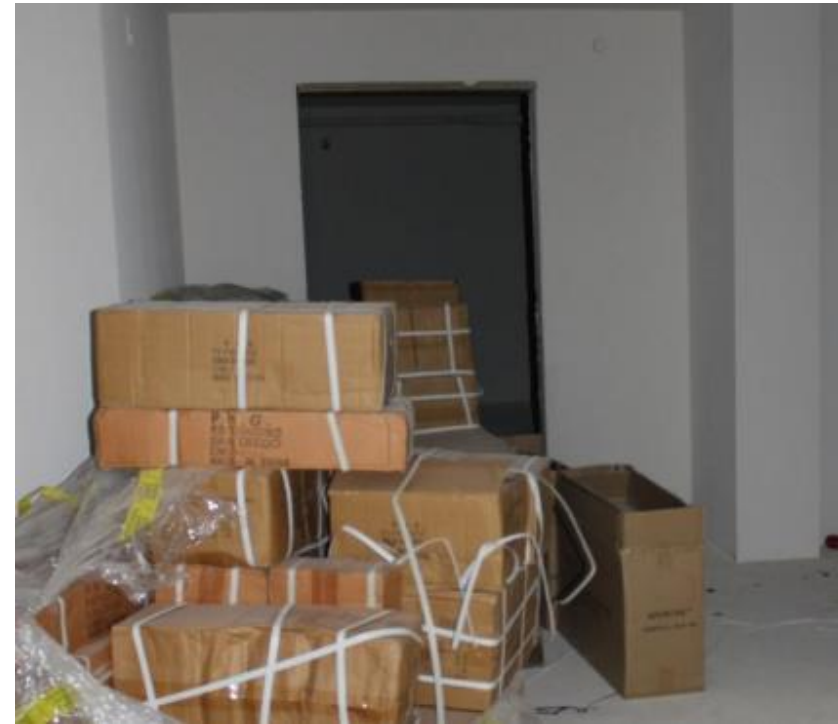
- Construction site of 4 story building, second floor.
- Elevator had not been installed yet, no guards at elevator shaft openings.
- Pallets were cluttered near the elevator shaft entrance.

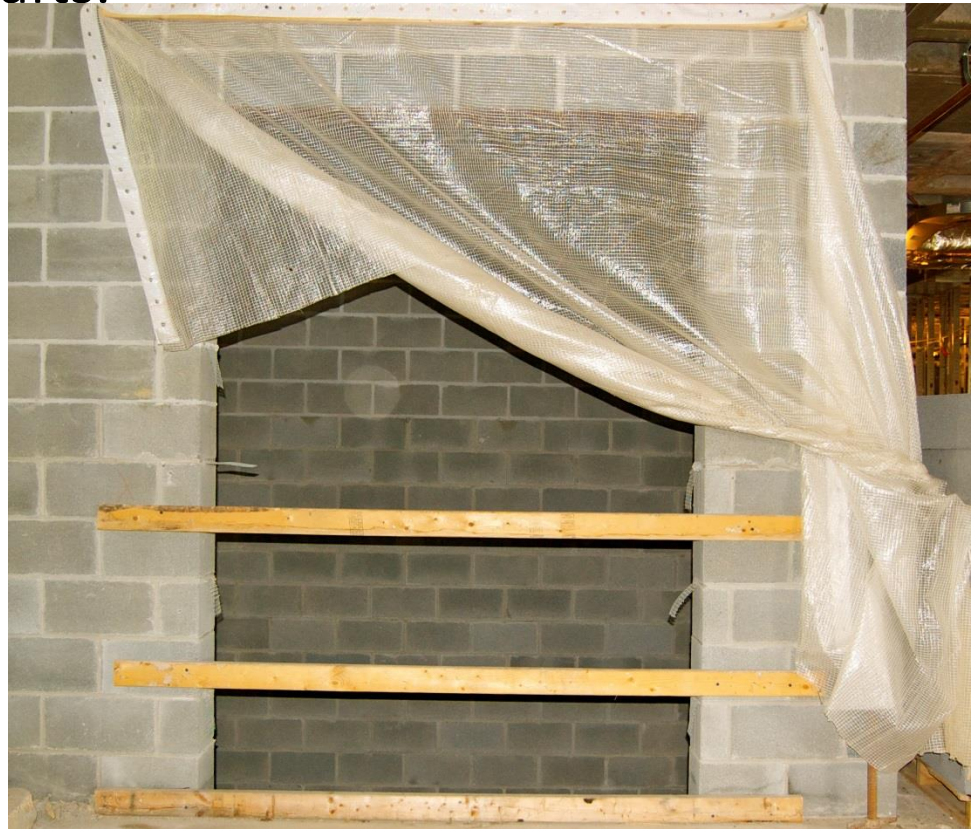
#1 - Elevator shaft was not properly guarded. Below is an example of a safe work practice for elevator shafts.

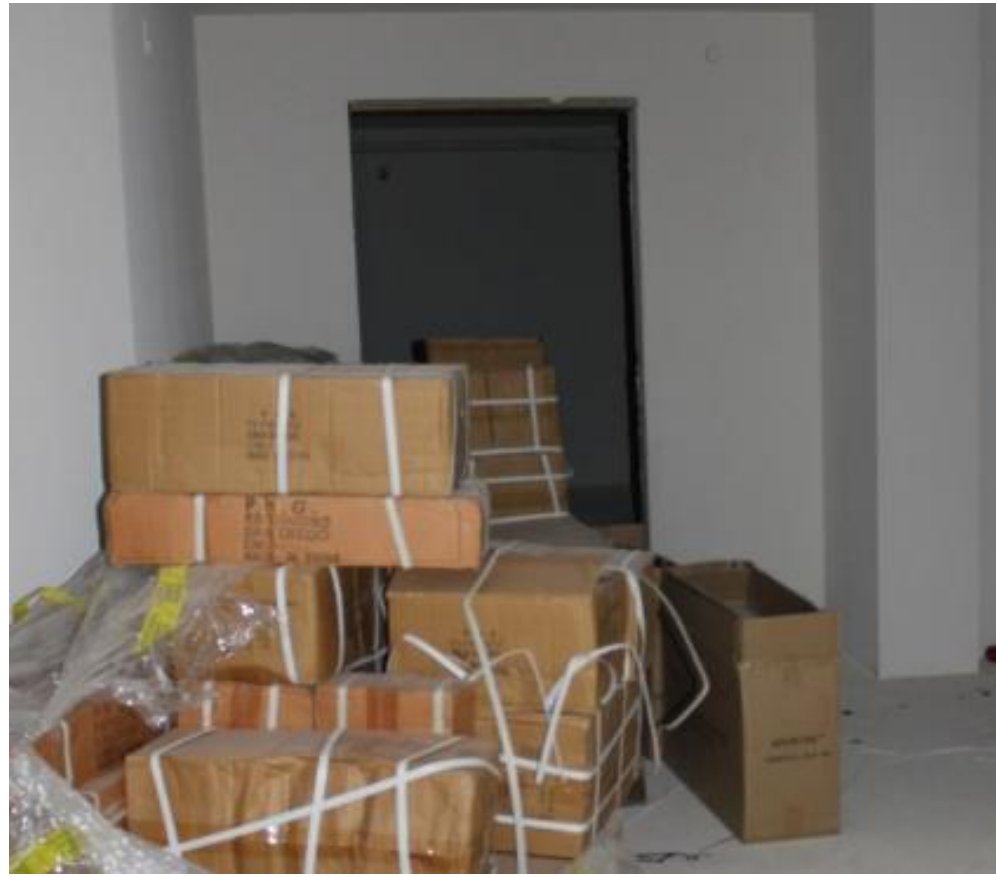
#2 – Pallets and boxes cluttered the area next to the unguarded shaft. Ensure that work areas are tidy and free of trip hazards.

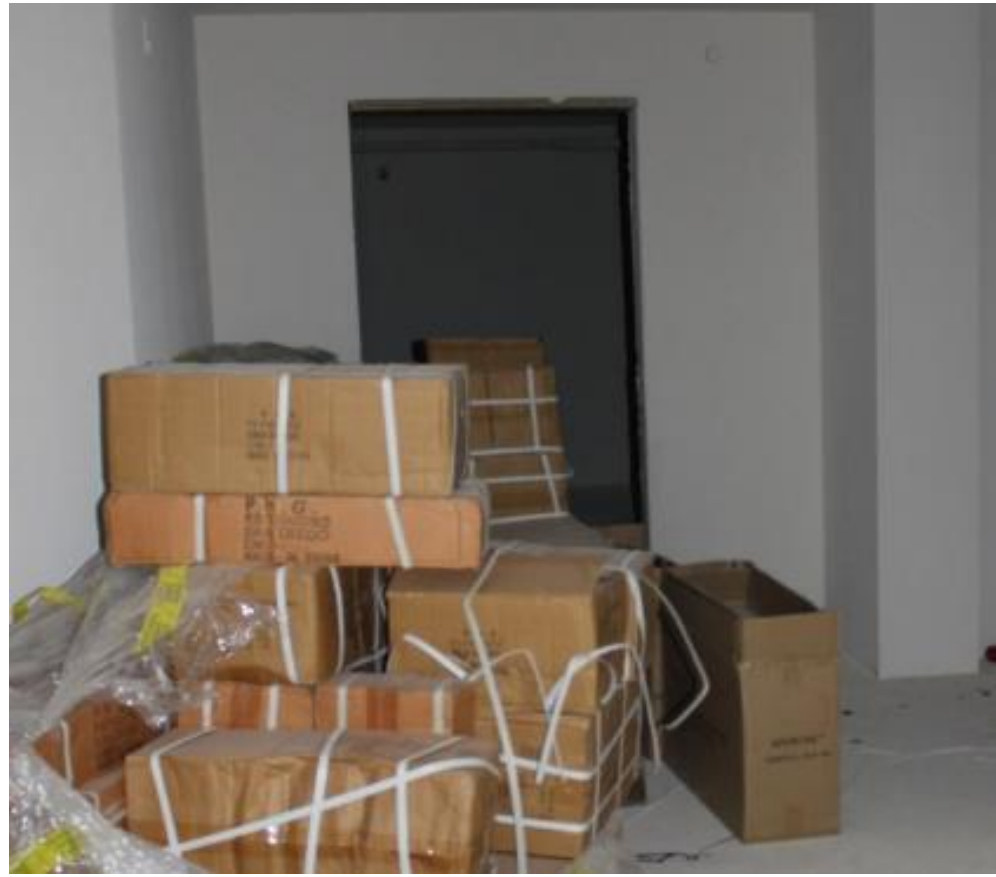
#3 – Lighting was absent from the work area. Lighting should be supplied in working areas in accordance with OSHA standards ([CFR 1926.56](#))
