REPORT#: 22KY083

REPORT DATE: March 28, 2023

Equipment operator crushed by skid-steer attachment—Kentucky

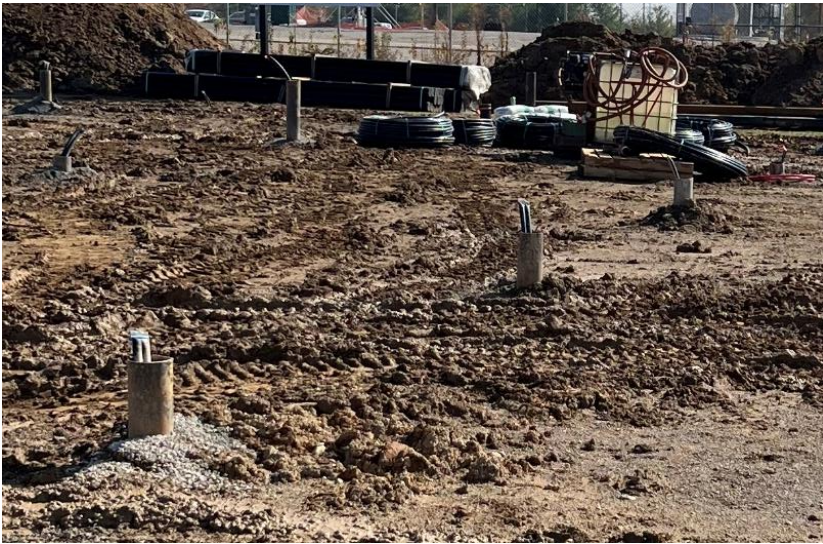
A geothermal system was being installed in a field adjacent to a larger construction project. The process involved drilling holes into the ground vertically, installing a pipe into each hole, and installing a water line into each open pipe. Pipes were then filled with gravel from a gravel bucket carried by a skid-steer. The work area, with several pipes filled with gravel, are shown in Photo 1.

Photo 1. Geothermal system pipes (Property of KY FACE)

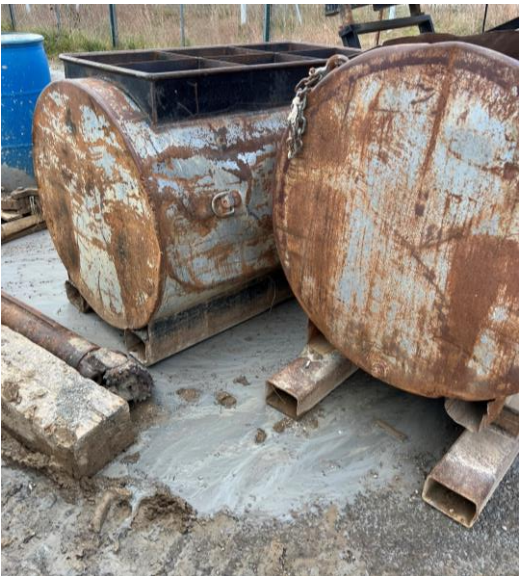
The gravel bucket involved in the incident was secured to a twin-fork attachment of the skid-steer through fork slots and chain was used to provide additional stability. Gravel buckets similar to those involved in the incident are shown in Photo 2, and a gravel bucket secured to a twin-forks attachment in a configuration similar to the one involved in the incident is shown in Photo 3. The combined weight of the attachment, bucket, and gravel involved in this incident are estimated to be 2,000 pounds [[EPA, 2016](#)].

Photo 2. Gravel buckets (Property of KY FACE)

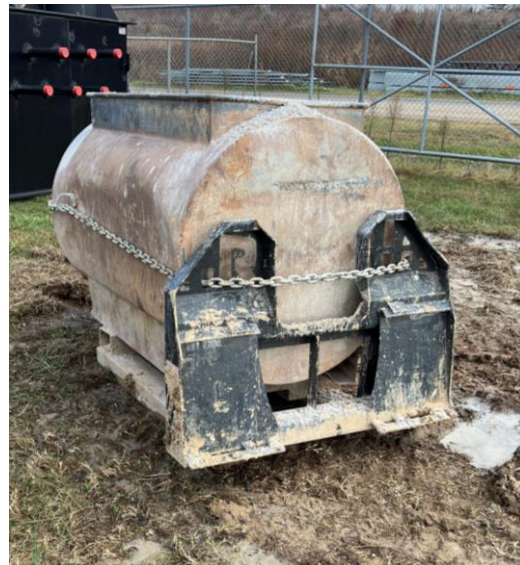
Photo 3. Twin-forks attachment with gravel bucket
(Property of KY FACE)

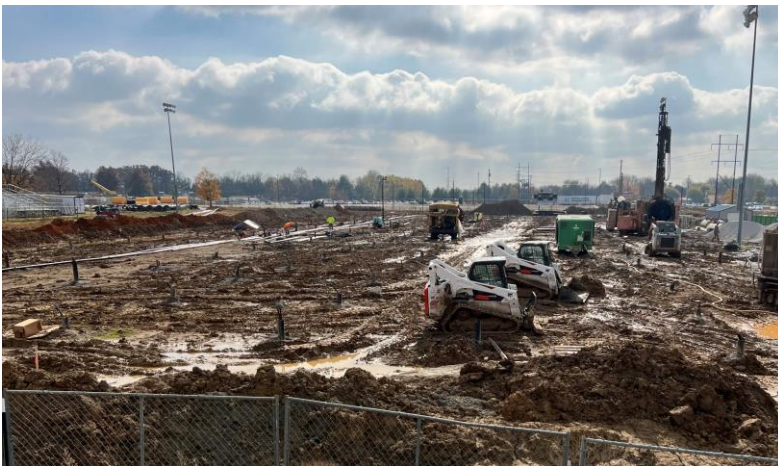
The scene was an outdoor area on level grade, estimated at 150 yards long by 75 yards wide. At the time of the incident a geothermal system was being installed. Processes underway included the drilling of vertical holes, insertion of vertical piping into the drill holes, installation of water lines into the vertical pipes, and filling of the pipes with gravel. The scene on November 1, 2020, is shown in Photo 4.

Photo 4. Incident Scene (Property of KY FACE)

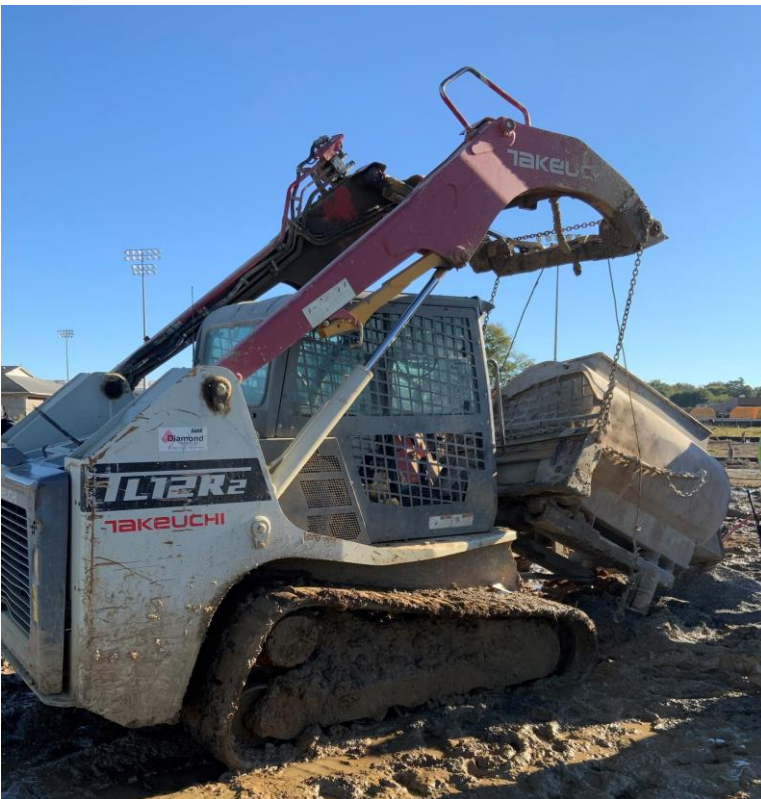
Two other employees were operating drilling equipment located on the far side of the work area from the skid-steer operator's activities. The drill operators did not witness the incident, but at some point one of them noticed that the skid-steer operator had exited the skid-steer and had become pinned against the cab. The twin-forks attachment had detached from the lift arms of the skid-steer, and the twin-forks attachment and gravel bucket had fallen onto the skid-steer operator. The skid-steer, detached twin-forks attachment, and bucket are shown in Photo 5.

Photo 5. Skid-steer with twin-fork attachment and bucket (Courtesy of coroner).

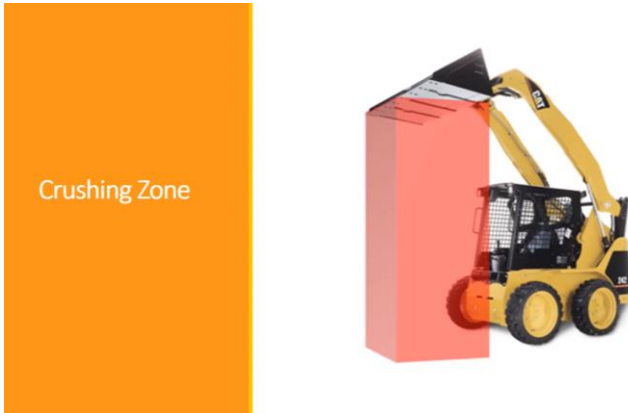
The operator was struck by the twin-forks attachment and bucket because he was located in the *crushing zone* when the twin-forks attachment separated from the lift arms. The crushing zone is illustrated in red in Diagram A.

Diagram A. Crushing Zone (KYSAFE [n.d.]. [Hazard Alert: Skid-Steer Loader video](#)).

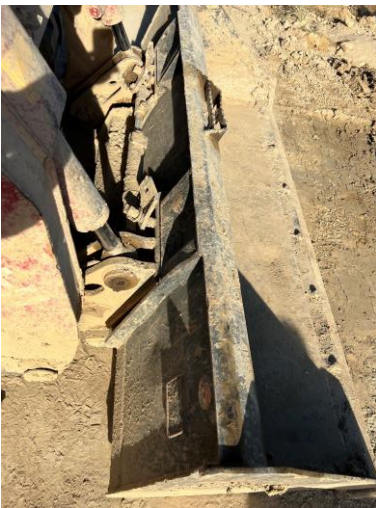
The skid-steer was designed to accept a variety of attachments. The twin-forks attachment involved in the incident secured to the skid-steer using a *quick hitch* built into the skid-steer's lift arms that inserted into slots on the twin-forks attachment. Once the quick hitch was inserted, two locking pins on the quick hitch were engaged to fully secure the attachment to the lift arms. A scoop attachment, which is attached to the lift arms in a similar fashion as the twin-fork attachment involved in the incident, is shown in Photo 6. The locking pins are detailed in Photos 7 and 8.

Photo 6. Skid-steer with scoop attachment (Courtesy of KY FACE).

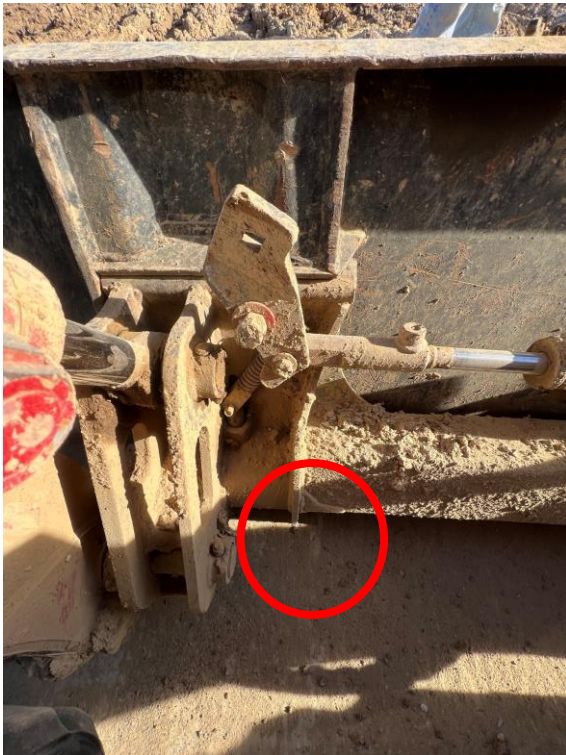
Photo 7. Skid-steer locking pin (Courtesy of KY FACE).

Employee interviews indicated that an equipment malfunction had likely occurred such that one or both of the two locking pins that secured the forks onto the arms of the skid-steer were not properly in place. Interviewees speculated that the presence of mud, rock, and other debris may have prevented the pin(s) from being securely locked into place. A visual inspection of the equipment, after coupling the attachment to the lift-arm, is necessary to ensure that the pins are properly secured in place.

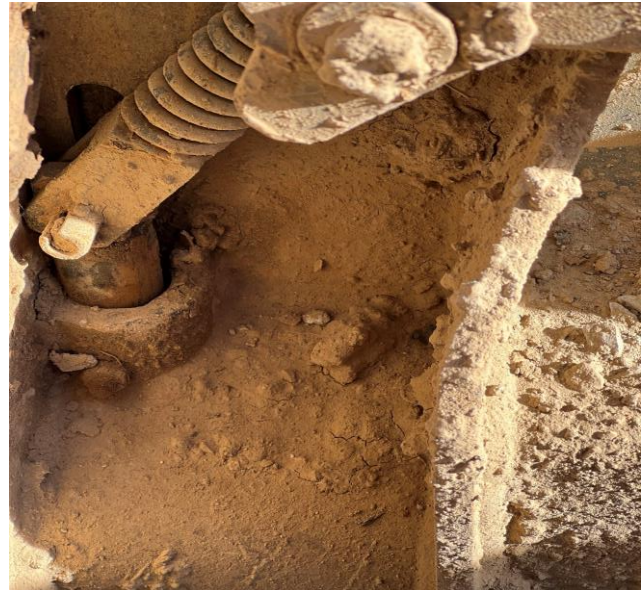
Photo 8. Detail of locking pin (Courtesy of KY FACE).

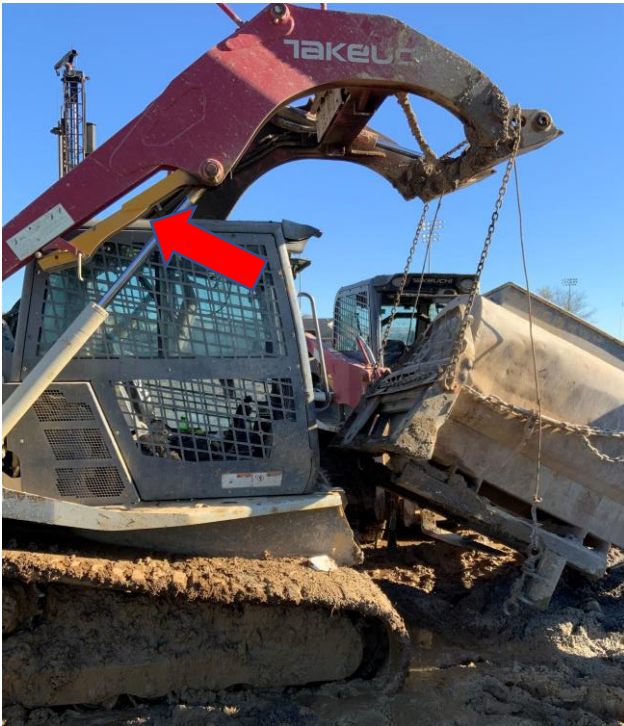
It is not known why the skid-steer operator exited the cab with the lift arms in the raised position. The skid-steer operator did not engage the skid-steer's lift arm stopper brace, indicated in Photo 9. The lift arm stopper is a safety device provided as original equipment by the skid-steer manufacturer. The stopper serves to safely brace the lift arm, should it be necessary to leave it in a raised position. The stopper brace did not play a direct role in the incident.

Photo 9: Lift arm stopper brace (Courtesy of coroner)

Discussion: Employers should ensure that their employees utilize equipment safety features rather than bypass them. The *seat bar*, also referred to as *safety bar*, is an essential safety device for skid-steers that should be used in accordance with the manufacturer's instructions. The operator's manual for the skid-steer directed that the operator should raise the safety bar before standing up from the operator's seat and lower the lift arms to the ground before exiting the cab. If the lift arms were needed to be left in the raised position, then the lift arm stopper was to be engaged.
