REPORT#: 23KY00901

REPORT DATE: 04/18/2023

Project Manager Dies after Falling through Skylight

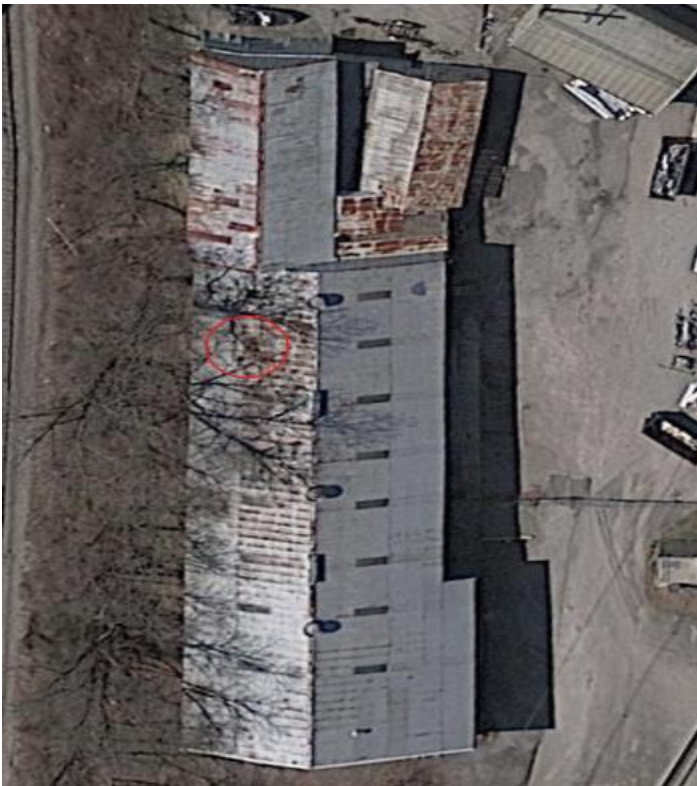
The incident occurred on the roof of a 19,024-square-foot commercial warehouse building that sits on a paved and fenced lot. The building is vacant and had recently been purchased by private investors. The roof is constructed of corrugated metal (photo 1). It measures 20 feet on either side, 31 feet at its peak, and has a pitch of 4:12, meaning the roof rises four inches for every 12 inches it moves toward the peak. A total of 16 polycarbonate skylights are present within the roof, all original to the construction of the building. The floor inside the building is constructed of concrete (photo 2).

Photo 1. Google Earth image of building where the incident occurred. The red circle indicates the skylight involved in the incident.

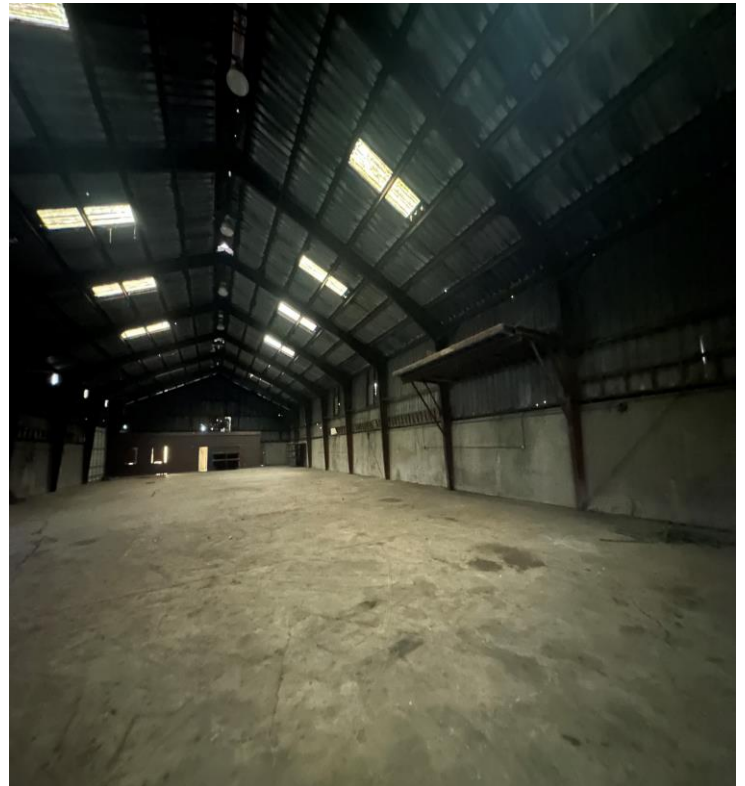
Photo 2. Photo showing interior and surface of the building where the incident occurred.

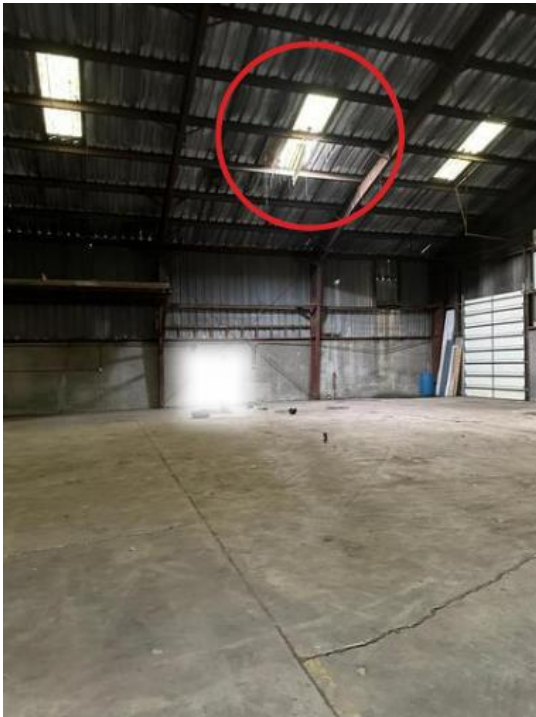
Photo 4. Red circle identifying the polycarbonate skylight the victim fell through.

Discussion: The roof where the incident occurred was constructed of corrugated metal and contained a total of 16 polycarbonate skylights. Skylights present risk to workers, as they can often be difficult to differentiate from roof panels. Even in instances where skylights are clearly visible, workers may be task focused and lose sight of skylight placement. The victim in this case was aware that skylights pose risk to employees. Thirty minutes prior to the incident, the victim verbally reminded his co-worker to be careful around the skylights, stating he had nearly stepped on one. OSHA standard 29 CFR 1926.501(b)(4)(ii) states that walking surfaces shall be protected from tripping on or stepping into or through holes, including skylights. Employers should guard skylights with railings (photo 6) or a skylight screen (photo 7) prior to performing work on roofs equipped with skylights. Skylight guarding provides employees with a physical barrier of protection from falling through skylights and serves as a visual aid by clearly identifying the location of the skylights.

Recommendation #2: Employers should guard skylights with railings or a skylight screen.

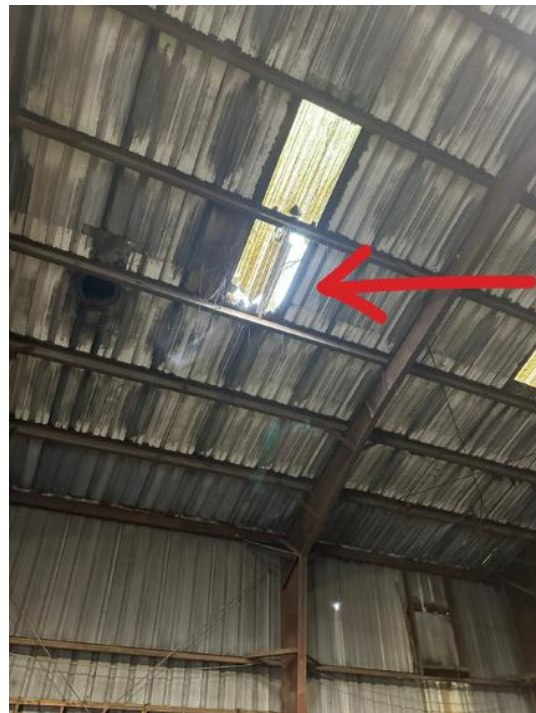
Photo 5. The red arrow indicating the now breached polycarbonate skylight.
