REPORT#: 23KY005

REPORT DATE: 12/12/23

Roofer in Boom Lift Electrocuted by Overhead Electrical Line — Kentucky

Fatality Assessment and Control Evaluation (FACE) Program

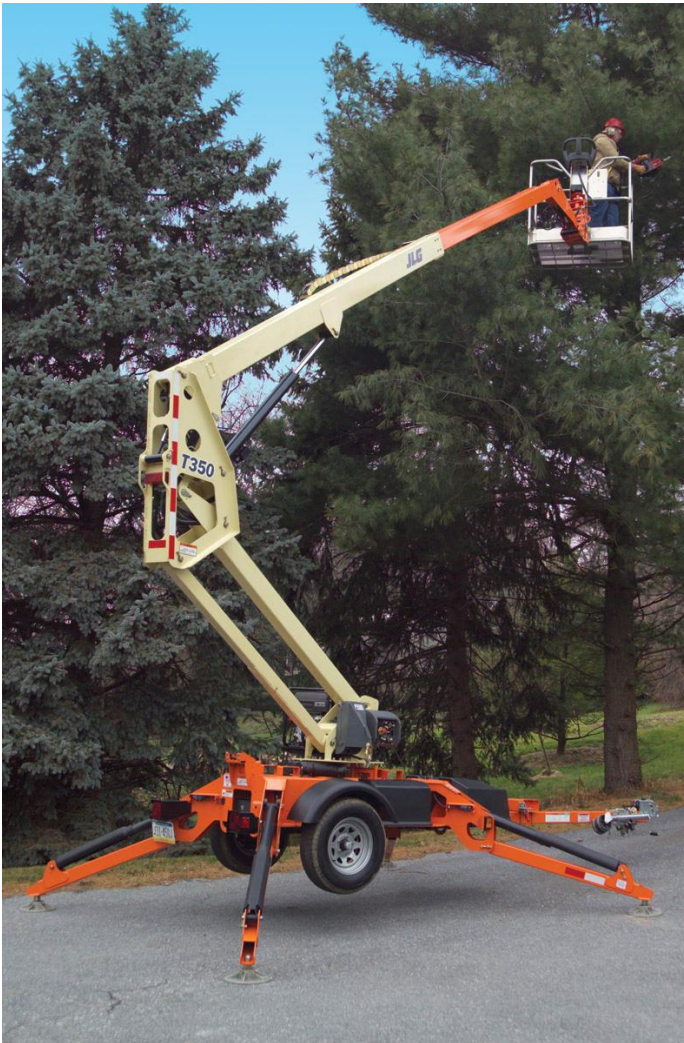
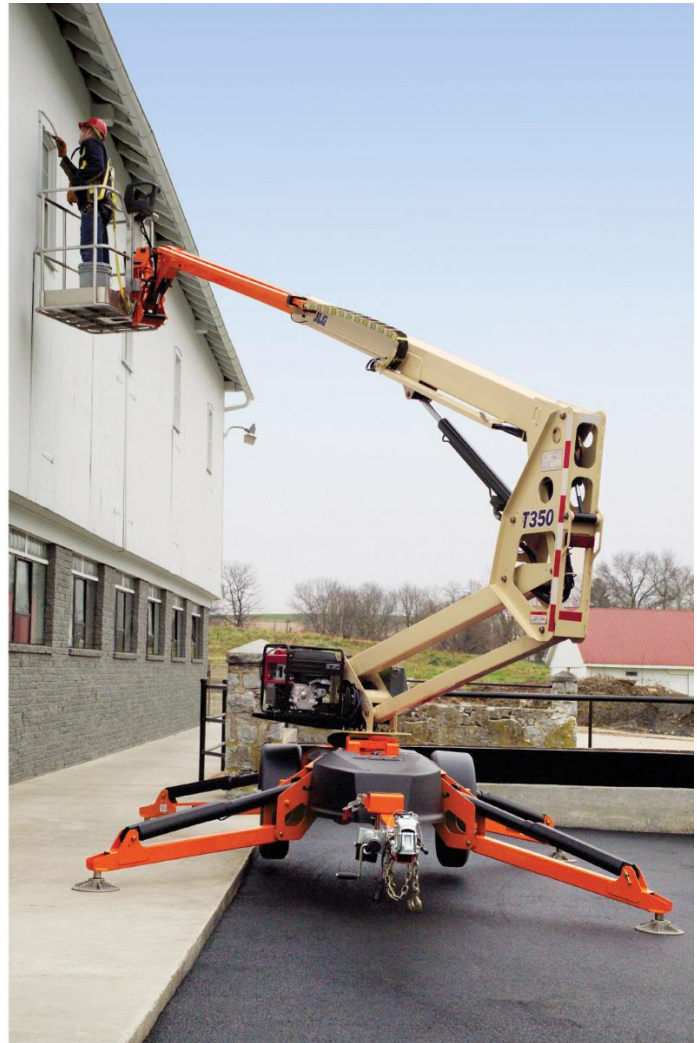
The telescoping boom lift used by the roofing workers to access the roof was a T350 model manufactured by JLG. This type of lift is transported using a tow hitch and then positioned by hand. Four outriggers are deployed to stabilize the lift. It is capable of raising the work platform to 34 ft. 5 in. in height ([JLG.com](https://www.jlg.com), 2023). It is unknown if the equipment was owned by the employer or rented. Images 1 and 2 show the type of lift involved in the fatal incident.

Images 1 and 2. T350 Telescoping Boom Lift (JLG.com, 2023)

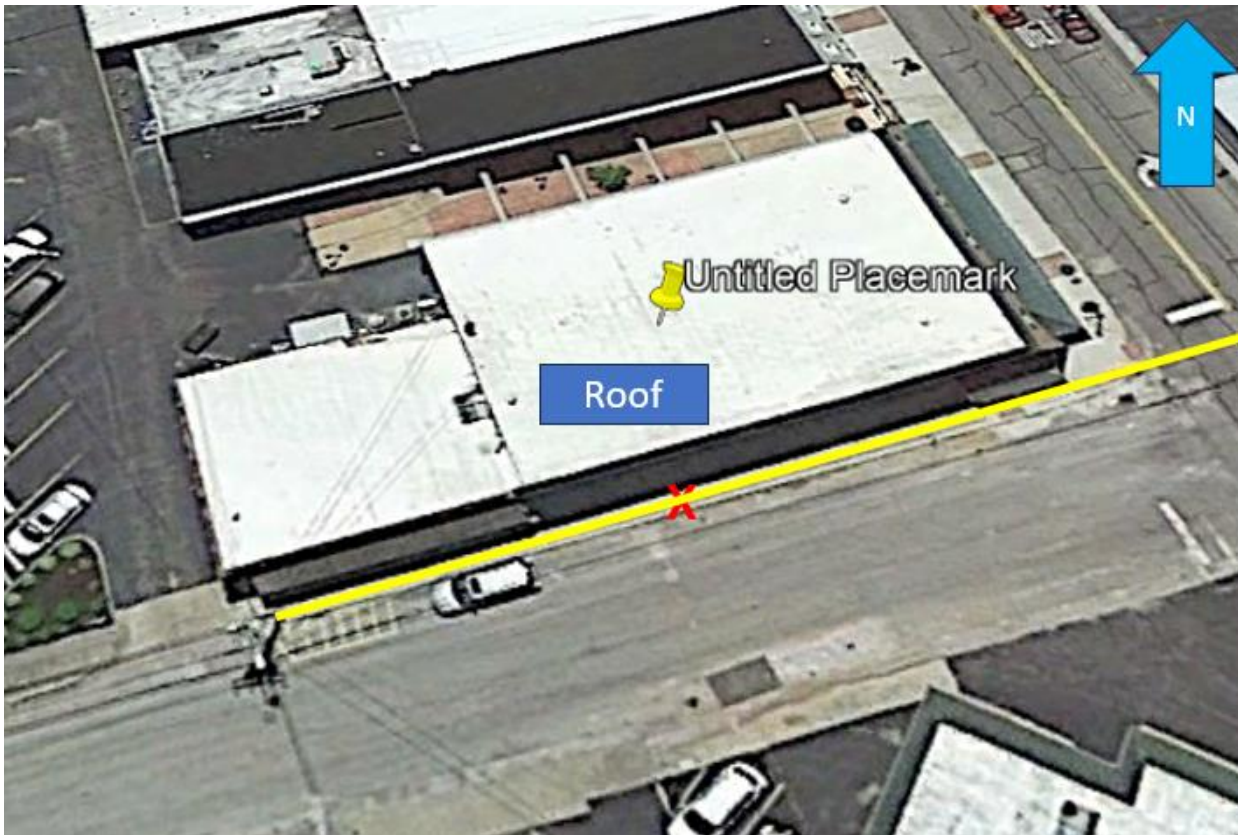
The scene is shown in images 3, 4, and 5. Image 3 indicates the roof being renovated, with a red "x" showing the location of the lift and a yellow line showing the overhead power lines. Note: this photo was not taken on the same date as images 4 and 5. The red "x" in image 4 shows the location of the lift, and the yellow circle shows the overhead

Image 3: Incident scene; aerial view. The yellow line represents overhead power lines. The red "x" shows the approximate location of the boom lift. (Google Earth Pro, 2023.)

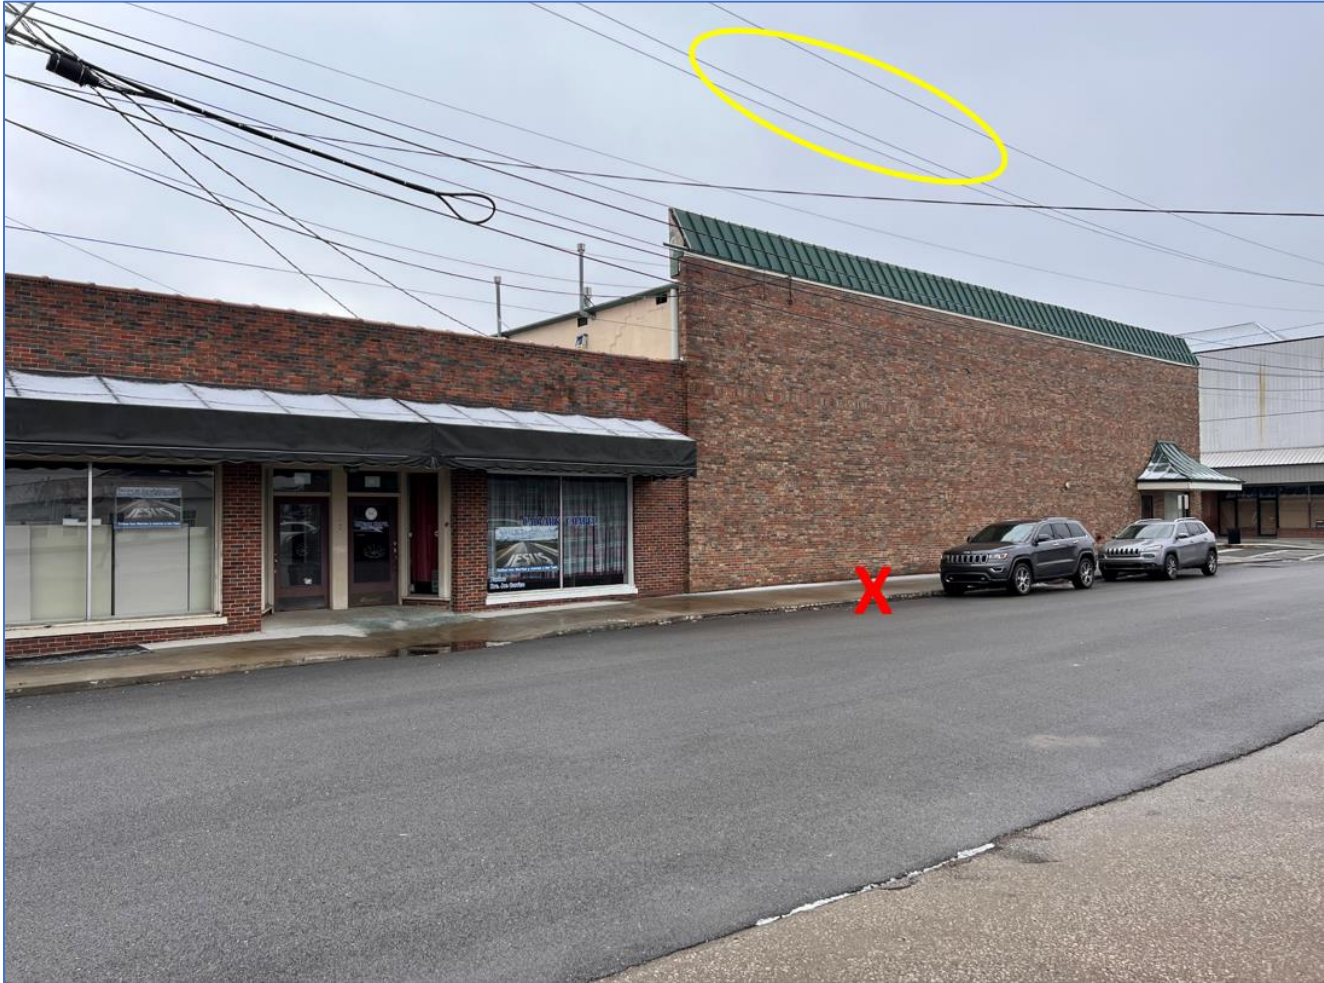
electrical powerlines involved in this fatal incident. The yellow circle in image 5 indicates the overhead electrical powerlines involved in this fatal incident.

Image 4: Incident scene with overhead wires; facing south. The yellow circle shows the approximate location where the roofer contacted the overhead power lines. The red “x” indicates the approximate location of the boom lift. (Property KY FACE.)

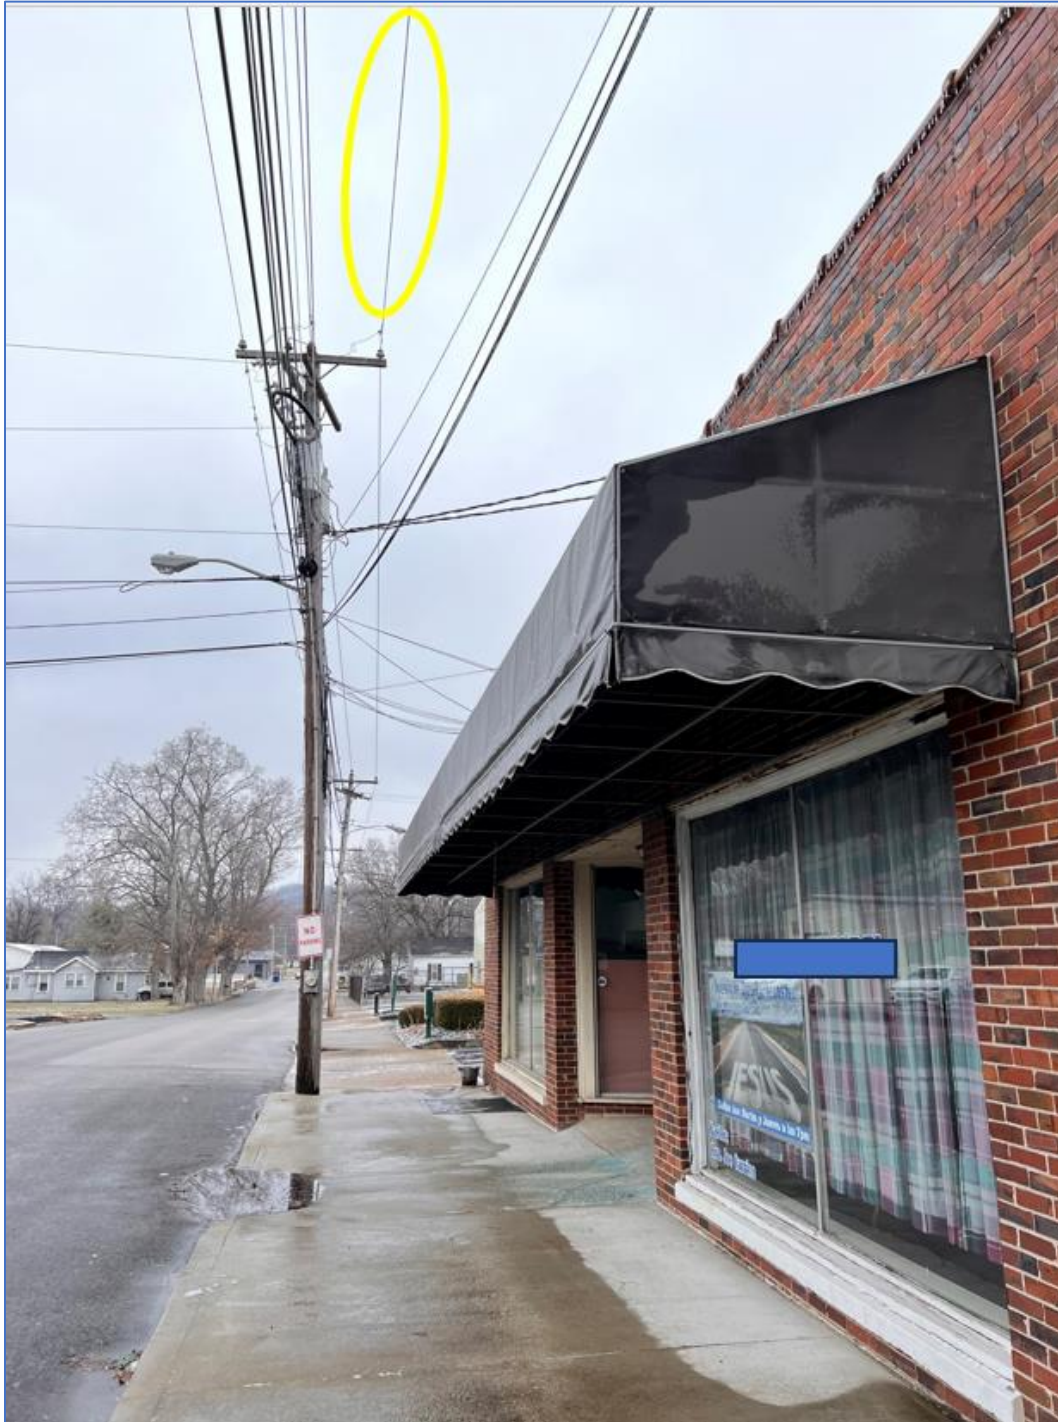
Image 5: Incident scene with overhead wires; sidewalk facing west. The yellow circle shows where the overhead power line contacted the worker during the incident. (Property KY FACE.)

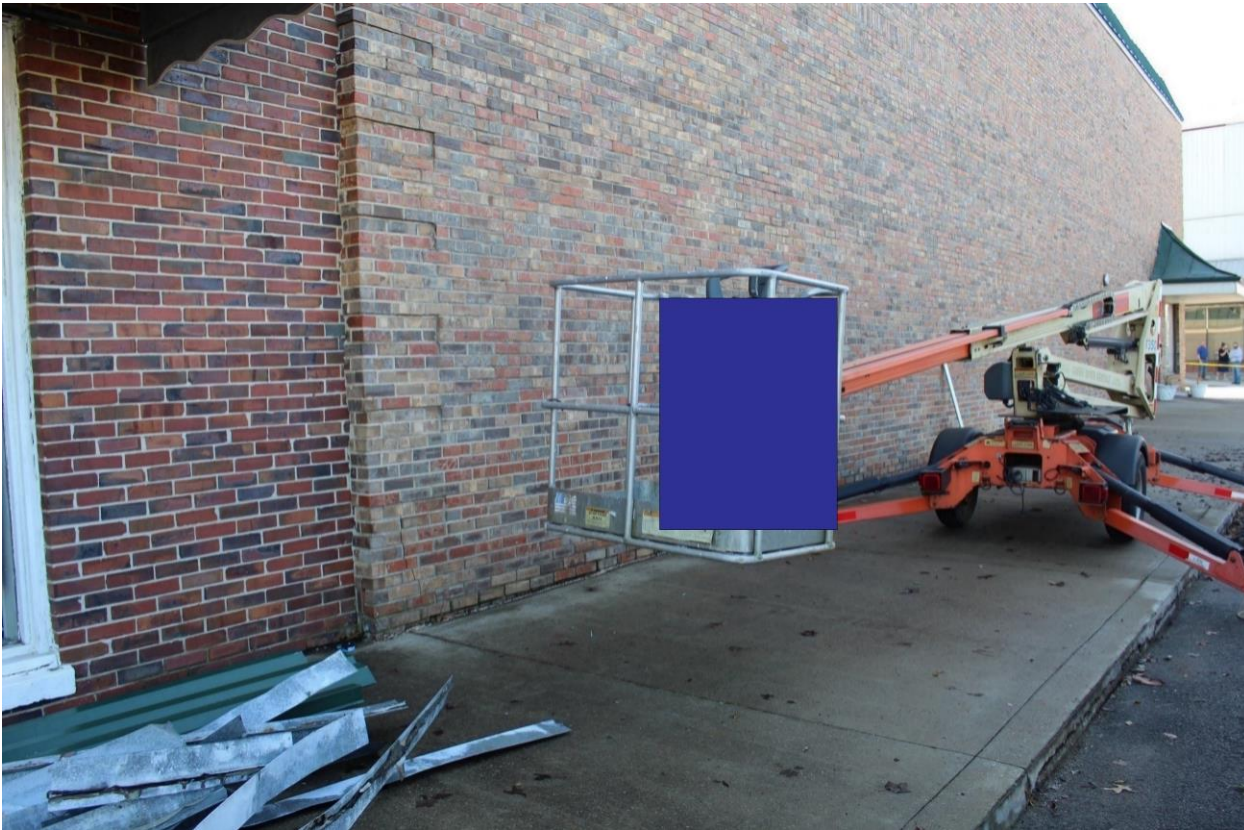
Image 6 shows the location of the lift and the deceased employee at the time of the incident. The deceased employee suffered 4th degree burns and a fatal shock. According to the EMS report, medical responders did not attempt resuscitation as he was clearly deceased. The other employee in the boom basket suffered second degree electrical burns to his left elbow, wrist, and hand.

Image 6: Boom lift position; sidewalk facing west (Property KY FACE)

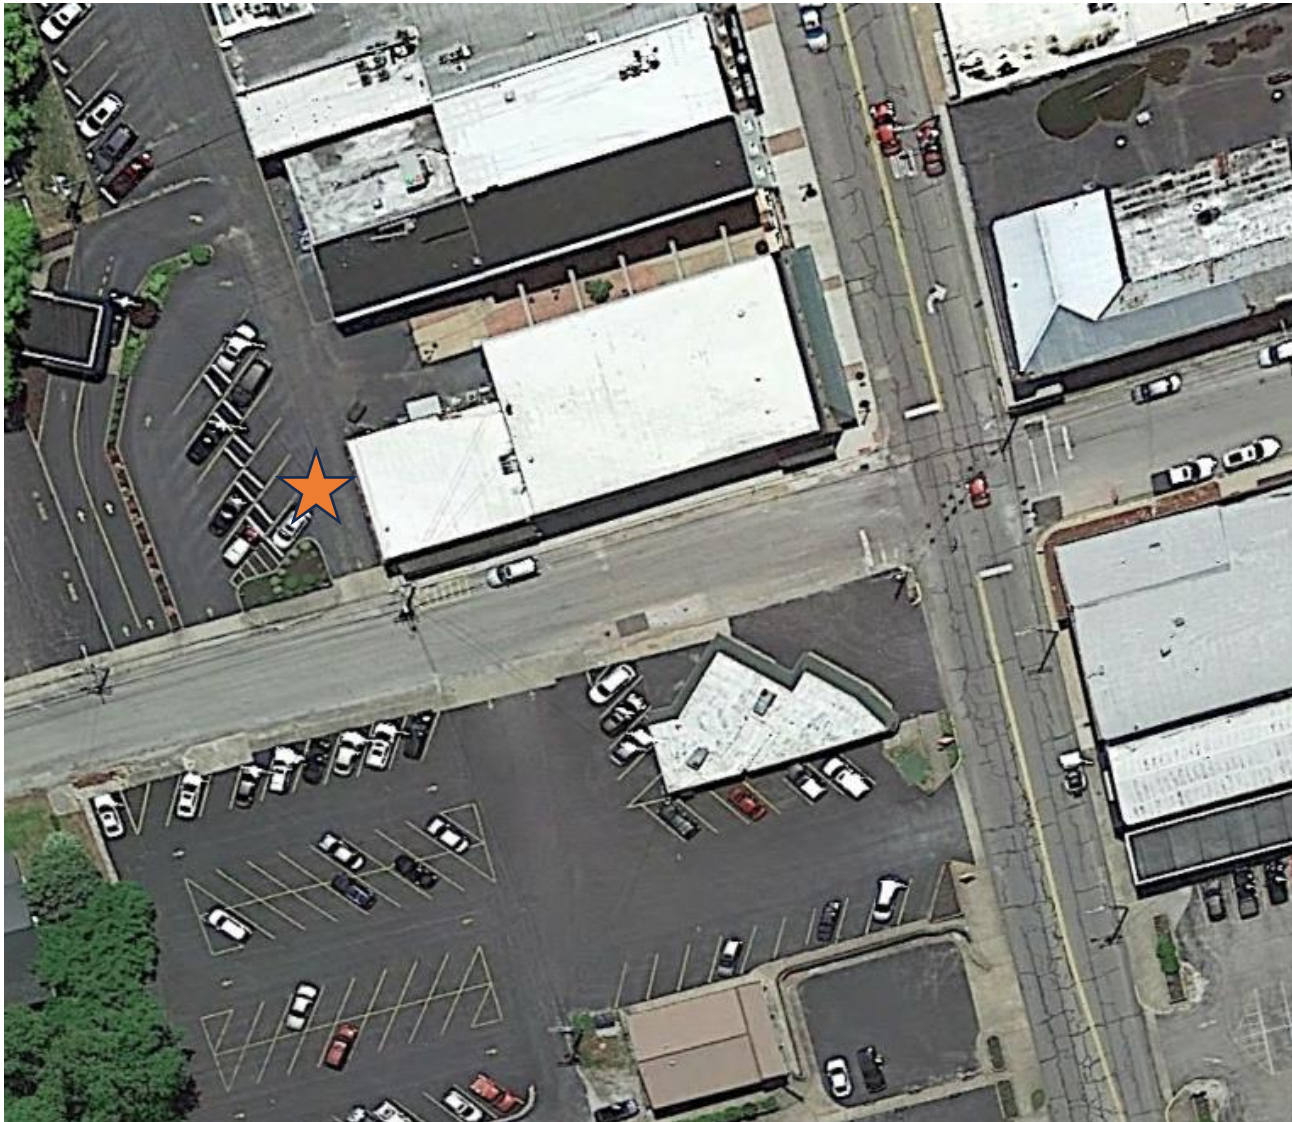
Image 7: Incident scene; aerial view. The orange star indicates the rear parking lot. (Google Earth Pro, 2023.)

Discussion: The location of the boom lift involved in this fatal incident provided insufficient clearance from the energized overhead power lines. Employers whose employees use lifts around live overhead electrical wires that are not protected by protective covers should, at a minimum, comply with OSHA's [[n.d.](#)] standard 29 CR 1926.451, which sets forth a requirement to maintain a minimum distance of 10 feet from lines carrying less than 50 kilovolts. In this case, the parking lot to the rear of the building may have provided adequate clearance from the overhead power lines. The orange star in image 7 indicates the rear parking lot area where the boom lift could have been located.

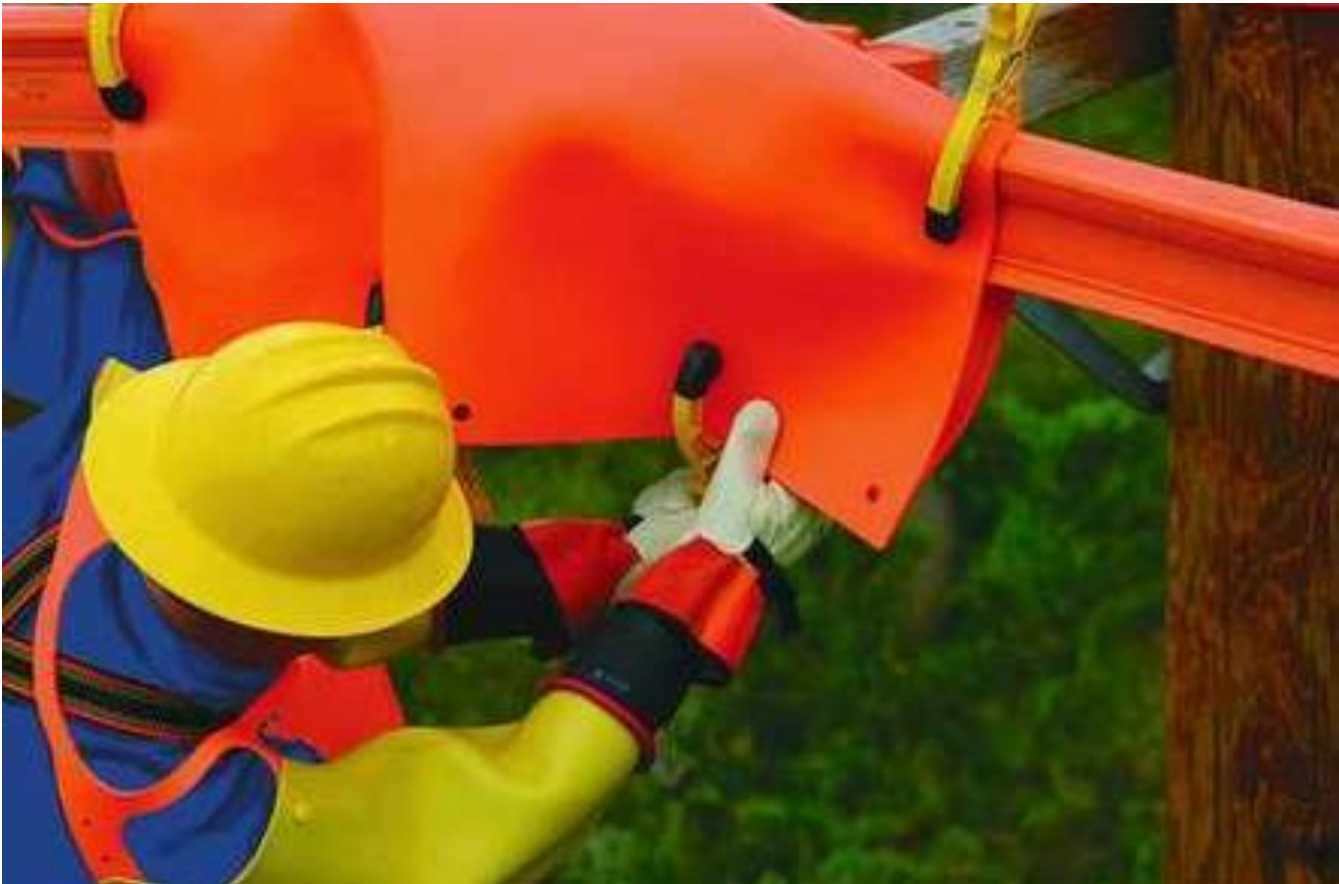
Image 8. Salisbury Insulating Blanket. (Zoro, 2023.)

Discussion: Employers should have insulative covers installed when employees and equipment cannot maintain safe working distances from power lines to prevent accidental contact. NIOSH [\[2022\]](#) has noted that employers should check with the local electric utility company before the start of work to request the installation of insulative covers on powerlines if workers are unable to maintain safe distances from power lines. Examples of insulating covers are shown in images 8 and 9.

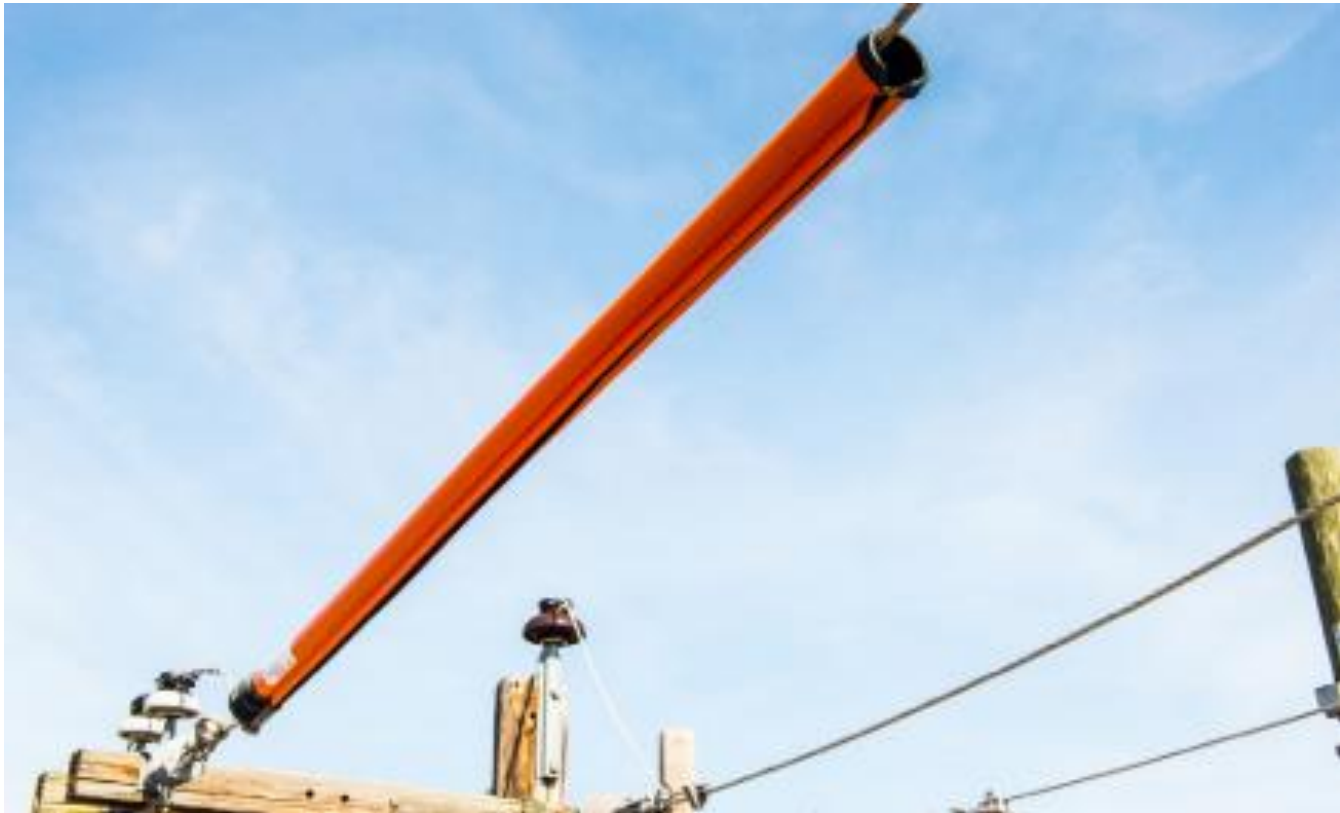
Image 9. Cover-up Equipment (Chance, 2020.)
