**REPORT#:** 24KY022

## Manufacturing Laborer Falls from Elevated Pallet, Succumbs to Injuries

On April 8, 2024, a 62-year-old male manufacturing laborer was mixing concrete additive solution when he fell from a pallet elevated on a forklift. The victim succumbed to the injuries sustained in the incident.

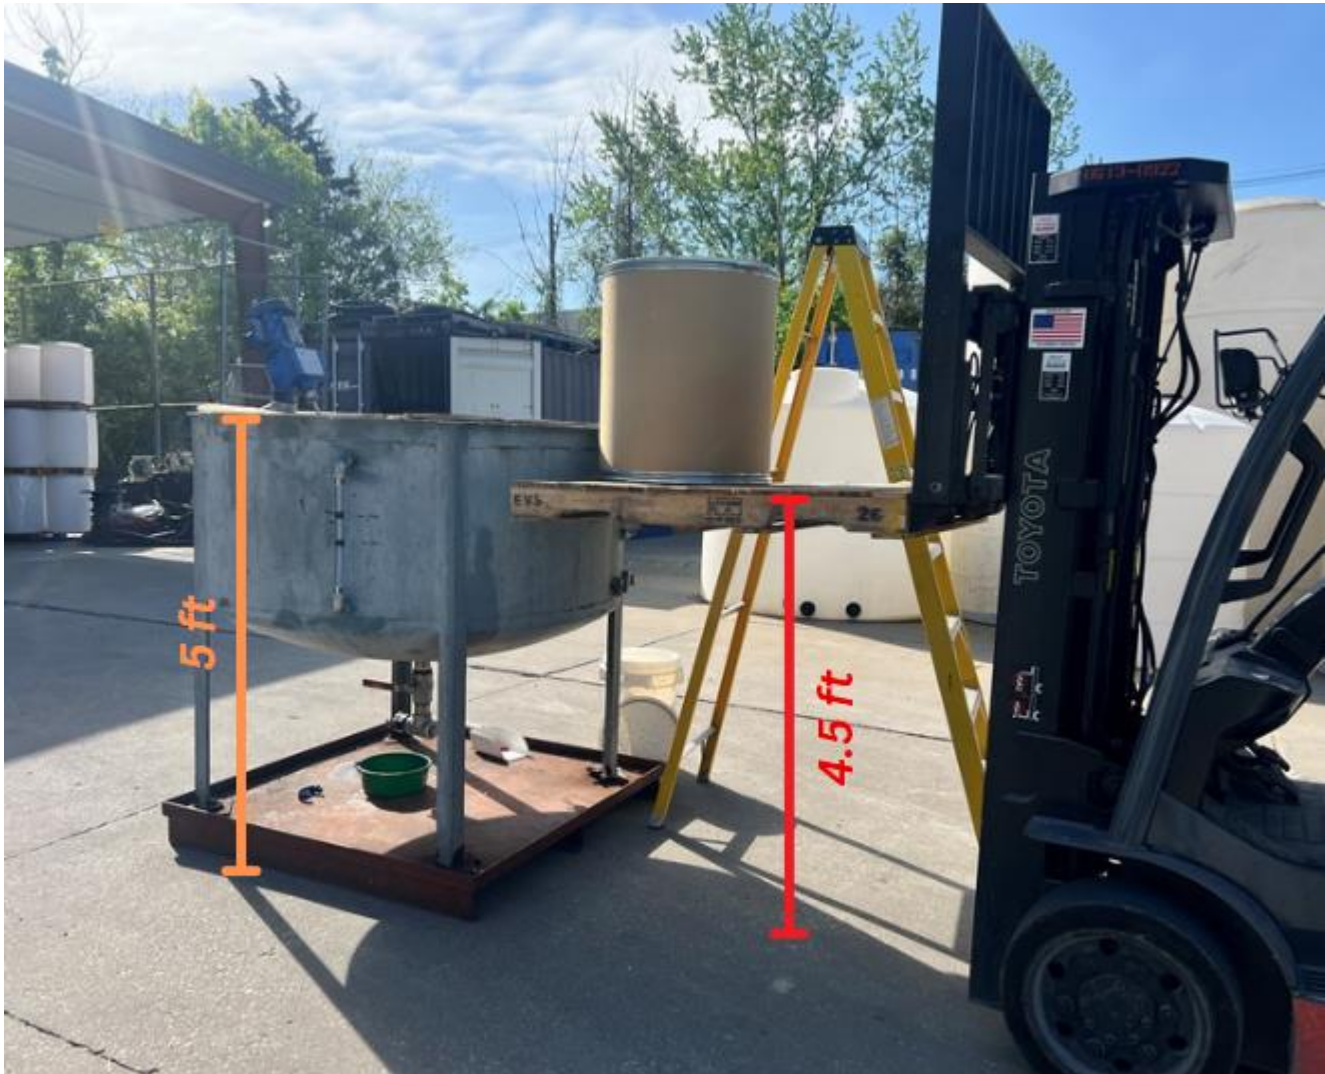
The commercial grade mixer sits approximately 5 feet from the concrete surface below. To access the mixer, the procedure in place at the time of the incident required employees to place the 132-pound drum onto a wooden pallet. Once on the pallet, the drum and pallet are lifted via forklift to the edge of the mixer. An 8-foot step ladder is then placed beside the elevated pallet, and employees climb the ladder to access the drum. From the ladder, the drum could be tilted forward to empty its contents into the mixer (photos 2 & 3). Although the process described above was the approved procedure the involved company had in place at the time the incident occurred, it required employees to improperly utilize [ladders](#).

However, it was discovered post-incident that employees were frequently standing on top of the pallet while emptying the drum, rather than utilizing the ladder. At approximately 7:54 a.m., while attempting to mix the contents of the drum into the mixer while standing on the pallet, the employee fell 4.5 feet from the pallet, striking the concrete surface below. Site security cameras did not catch the fall and the incident was not directly witnessed by other employees. However, an employee did catch the impact of the victim striking the surface below in his peripheral vision. The employee ran to the aid of the victim, who was initially responsive but going in and out of consciousness. A call to local emergency services was placed at 7:56 a.m.; an ambulance arrived 9 minutes later at 8:05 a.m. Emergency personnel transported the victim to a major Kentucky university medical center, where he succumbed to the injuries sustained in the incident the next day, on Tuesday, April 9, 2024, at 9:45 p.m.

Photo 2. Photo of commercial grade mixer, 132-pound product drum, ladder, forklift, and pallet, which were utilized when the incident occurred. Scene was reconstructed for investigation purposes. **Orange line** represents height of commercial grade mixer from the surface below. **Red line** represents height of the elevated platform the victim was standing on to the surface below. Photo property of Kentucky FACE.

**Recommendation #1: Consider utilizing a drum handling device in lieu of working at heights.**

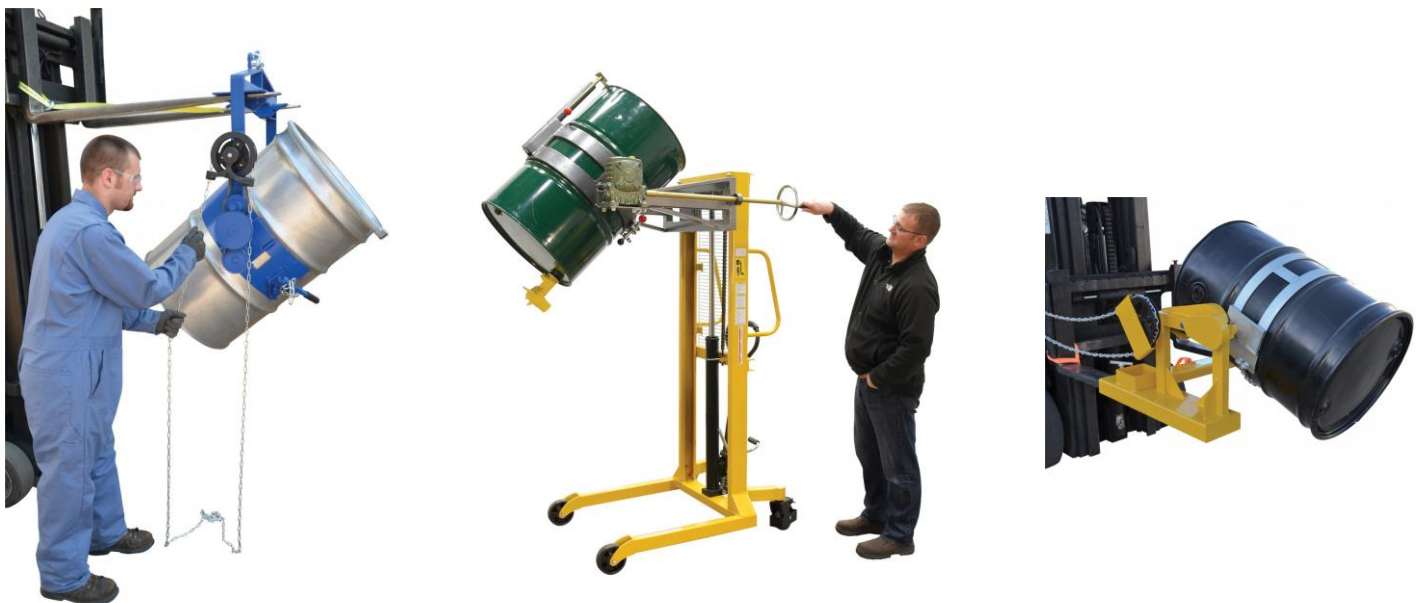
Photo 4. Photos showing various drum handling device options. Images obtained via Google search.

Discussion: According to the National Safety Council, falls to a lower level were the third leading fatal workplace event in 2022, resulting in 700 deaths.<sup>2</sup> In the case of this incident, it was discovered post-incident that employees were frequently standing on top of an elevated wooden pallet, approximately 4.5 feet from the surface below, to empty the contents of the drum into the mixer. The most effective way to address risk is to eliminate them when possible. Employers performing similar tasks should consider purchasing and requiring employees to utilize a drum handling device (photo 4), which would allow the same task to be completed while eliminating the need to work from an elevated surface and thus the risk of a fall. A variety of drum handling devices are available; employers should assess the functionality of each and select the device that best fits their needs.

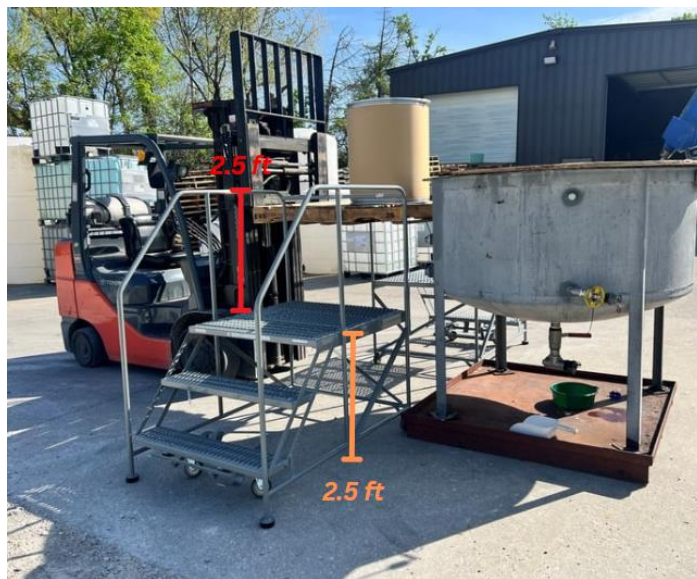
- The new ladder reduces the height at which the employees perform work from 4.5 feet to 2.5 feet,
- The new ladder offers fall protection via an integrated guardrail system, and
- The new procedure prioritizes the utilization of two employees, making the task less strenuous.

While the process reduces the risk associated with the task, it should be noted that if disregarded by employees, the elevated pallet is still accessible for employees to stand on.

Photo 5. Photo showing new ladders and process implemented by involved company. Photo property of Kentucky FACE.

***Recommendation #2: Consider modifying job procedures to prioritize the utilization of two employees when possible.***

Discussion: The involved company made alterations to its procedure shortly after the incident occurred to lower the risk associated with performing the mixing job task. The new procedure, demonstrated to FACE investigators during a site assessment, prioritizes utilizing two employees to complete the task, rather than one. As explained to investigators, standing on the pallet is prohibited. In lieu of utilizing a standard step ladder, the involved company purchased two platform ladders (photo 5) that are equipped with a guard rail system that offers fall protection to employees. The platform ladder on which employees stand measures 2.5 feet from the ground, and the guard rail extends 2.5 feet from the standing platform. Once the 132-pound drum is loaded onto the pallet, a forklift elevates the pallet to the mixer's edge. Once in place, the two platform ladders are placed on both the left and right side of the pallet (photo 5). Two employees, one on each ladder, work in unison to tilt the drum, emptying its contents into the mixer.
