REPORT#: 25KY028 REPORT DATE: 02/02/2026

Concrete Finisher Crushed by Collapsing Dump Bed

SUMMARY

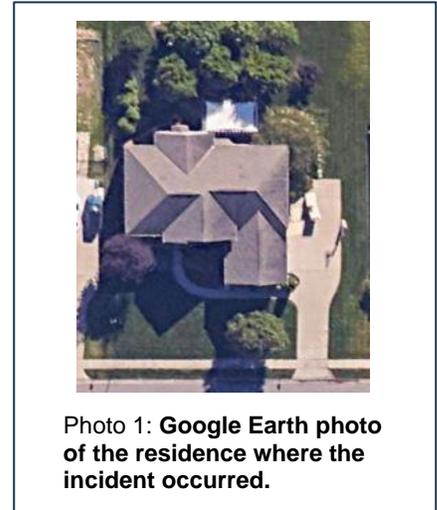
Residential (photo 1)

The victim arrived at the residential job site (photo 1) at approximately 8:35 a.m., 20 minutes after departing the gravel yard. Upon arrival, the victim backed the Ford F-550 dump truck into the residential driveway and raised the hydraulically controlled dump bed 2 feet to assist with the gravel unloading process (photo 2). After raising the dump bed, the victim, job supervisor, and an additional concrete finisher began unloading the gravel with a Toro Dingo. After each scoop, which was approximately 400 lbs., the gravel was transported to the backyard of the residence for unloading and prep for a concrete pour scheduled for later that day.

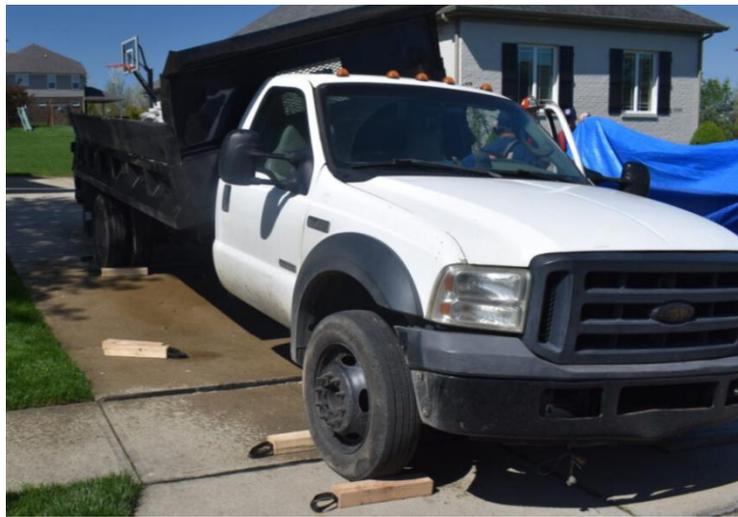
Photo 2: Photo showing dump truck parked in the driveway of the residence on the day the incident occurred. Note: Dump bed is in the down position; this picture was taken post-incident. Photo obtained via Kentucky open records request.

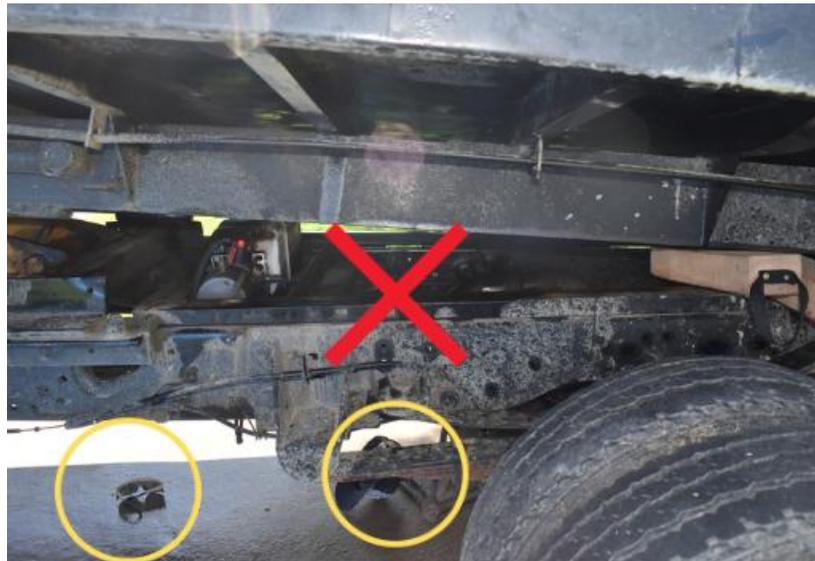
After removing the fifth scoop, the victim noticed hydraulic fluid on the concrete driveway below the dump bed. Upon further evaluation, the victim discovered a leaking hose that controlled the raise/lower functions of the hydraulic dump bed. According to a representative from the company involved, the job supervisor instructed the victim to ignore the mechanical issue, stating he would call a mechanic to repair. The supervisor and additional concrete finisher proceeded to the backyard with the fifth load of gravel. At approximately 9:50 a.m., while unloading and spreading gravel, the supervisor noticed that the victim was not present or assisting them. After calling out to the victim and receiving no response, the supervisor walked from the backyard of the house to the driveway to check on him. He found the victim caught between the frame of the truck and the dump bed, which still contained approximately 3,000 lbs. of gravel (photo 3).

Photo 3: Photo showing location victim was found (red X). The yellow circles show the victim's sunglasses and hat beneath the truck. Photo obtained via Kentucky open records request, edited by Kentucky FACE.

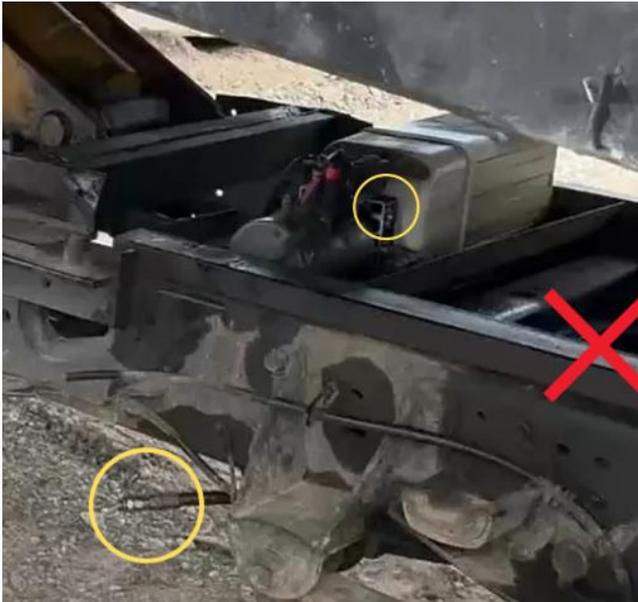
The investigation concluded that the victim positioned himself between the frame rail of the truck and the dump bed to tighten the leaking hydraulic hose fitting but in error loosened the fitting, which resulted in the hose disconnecting completely (photos 4 & 5). As a result, the hydraulic system lost pressure, which allowed the bed to collapse, crushing the victim between the frame rail and dump bed. The area of impact was to the victim's back and chest. A representative of the involved company stated that their policy does not allow employees to perform maintenance on equipment, which is why the supervisor instructed the victim to ignore the issue.

Photo 4: Photo showing hydraulic hose and hydraulic pump inlet (yellow circles). Red X indicates location of victim when the incident occurred. Photo provided by involved company.

- Examine attachment for cracks, visible signs of wear, damage, or malfunction,
- Examine connection points to ensure connections are free of damage,
- Inspect hydraulic hoses and connections for leaks, cracks, or other damage,

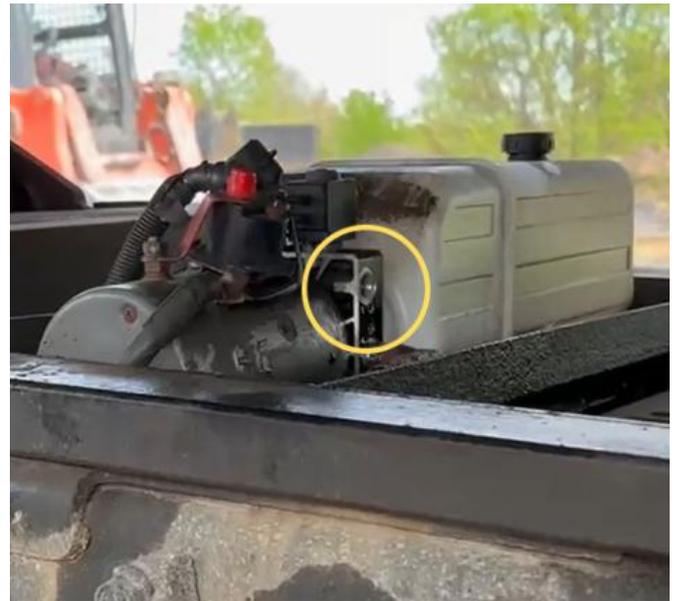
Photo 5: Photo showing closer view of hydraulic hose disconnect point. Photo provided by involved company.

In this incident, an employee was attempting to tighten a leaking hydraulic line while the bed was in the raised position. In error, the employee turned the fitting in the wrong direction, disconnecting the line entirely. As a result, the dump bed collapsed, fatality injuring the employee.

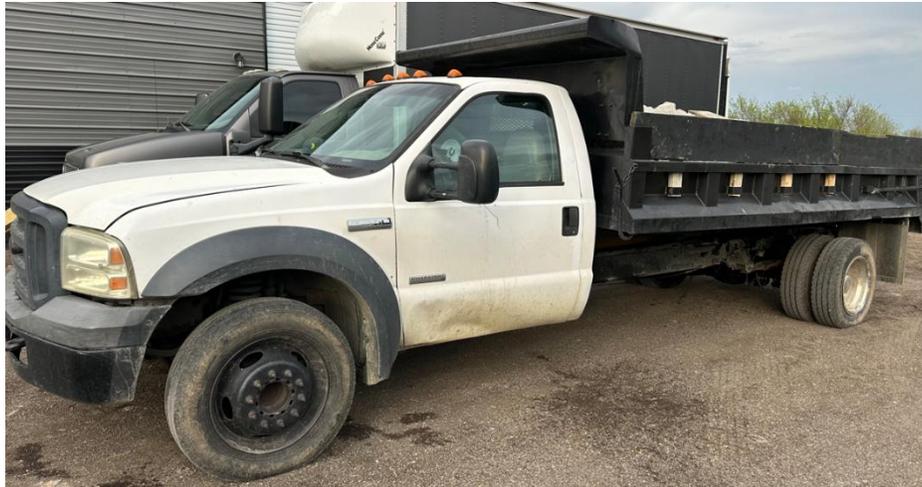
- The company involved was operating a 2006 Ford F-550 pickup truck with a hydraulically operated dump bed (photo 6).
- The company involved was also utilizing a Toro Dingo to unload gravel (photo 7).

Photo 6: Photo showing the 2006 Ford F-550 pickup truck involved in the incident. Photo provided by involved company.

The dump truck involved was equipped with a permanently affixed safety bar; however, the bed was not raised high enough to engage the safety support bar. It is unknown whether the dump bed in this incident could have been raised higher to engage the safety bar prior to performing work. According to OSHA, height restrictions on factory-installed bracing devices are a common reason for lack of utilization. Most factory-installed bracing devices (photo 8) can be engaged only at one height. If the set height is too low or too high to grant employee access for repairs, it can lead to the device not being utilized at all.² Aftermarket bracing options are available (photo 9) and may be a solution for bracing when the factory bar cannot be used.

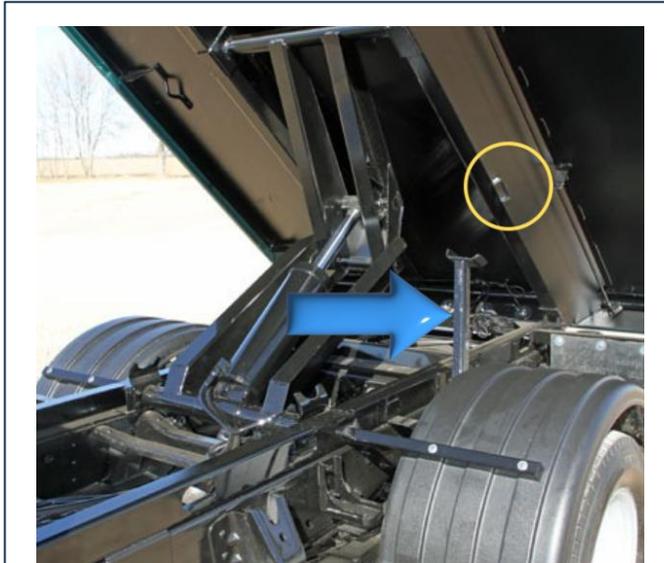
Photo 8: Stock photo showing an example of factory-installed safety support bar. Blue arrow points to the safety bar; yellow circle indicates notch where the safety bar rests on the dump bed frame. Image obtained via Google search, edited by Kentucky FACE.

Discussion: As stated previously, the dump bed utilized in this incident was equipped with the required positive means of support system, more commonly referred to as a safety bar. Safety bars lock the bed in a fixed position and height, preventing the bed from collapsing while employees perform maintenance. OSHA suggests that factory-installed systems are often underutilized due to their lack of adjustability.² If the fixed height is too low or too high to perform the needed tasks, employees often don't use them at all, which can have deadly consequences.

Kentucky FACE investigators suggest that manufacturers design a permanently affixed, positive means of support system that allows the dump bed to be braced at multiple heights and positions. In doing so, utilization of the safety bar may increase, which should reduce the likelihood of on-the-job injury.

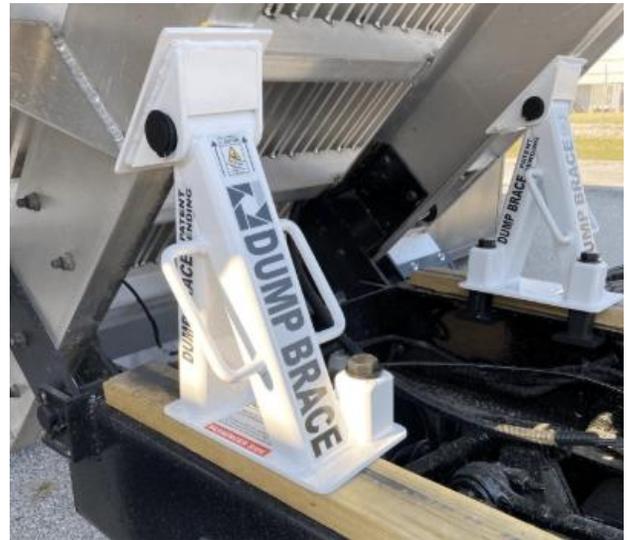
Photo 9: Image showing aftermarket example of dump bed braces. Image obtained via Google search.

Kentucky FACE investigators recommend that employers prohibit employees from performing maintenance on dump beds while in the raised position. If bed cannot be lowered, employers should require utilization of

blocking and bracing devices.
